Cadia – Northern Tailings Dam

In the late afternoon of Friday 9 March 2018, a limited breakthrough of tailings material was identified at the Cadia northern tailings dam embankment.

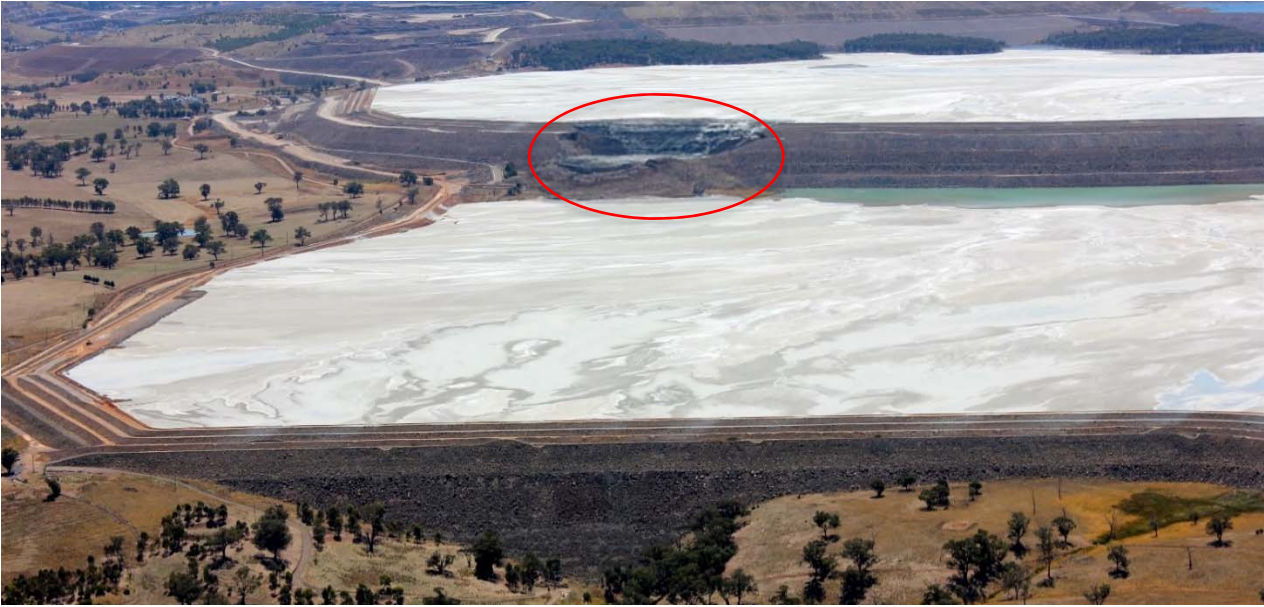
Photo of the Northern and Southern (forefront) Tailings Dams at Cadia

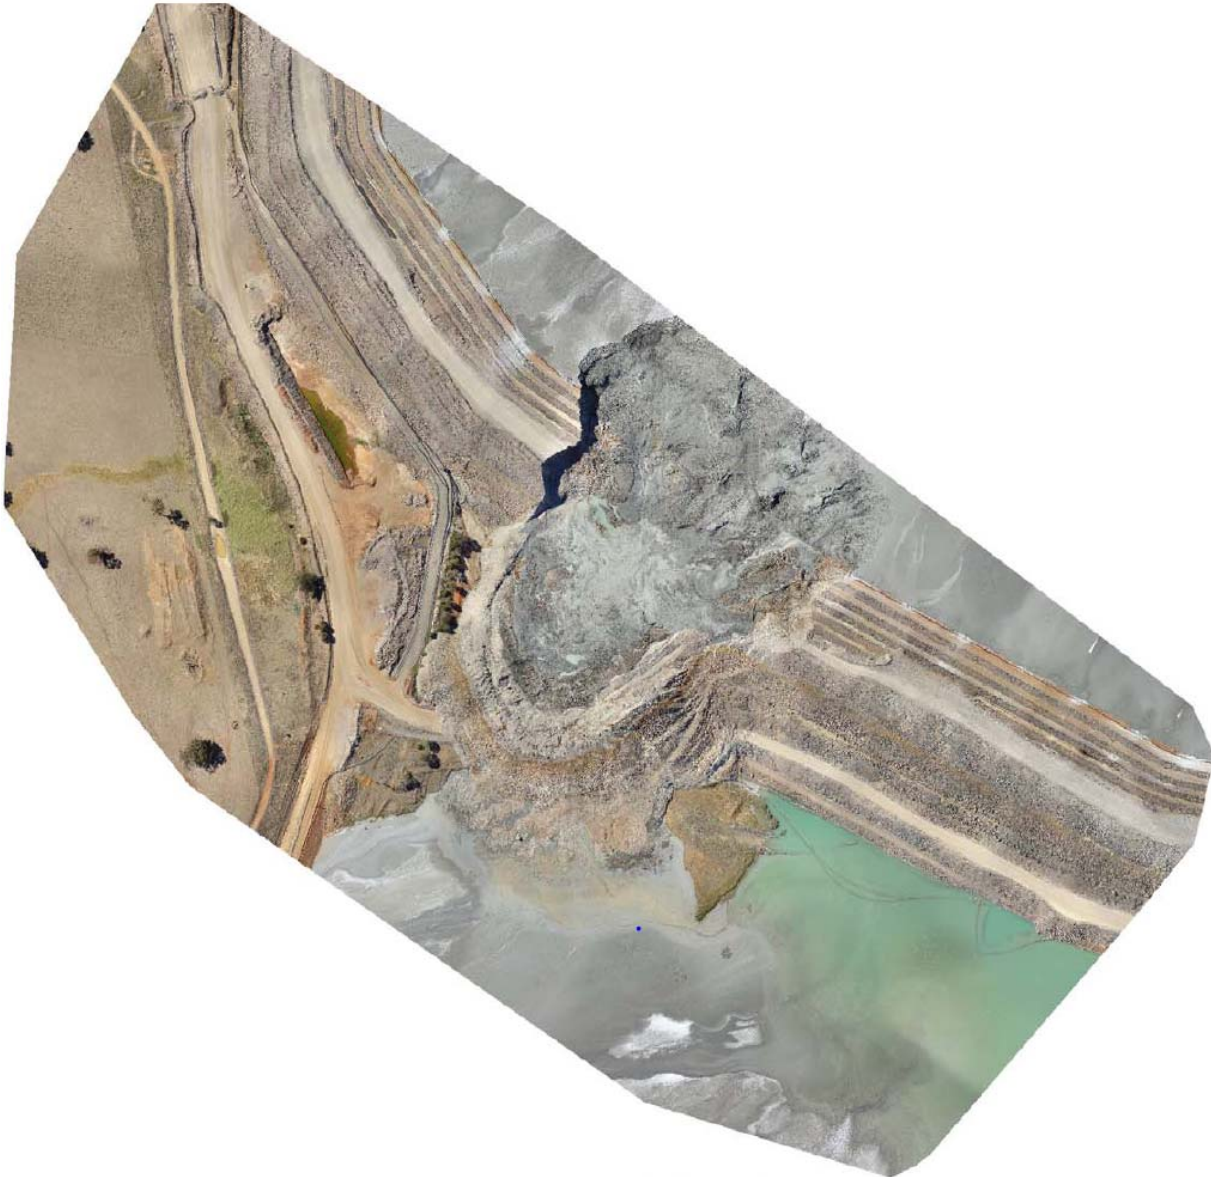
An area of the embankment slumped late Friday 9 March 2018 following the identification of cracks earlier in the day in the dam wall during a regular inspection. When such cracks were noticed the site team quickly engaged an independent geotechnical consultant to assist Newcrest's geotechnical engineers at Cadia with an inspection and preliminary assessment of the embankment.

Aerial view of failure zone

Geotechnical analysis has commenced on possible repair options of the failure zone. Work has also commenced on multiple recovery scenarios including alternative tailings locations such as the old Cadia Hill open pit, which is already the subject of a prefeasibility study to assess suitability for tailings disposal.
