12 April 2021

Saki Drill Pad and Trench Site Inspections Ahead of Fieldwork

Drill Pad Site Investigation:

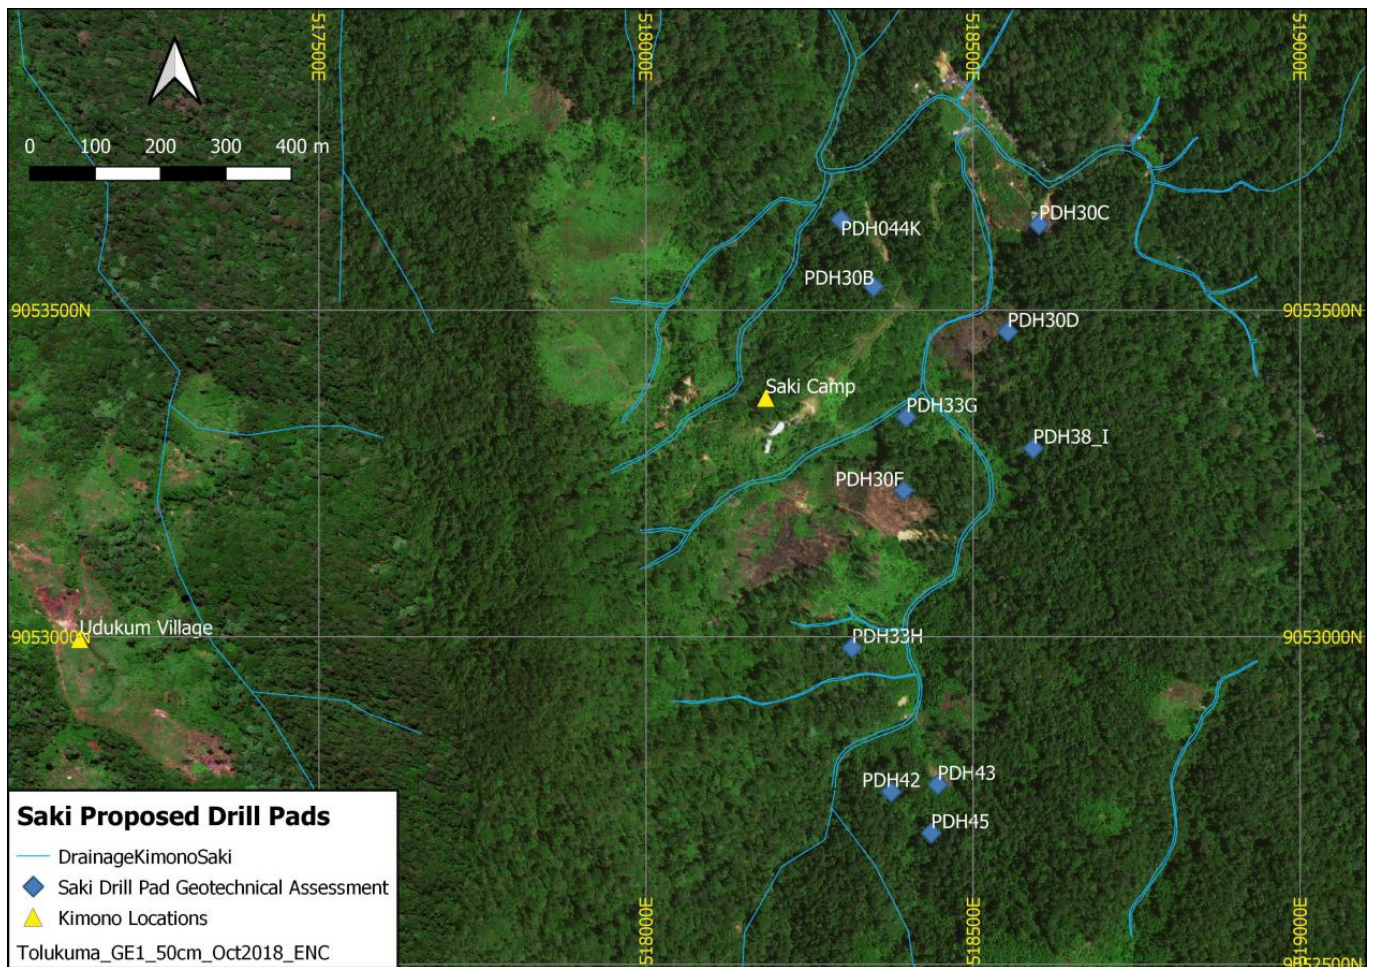
The geotechnical site investigation identified potential geohazards (landslips, tension cracks, wedge failures etc) that required immediate corrective safety measures. Four (4) drill pads were identified to be in high risk zones (landslips, steep gullies) and were relocated to safer areas (Figure 2). Two drill pads (PDH30D and PDH38I) with medium risk rating have nearby landslide (35m down hill) and active soil creeping respectively and needs to be monitored during pad clearance.

2. Drill Pad# PDH30C (518601e, 9053631n): The proposed pad has been relocated 31m north of the original proposed site. The original site is within a steep gully that is 40m above a recent landslide. It may need to be re-located again following a major landslide in late December 2020.

Figure 2: Relocated Drill Pad Locations (PDH30C, E-F and H)

4. Drill pad PDH30E & F (518394e, 9053224n): Original proposed site unfavourable due to massive landslide. Pad relocated 24m north towards to a stable gentle slope (20°). Slope stability okay. Saprolite and brown-orange soil. Large area which will require 1 week of pad construction.

6. Drill Pad# PDH33H (518315e, 9052983n): Original site is unsuitable so pad has been relocated 27m north west up to the ridge. Favourable site along bush track and near ridge top. Ground is stable, composed of competent pyroclastics. Slope stability okay. 2-3 weeks pad construction required.

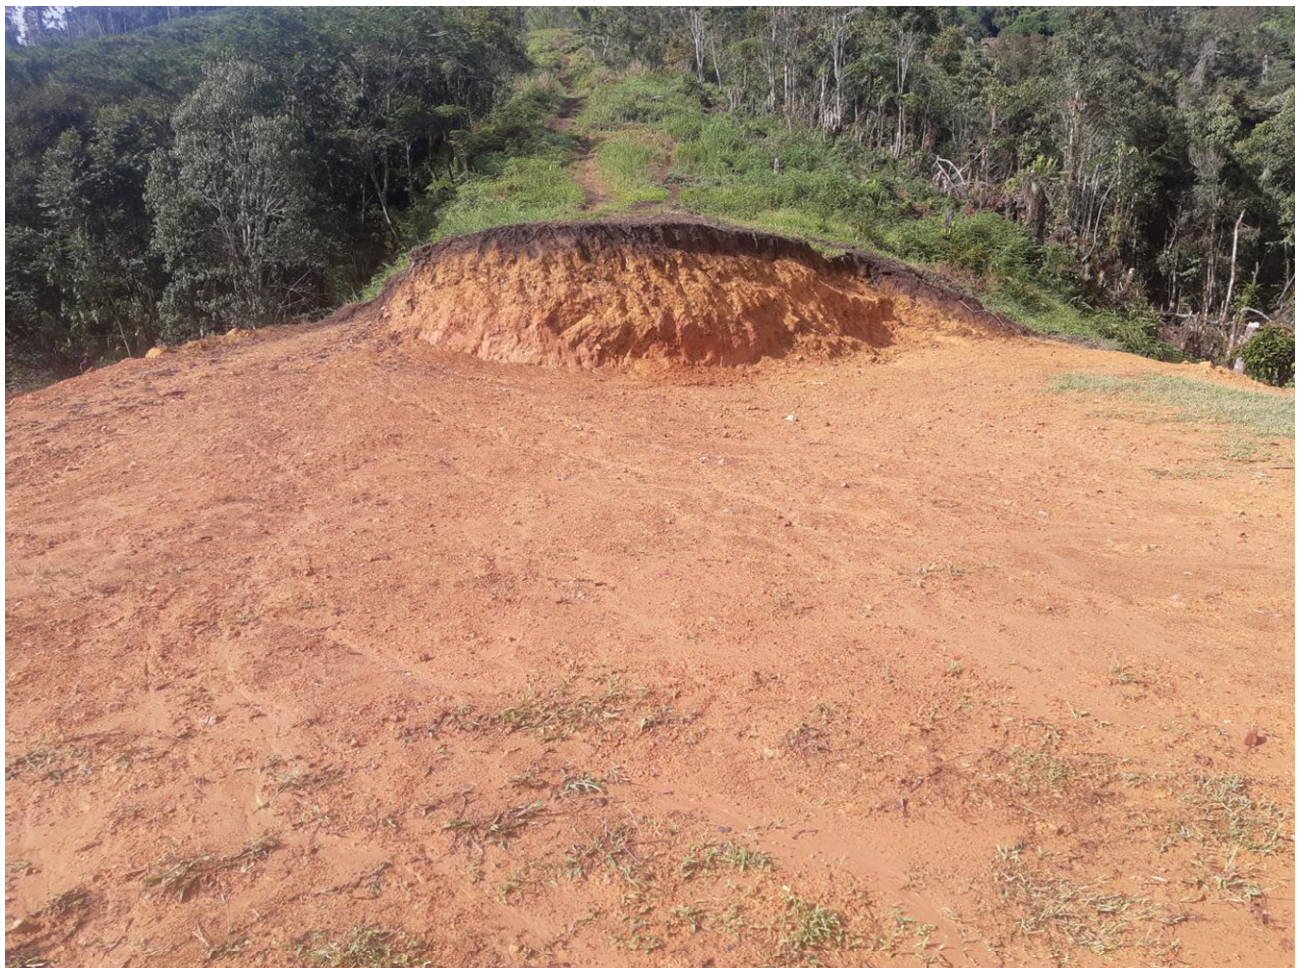
1. Drill Pad# PDH30A & B (518348e, 9053536n): Site had been cleared by the locals and currently used as a helipad and is on stable ground. The pad is on a gentle slope so there is no major risk of landslides within the pad vicinity. The pad dimension is 20m X 14m, completed and ready for drilling (Photo 1).

Photo 1: Constructed Drill Pad PDH30A & B Completed and Ready for Drilling.

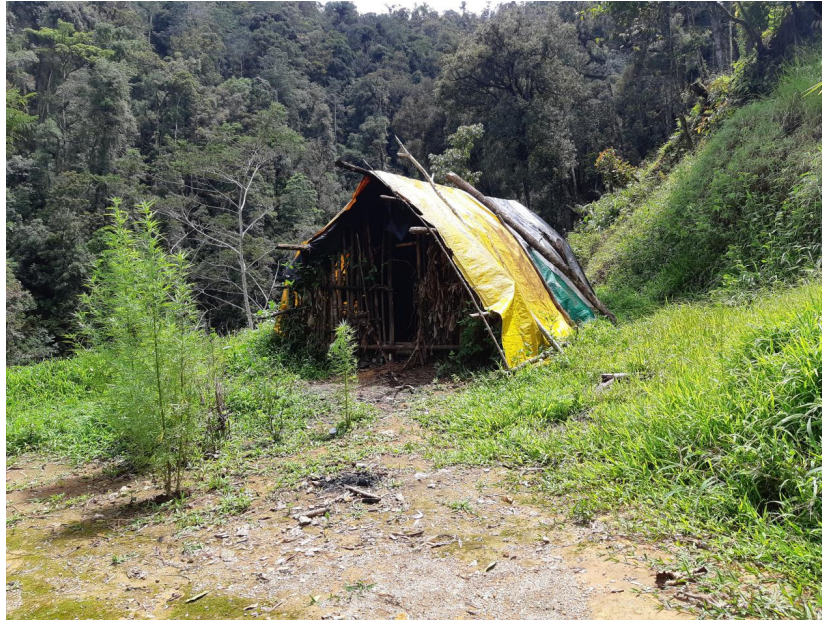
5. Drill Pad# PDH33G (518398e, 9053337n): Pad is on favourable competent ground and down slope angles are low-moderate. Pad dimension is 17m X 10m and ready for drilling. Will need to remove a local villager's hut on the pad prior to drilling (Photo 2).

Photo 2: Drill Pad PDH30G

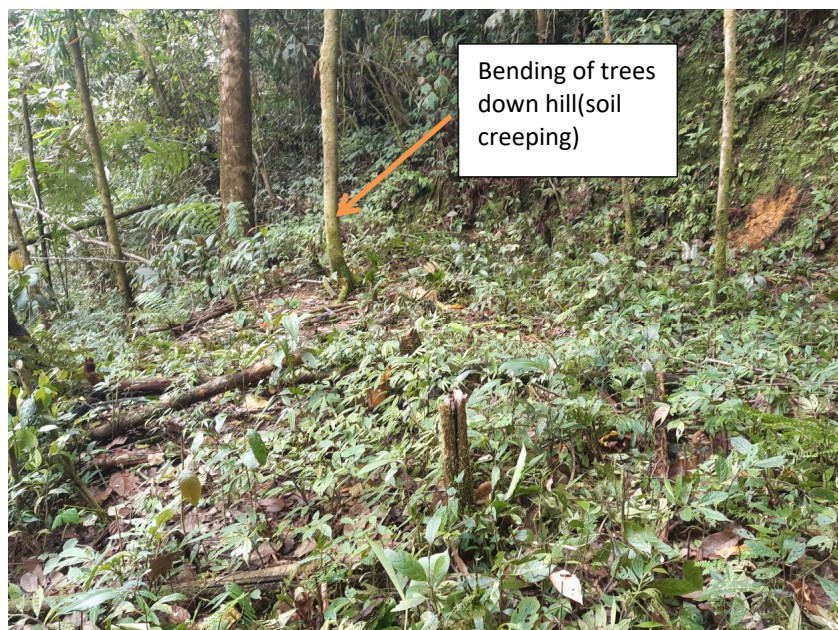
7. Drill Pad# PDH38I (518592e, 9053289n): On a ridge on totally oxidised and weathered pyroclastics but still competent. No signs of landslips but some bit of soil creeping shown by trees (Photo 3). Pad dimension is 11m X 5m and needs extensions of 3m X 3m with 1 week of digging required to complete.

Photo 3: Pad PDH38I with Soil Creeping Shown by Slight Bending of Trees
