**COLORADO DEPARTMENT OF TRANSPORTATION  
INTERSTATE 70 VAIL PASS PAVING TRIAL UPDATE**

### Colorado Department of Transportation Interstate 70 Vail Pass Paving Trial Update

### **Eden's 1-Year In-Service Evaluation**

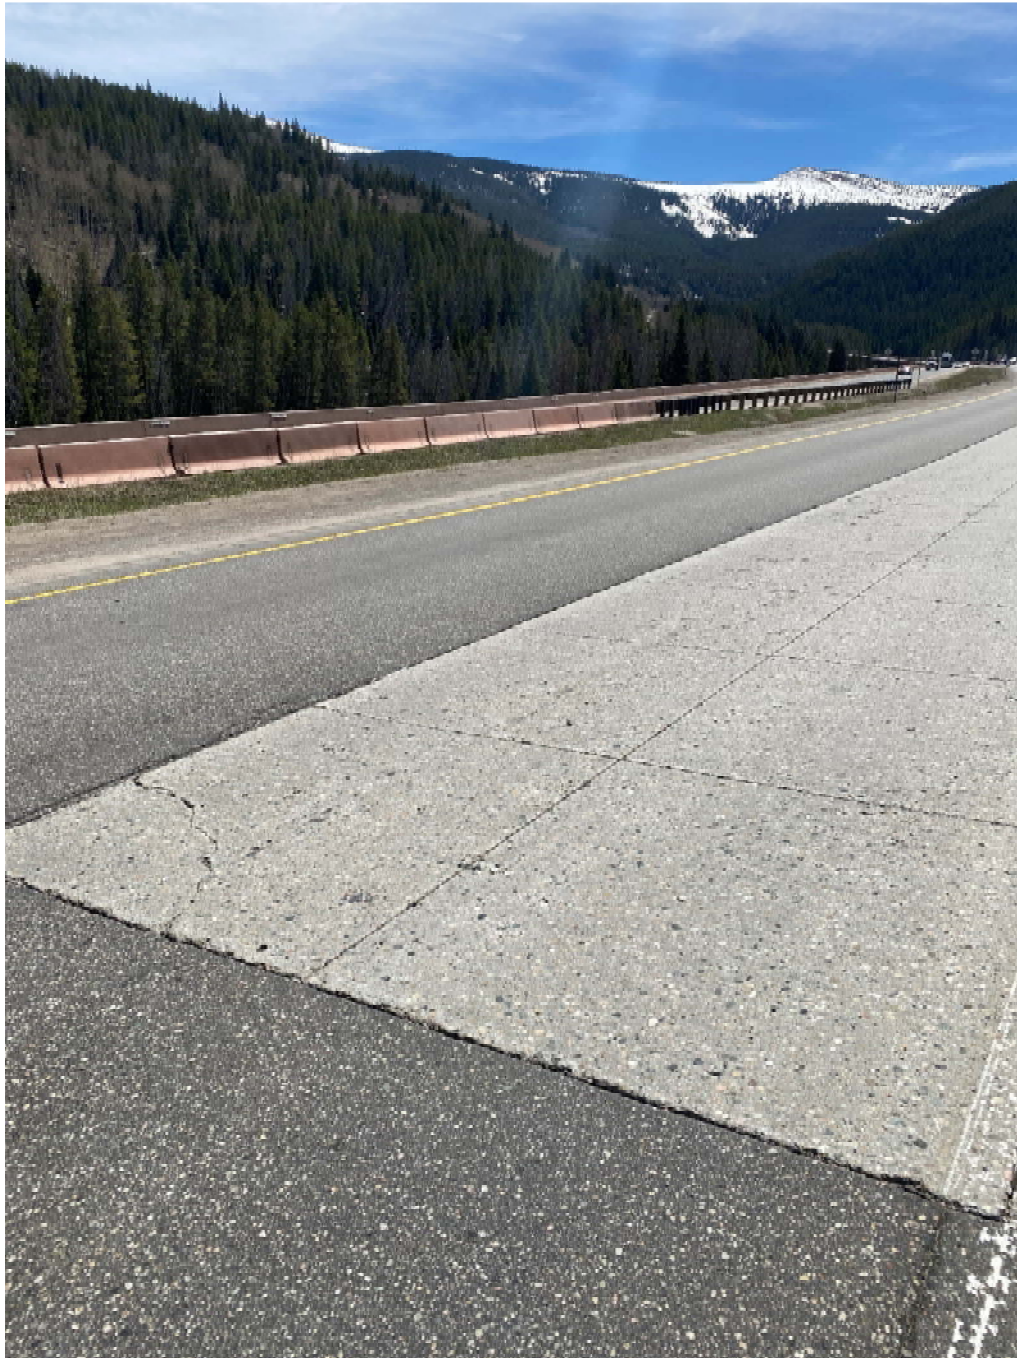
**Figure 4**

Considering the pitting, small potholes, and shallow rutting already occurring, this section of pavement could require repair as it continues to deteriorate to a level which is unsafe for public and commercial vehicle traffic. The top surface of the pavement has abraded below the surface of the coarse aggregate from edge to edge and along the entire length of the reference section. There is a large crack across one section of the reference pavement and there is damage from snow chains across the entire surface.

Beginning-Section Reference Slab -12 months

Top concrete surface worn off, Cracking, Scaling, Surface Aggregate Pop Outs, Rutting, Joint Rot

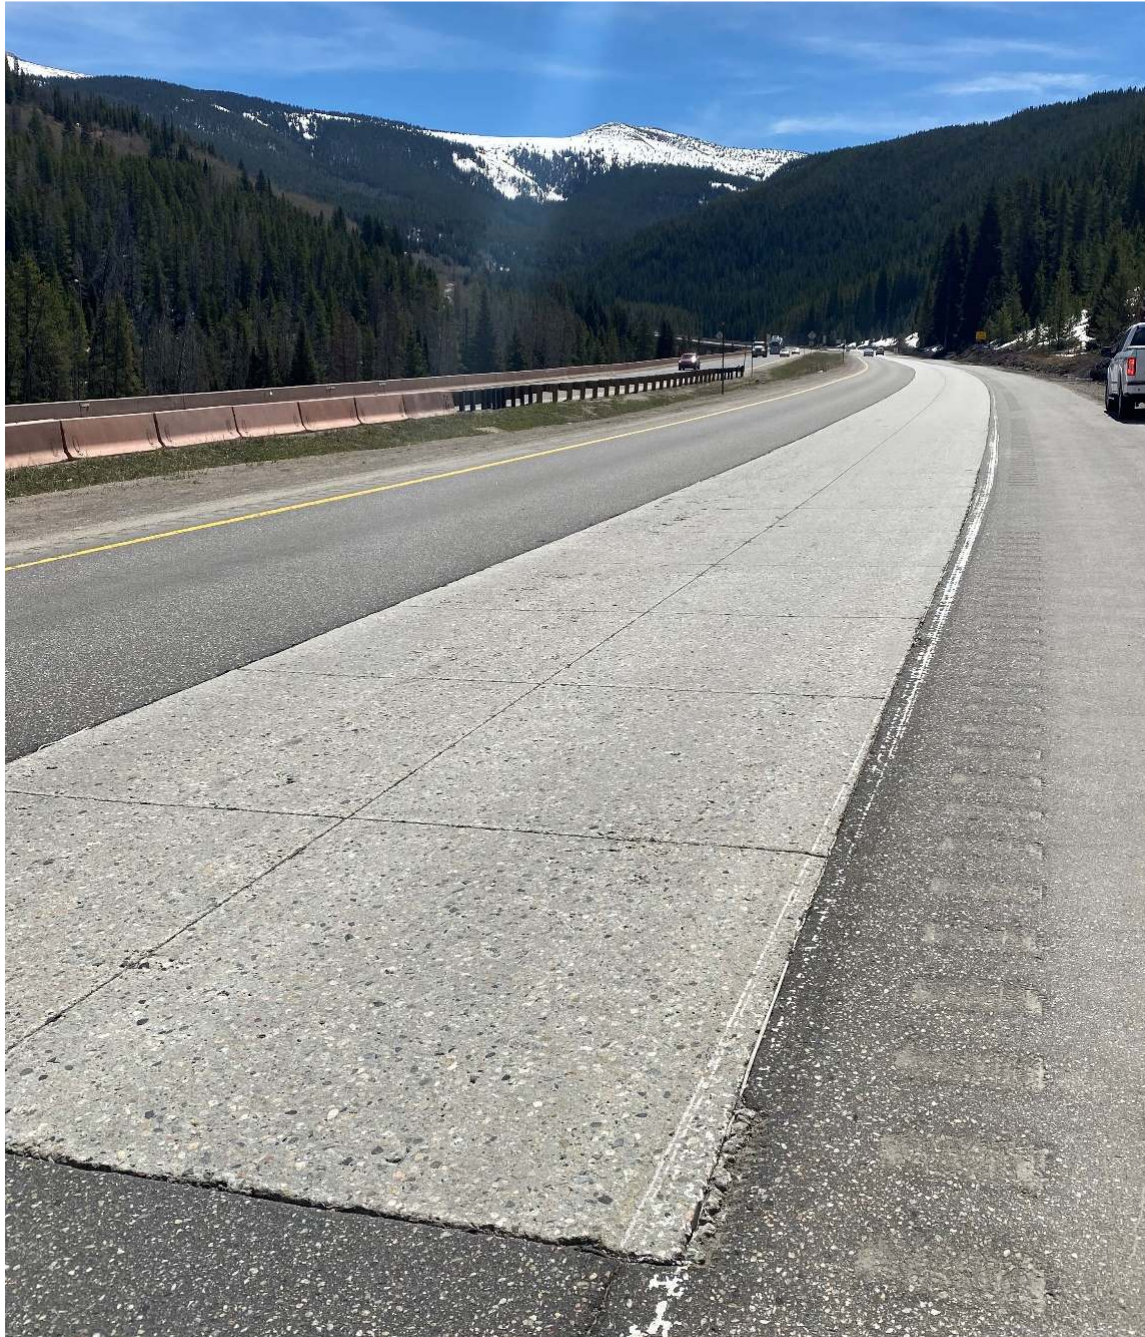
**Figure 5**  
Beginning-Section Reference Slab -12 months  
Top concrete surface worn off, Cracking, Scaling, Surface Aggregate Pop Outs, Rutting, Joint Rot

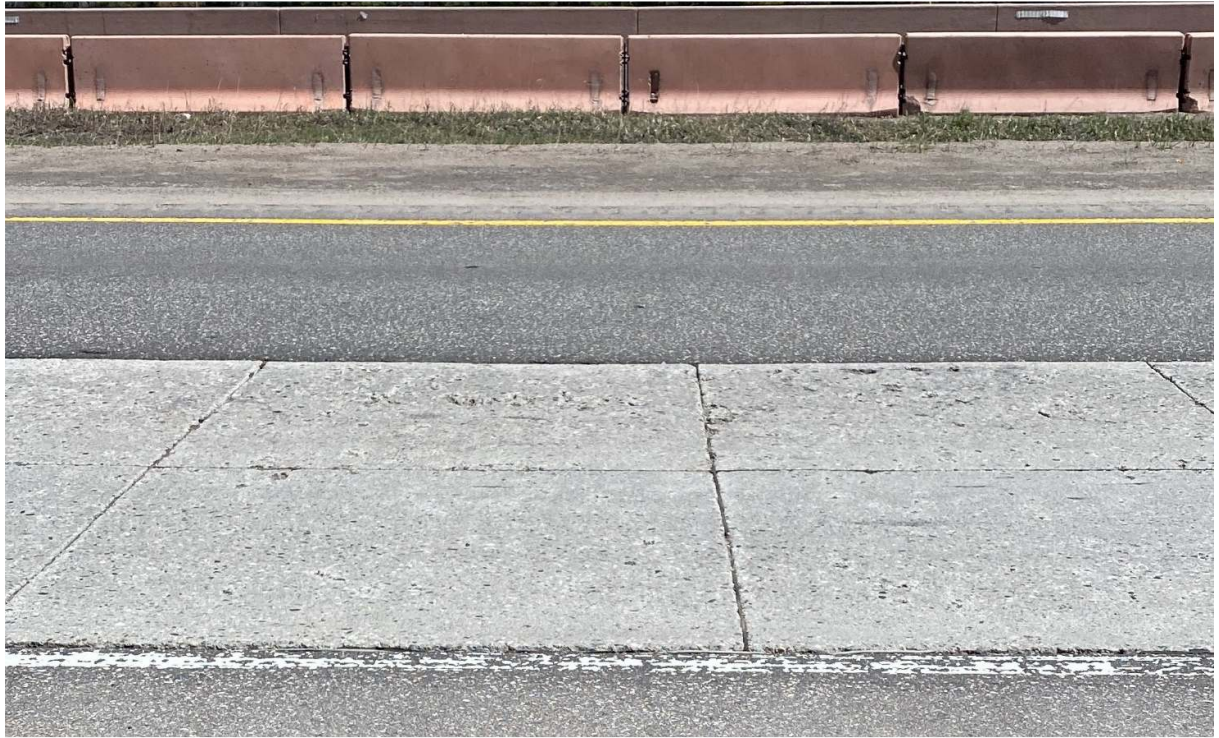
**Figure 6**  
Mid -Section Reference Slab -12 months  
Scaling, Surface Damage, Pitting and Aggregate Pop Outs, Rutting, Joint Rot

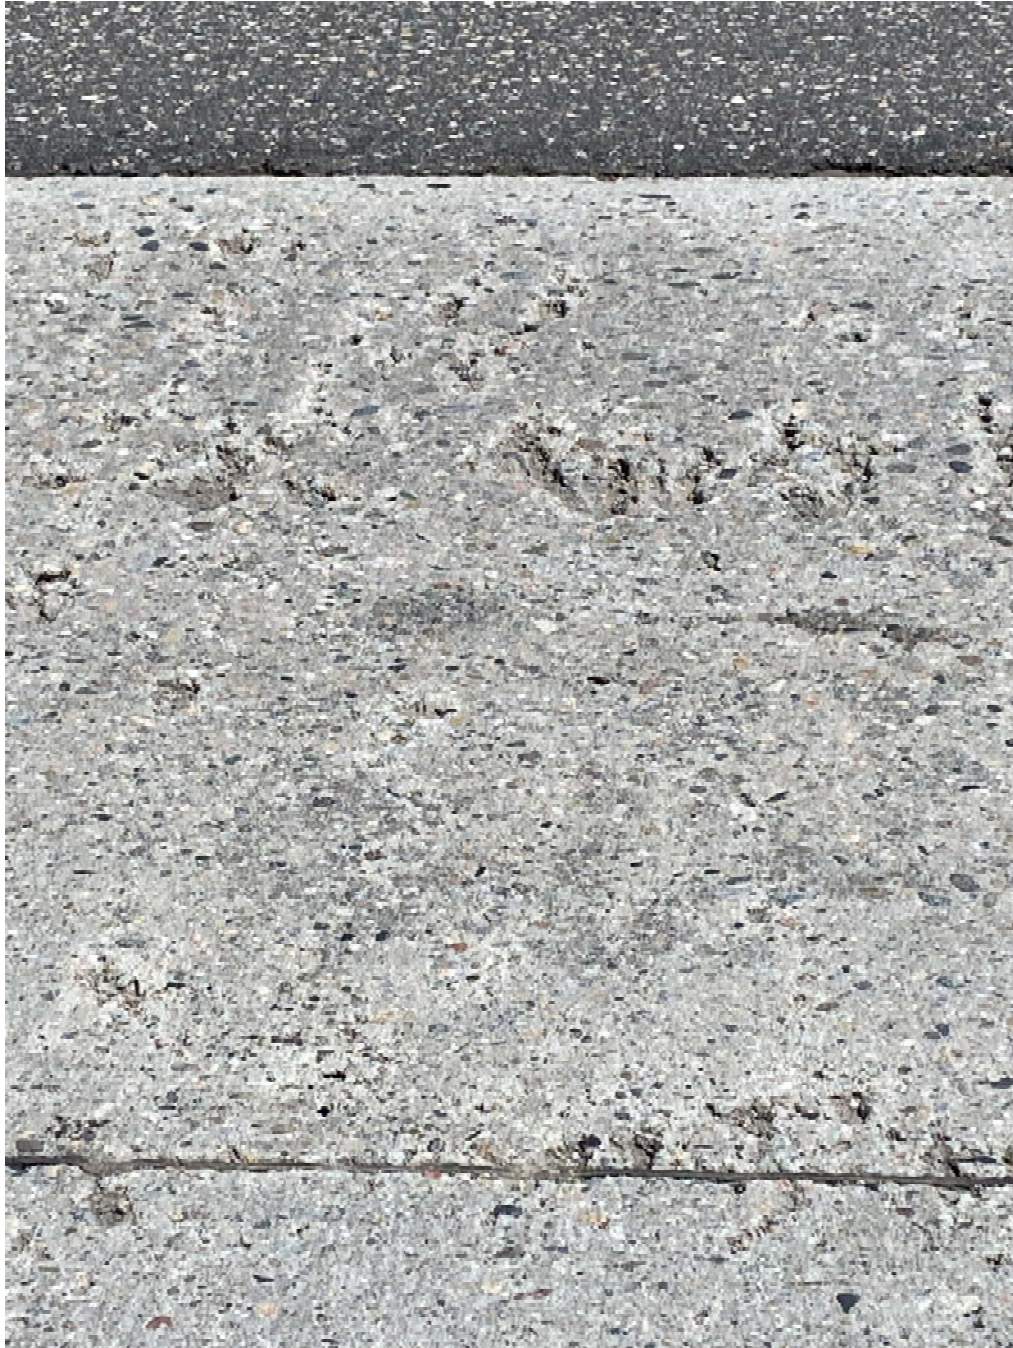
**Figure 7**  
Mid-Section Reference Slab -12 months  
Close up Figure 3 Scaling, Surface Damage, Pitting and Aggregate Pop Outs

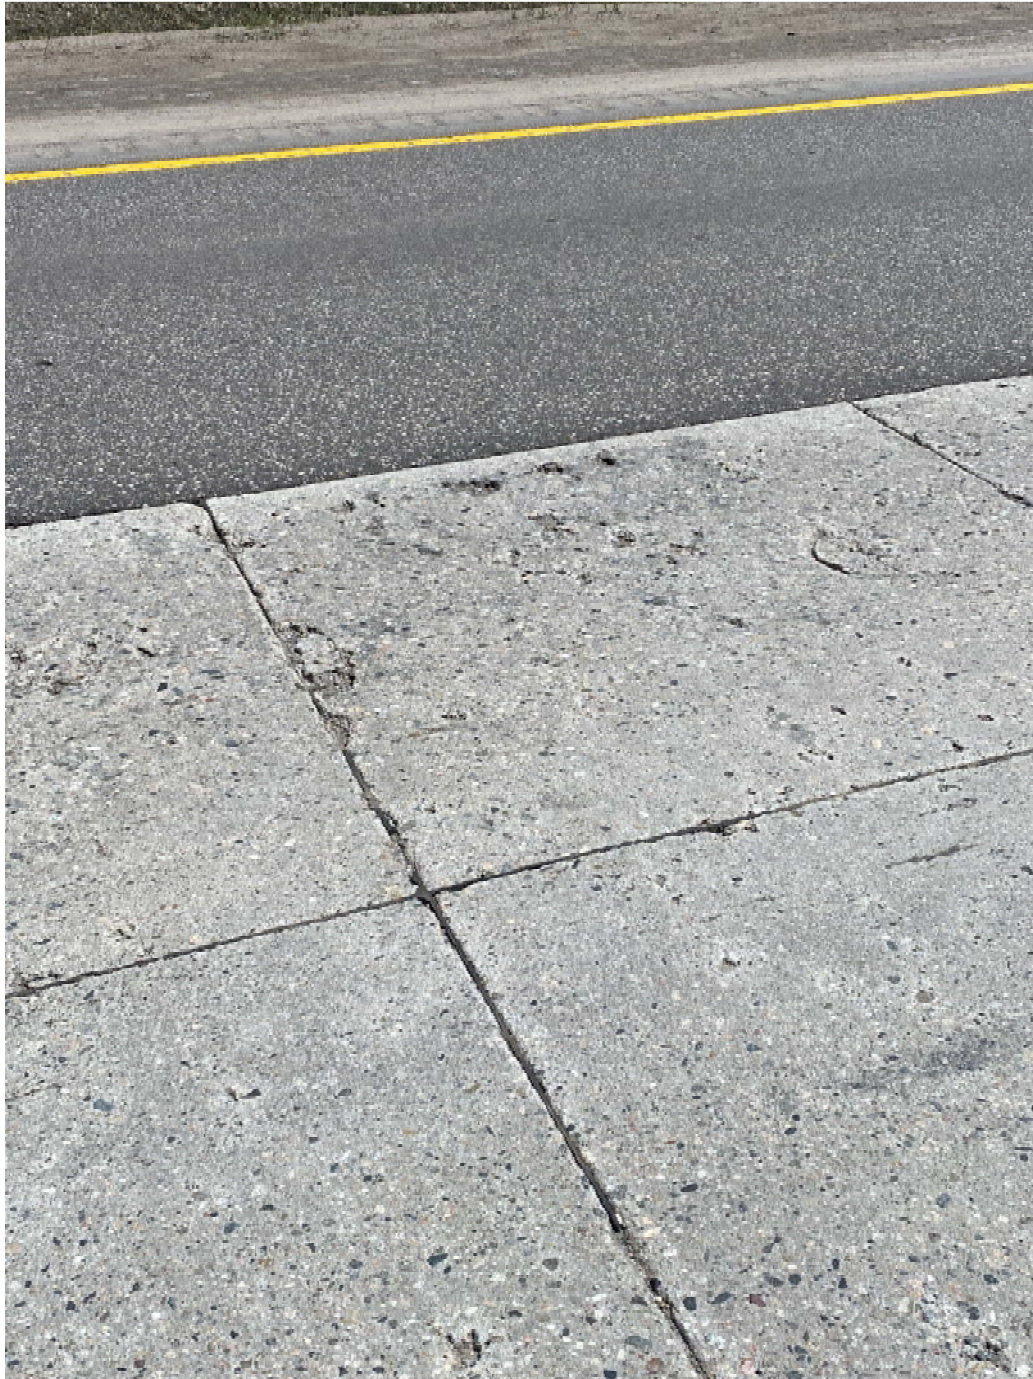
**Figure 8**  
Mid-Section Reference Slab -12 months  
Close up Figure 3 Severe Surface Damage, and Joint Rot

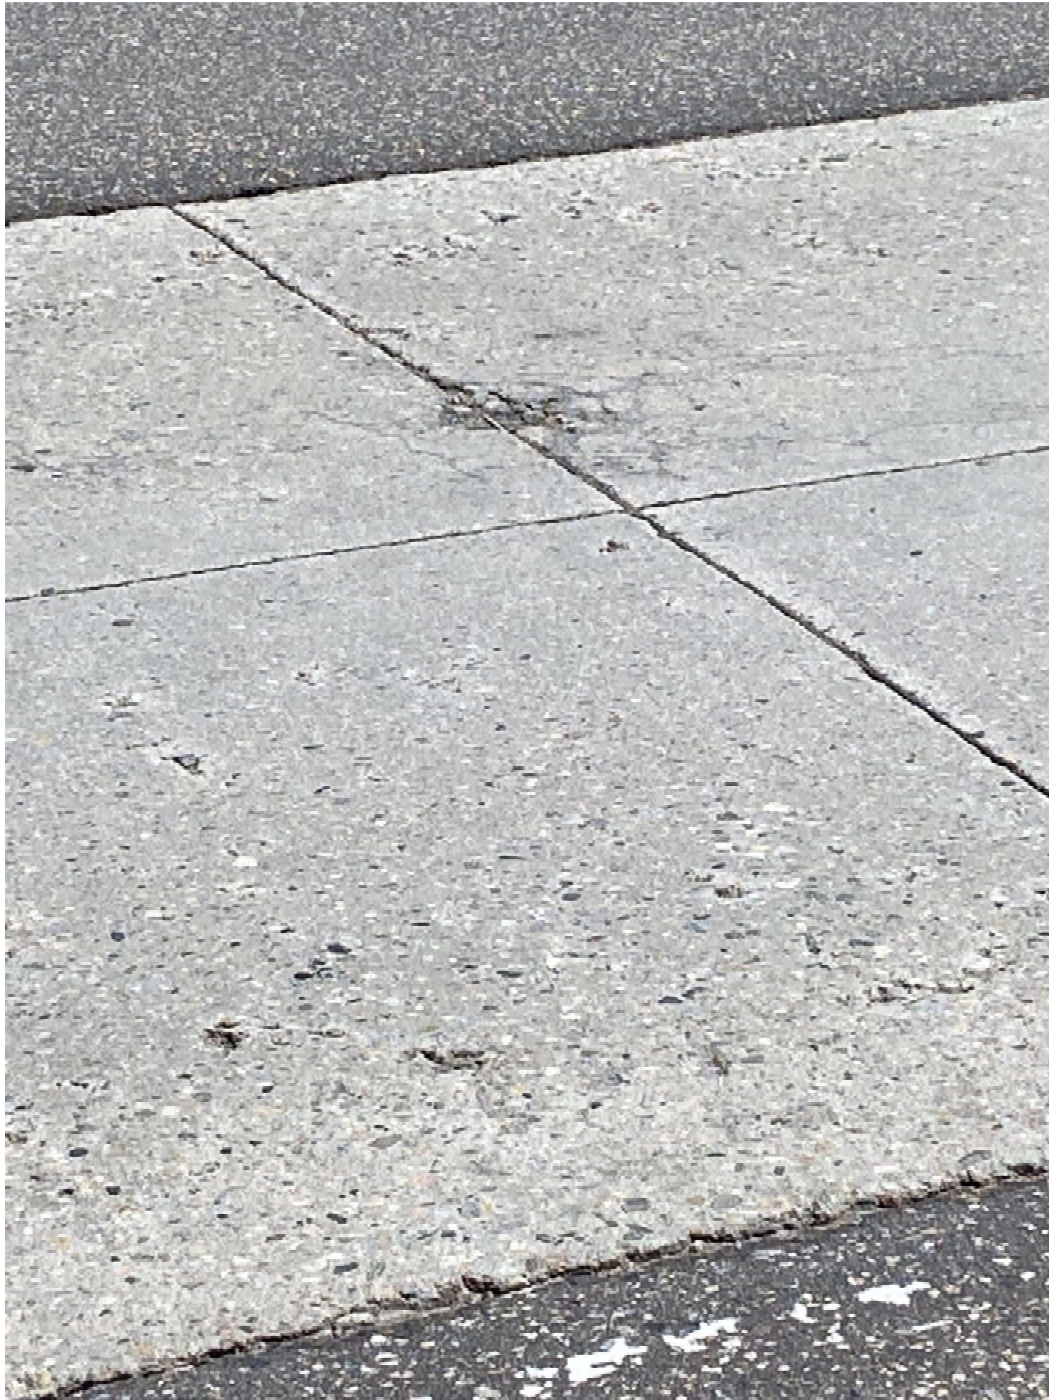
**Figure 9**  
Mid-Section Reference Slab -12 months  
Scaling, Surface Damage, and Joint Rot

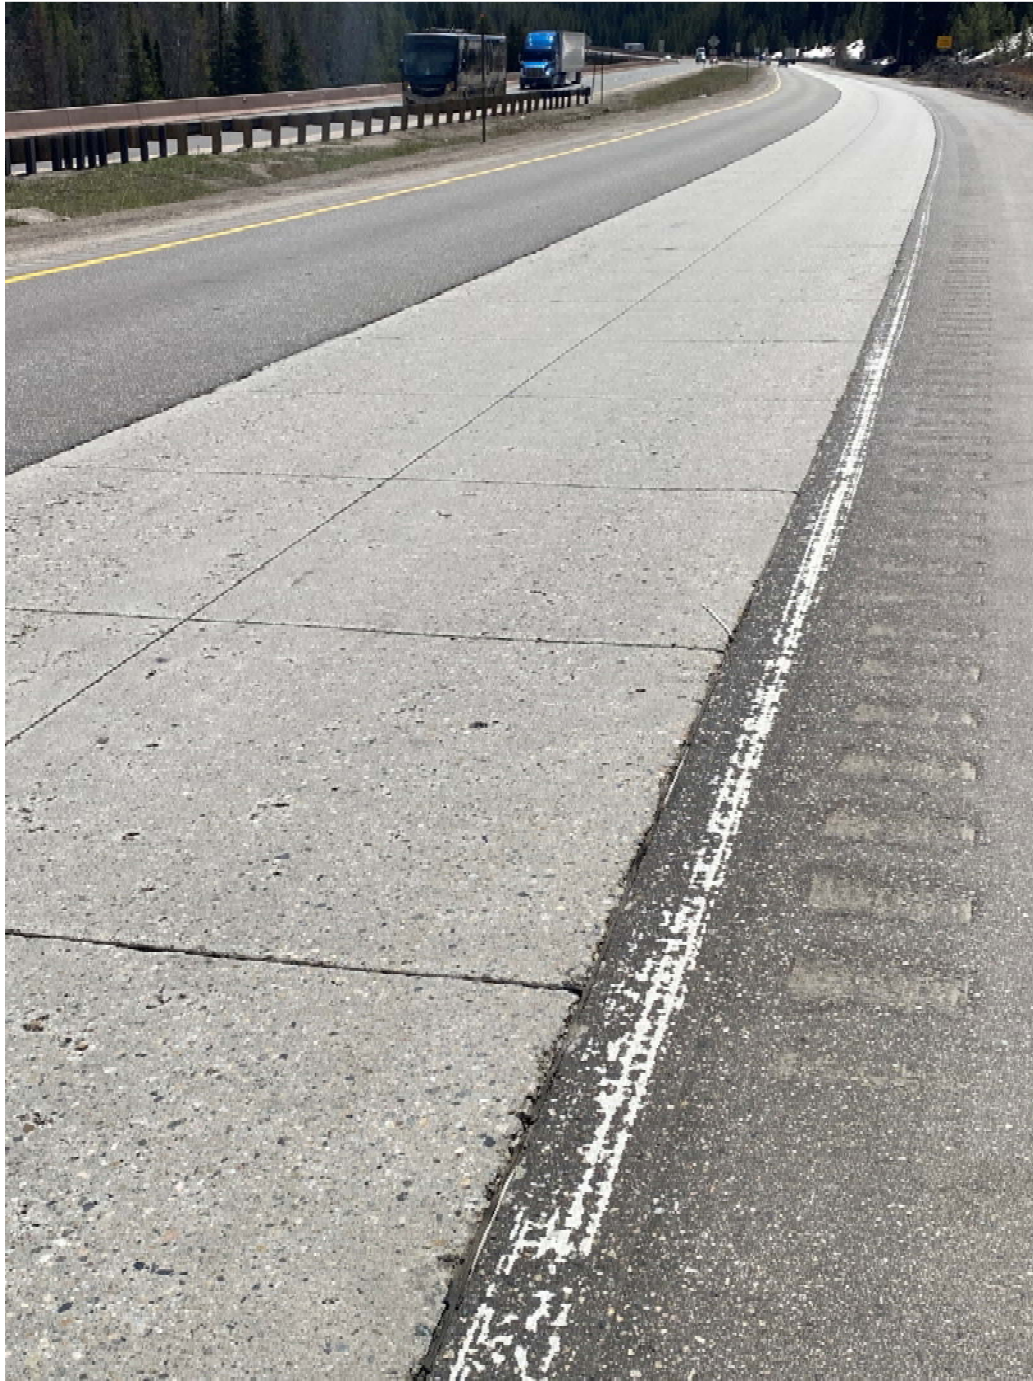
**Figure 10**  
End-Section Reference Slab - 12 months  
Scaling, Surface Damage Aggregate Pop Outs

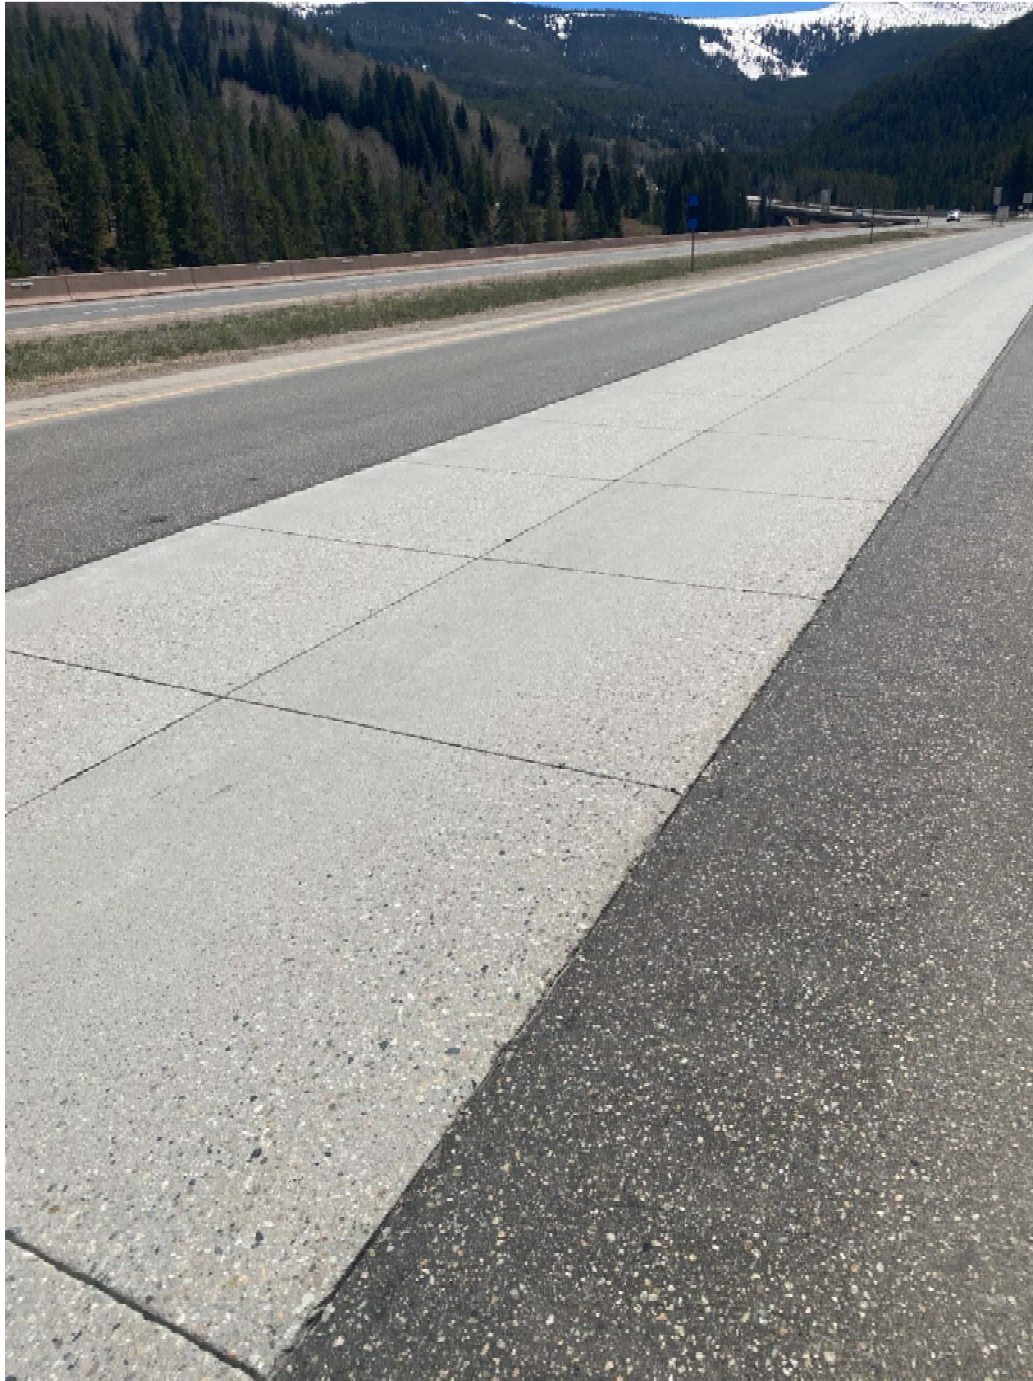
**Figure 11**

Beginning-Section EdenCrete® Slab - 12 months

Top concrete surface partially worn off, No Scaling, No Surface Damage, No Pitting and Aggregate Pop Outs, No Rutting, No Joint Rot

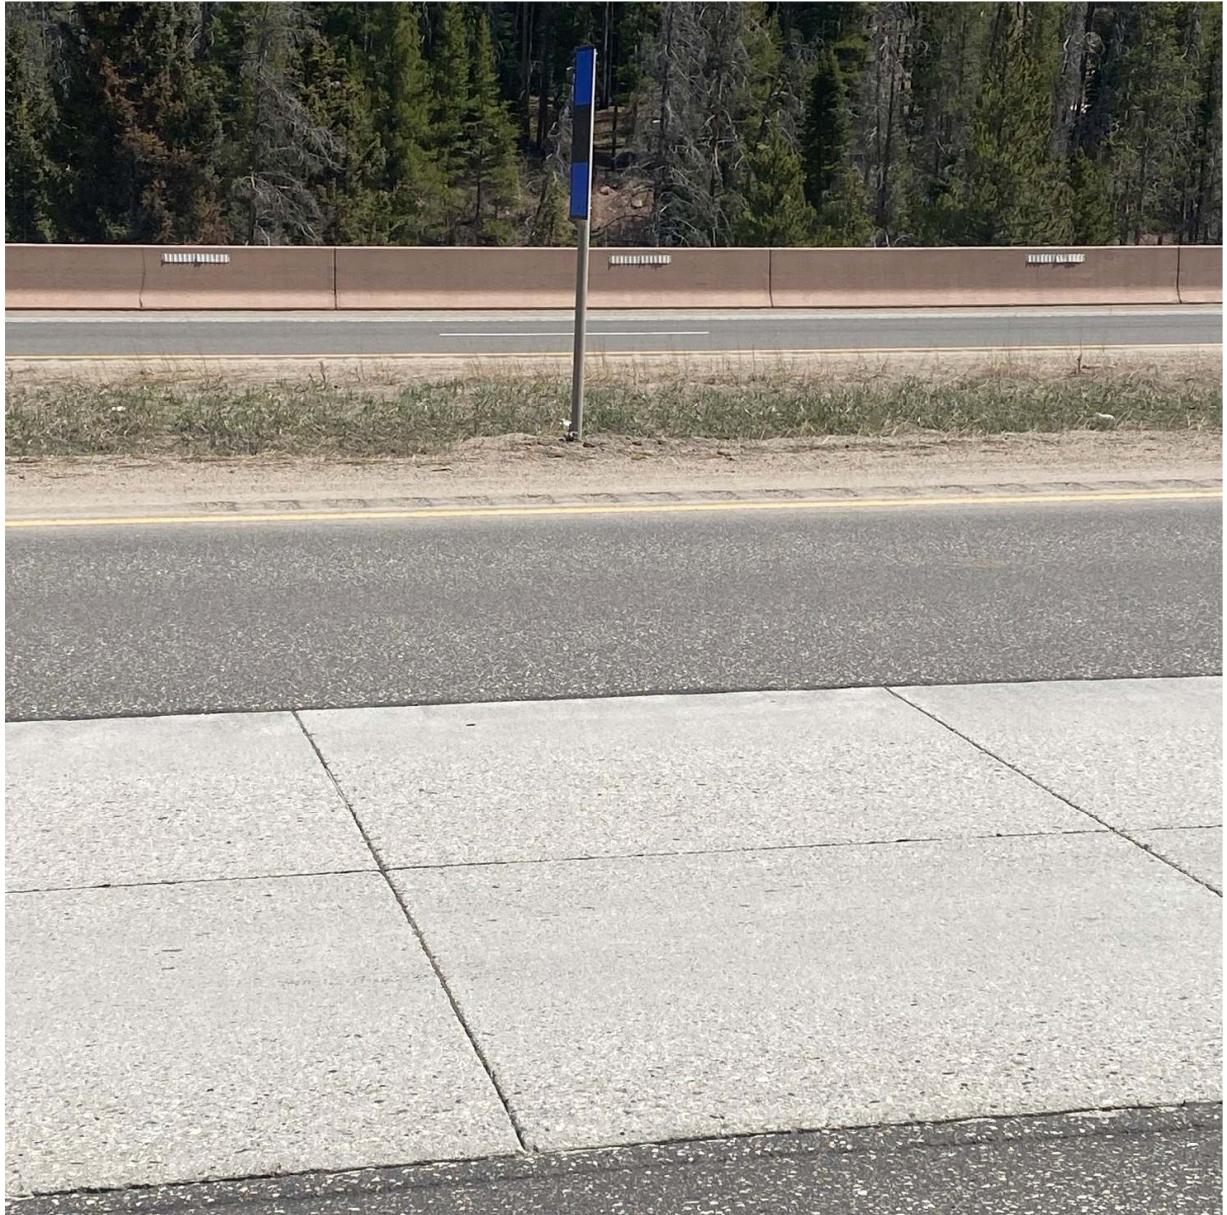
**Figure 12**

Mid-Section EdenCrete® Slab – 12 months

Top concrete surface partially worn off, No Scaling, No Surface Damage, No Pitting and Aggregate Pop Outs, No Rutting, No Joint Rot

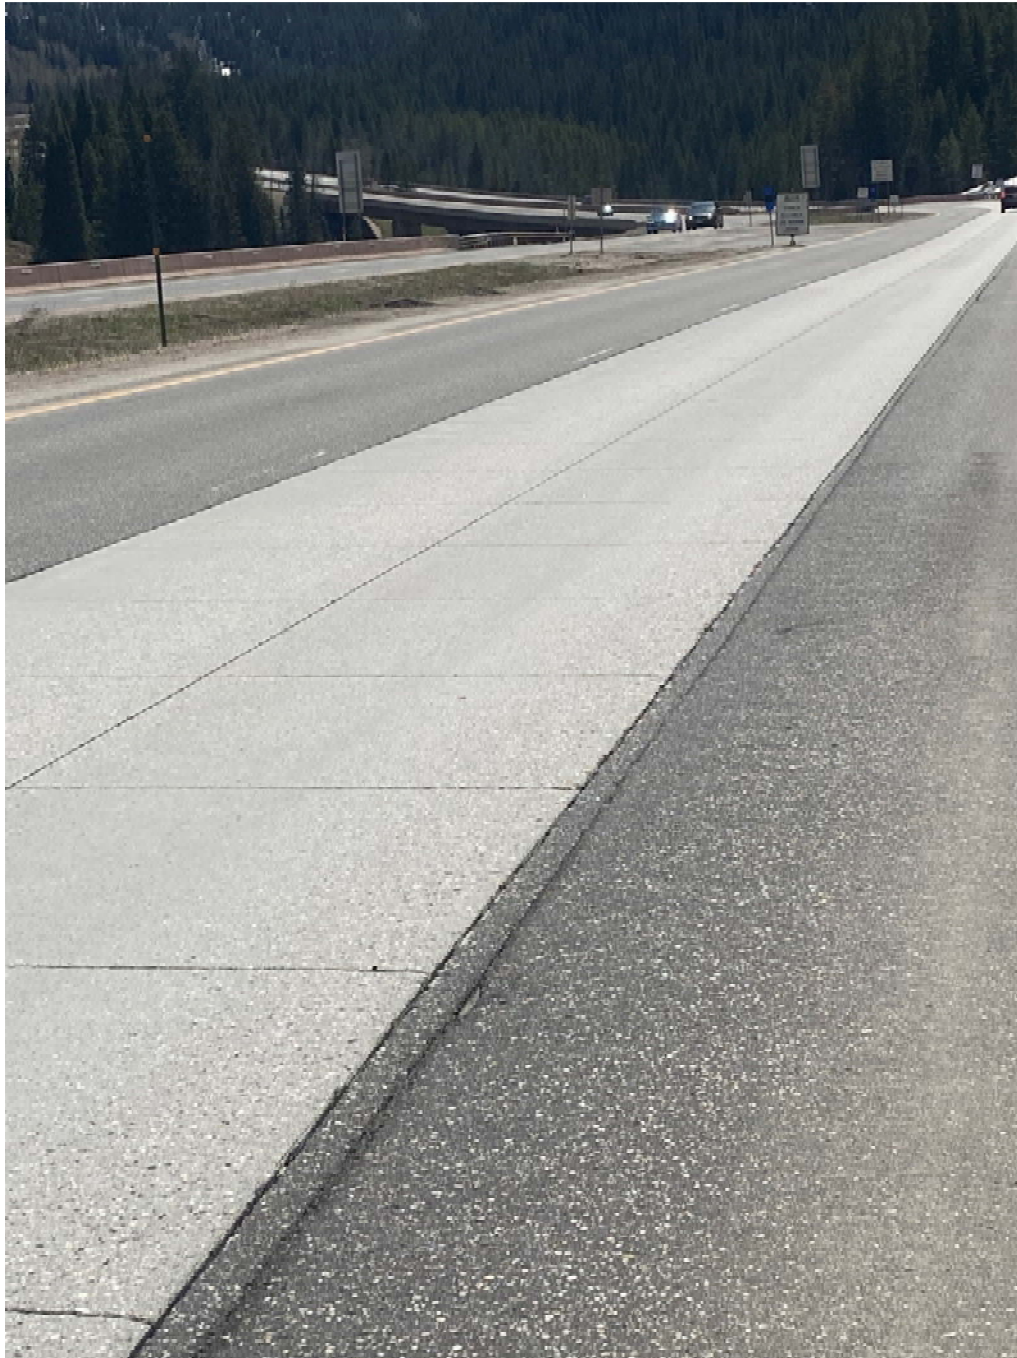
**Figure 13**

Mid-Section EdenCrete® Slab - 12 months

Top concrete surface partially worn off, No Scaling, No Surface Damage, No Pitting and Aggregate Pop Outs, No Rutting, No Joint Rot

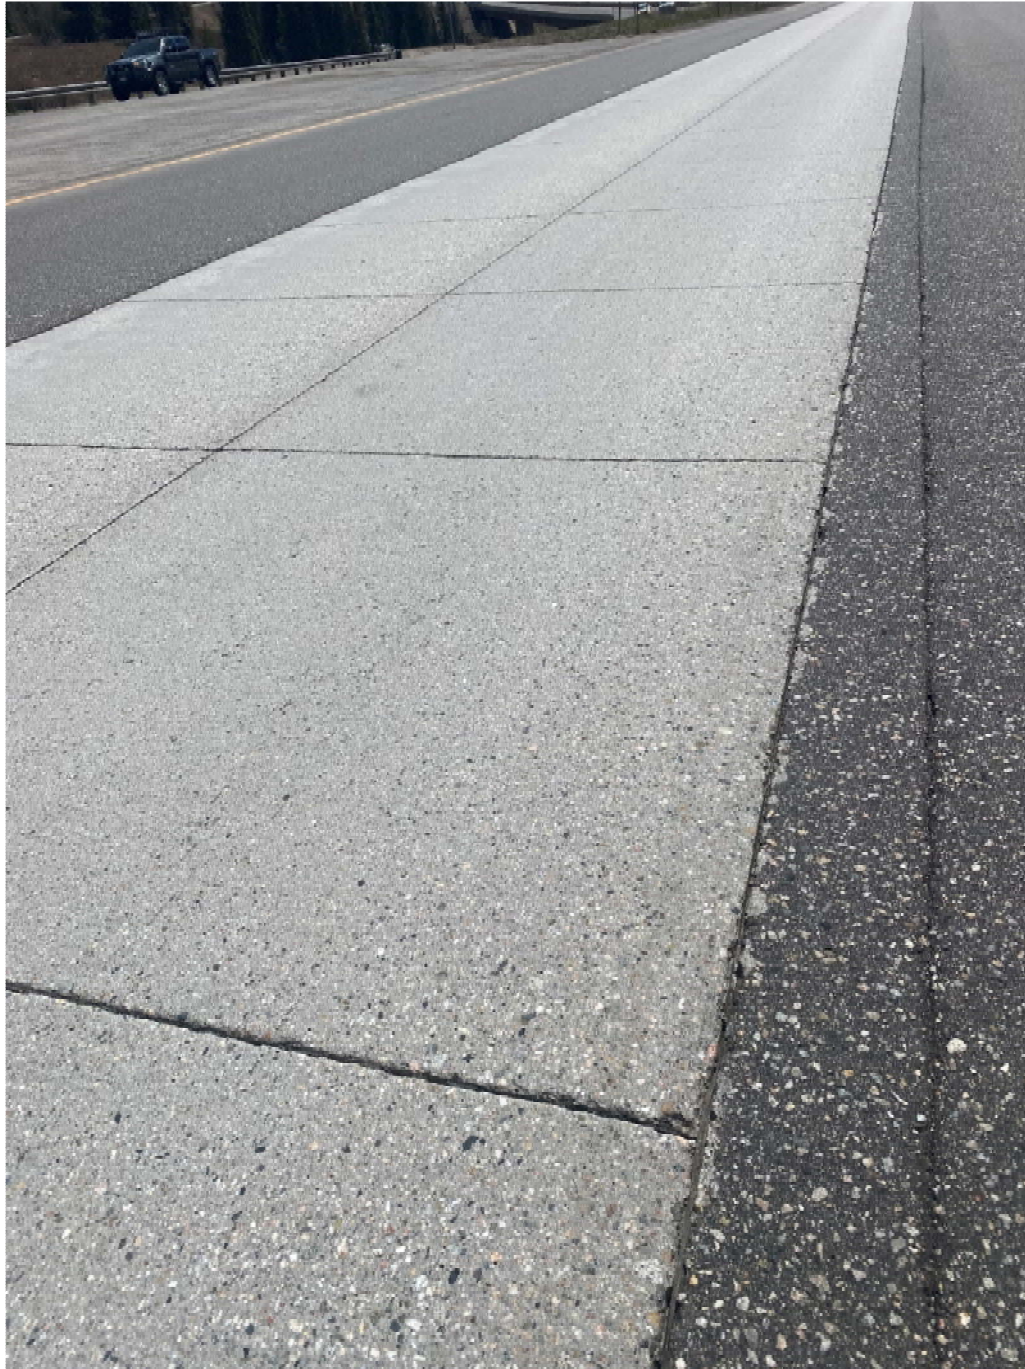
**Figure 14**

End-Section EdenCrete® Slab -12 months

Top concrete surface partially worn off, No Scaling, No Surface Damage, No Pitting and Aggregate Pop Outs, No Rutting, No Joint Rot

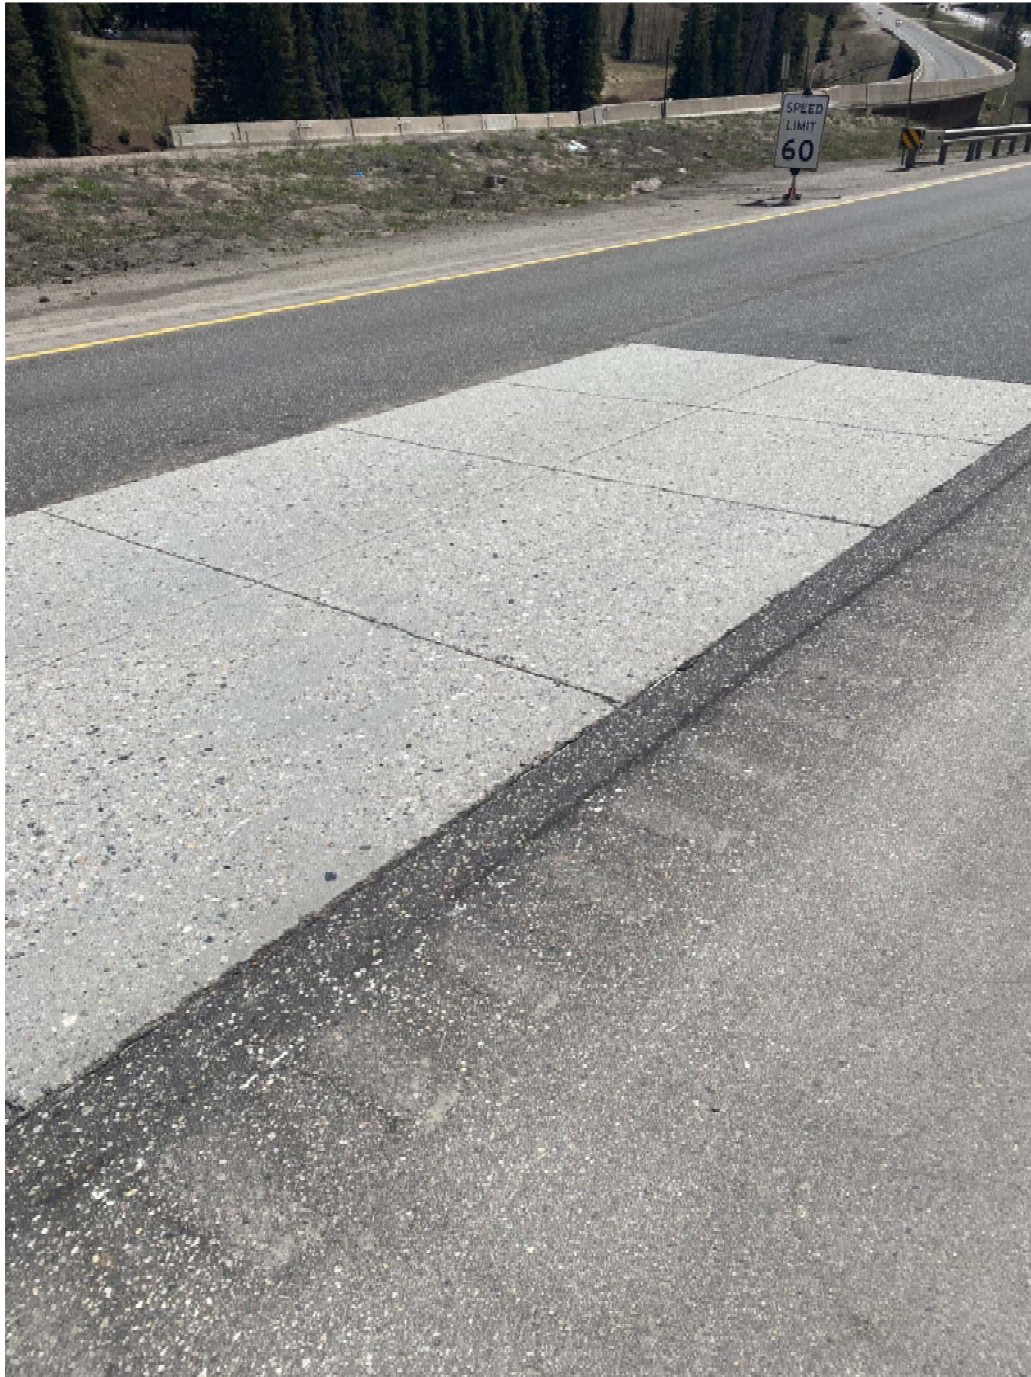
**Figure 15**

End-Section EdenCrete® Slab – 12 months

Top concrete surface partially worn off, No Scaling, No Surface Damage, No Pitting and Aggregate Pop Outs, No Rutting, No Joint Rot

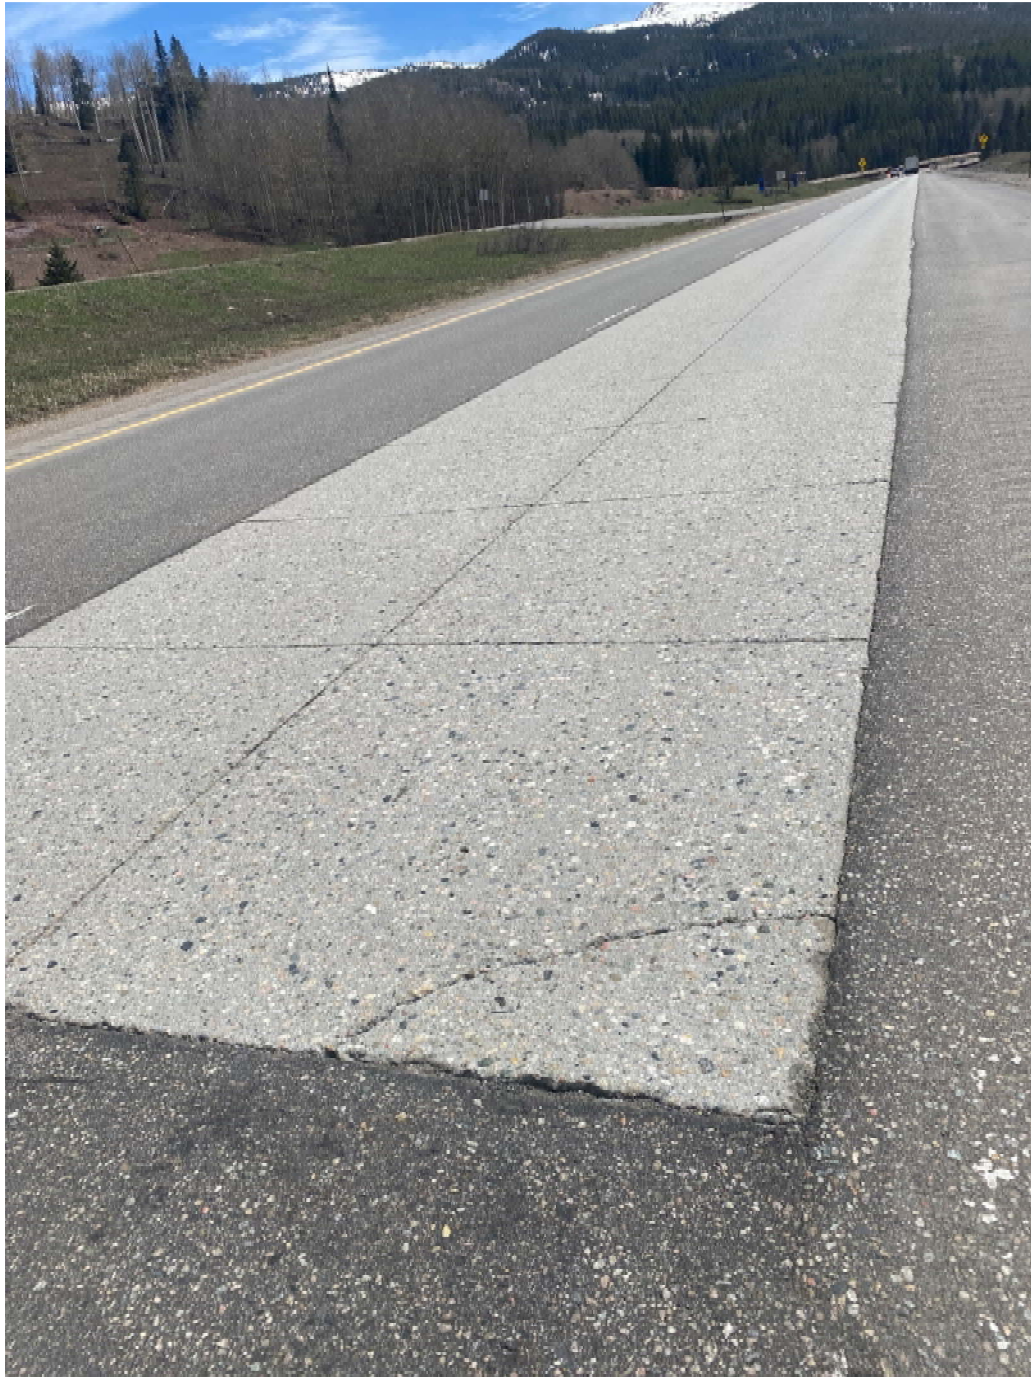
The silica fume pavement has also deteriorated significantly, as is also reflected in the summary table with a ‘yes’ for 4 of 5 modes of deterioration, and also in Figures 16-20. Similar to the reference, the top surface of the pavement has scaled to the point of delamination and the surface has abraded below the surface of the coarse aggregate across the entire surface. There is also a large crack across one section of the silica fume pavement. Snow chains are also damaging the surface to the point of rutting.

**Figure 16**  
Beginning-Section Silica Fume Slab – 12 months  
Top concrete surface worn off, Scaling, Cracking, Pitting and Aggregate Pop Outs, Joint Rot

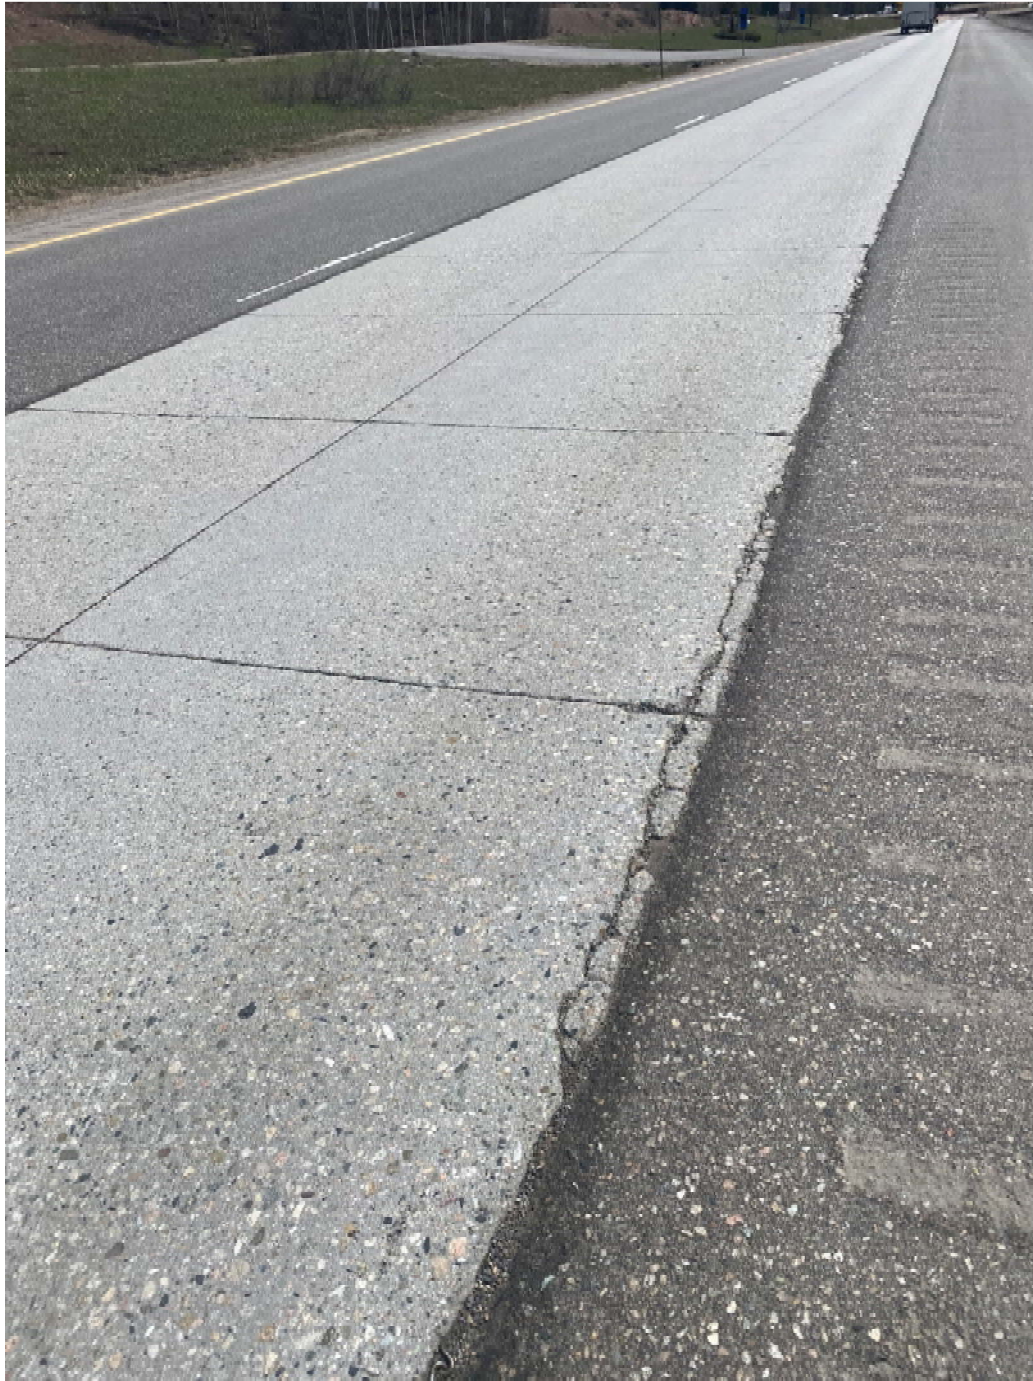
**Figure 17**

Beginning-Section Silica Fume Slab - 12 months

Top concrete surface partially worn off, Scaling, Cracking, Pitting and Aggregate Pop Outs, Joint Rot

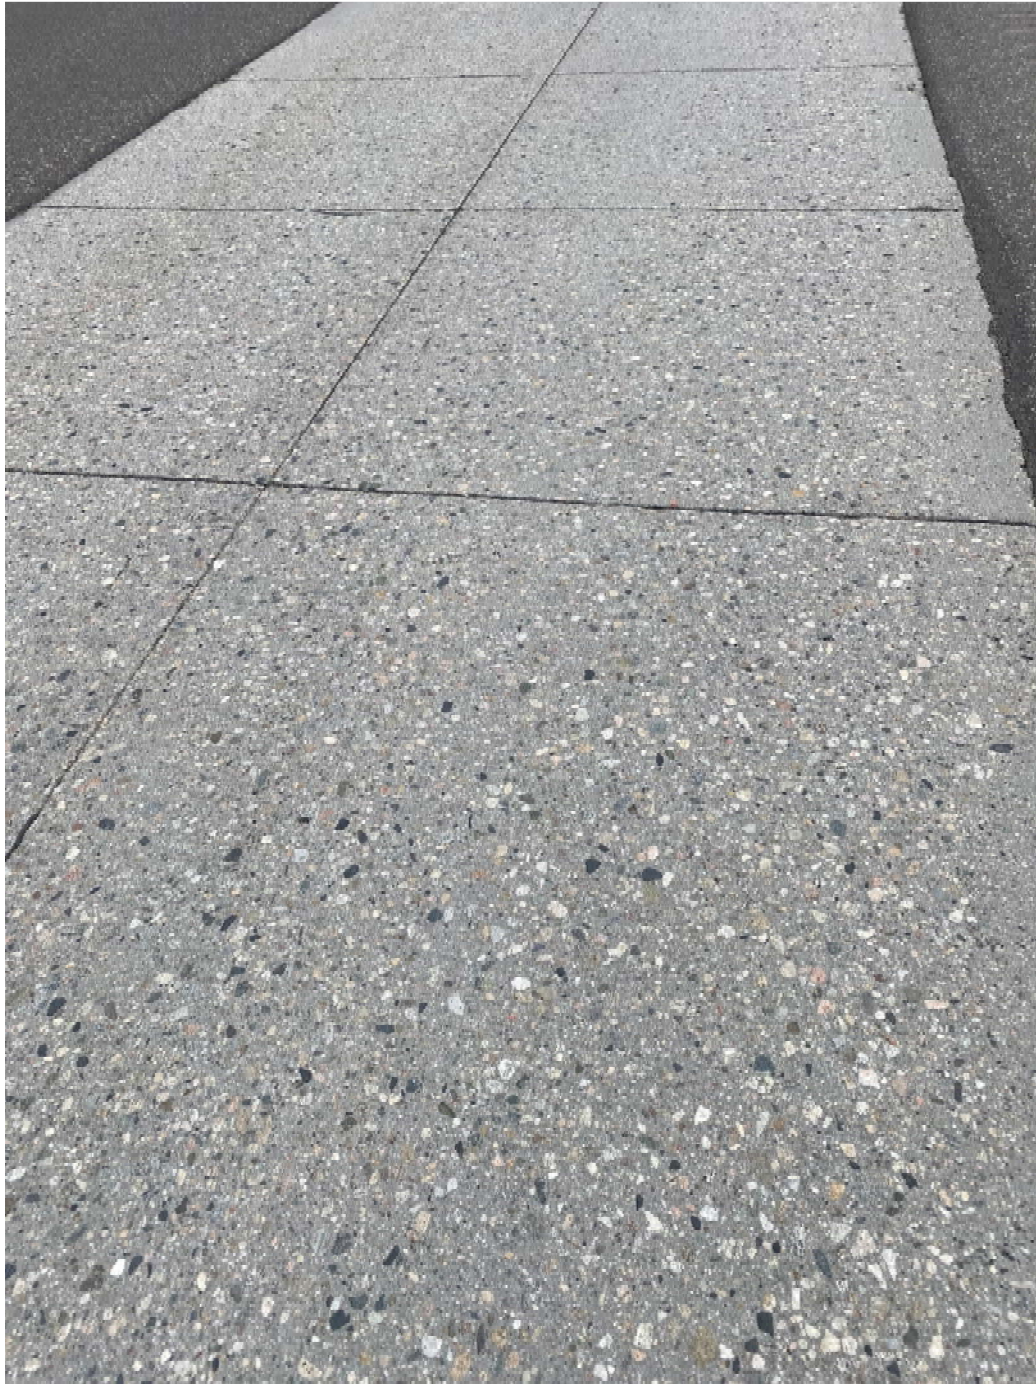
**Figure 18**  
Mid-Section Silica Fume Slab - 12 months  
Top concrete surface worn off, Scaling, Pitting and Aggregate Pop Outs

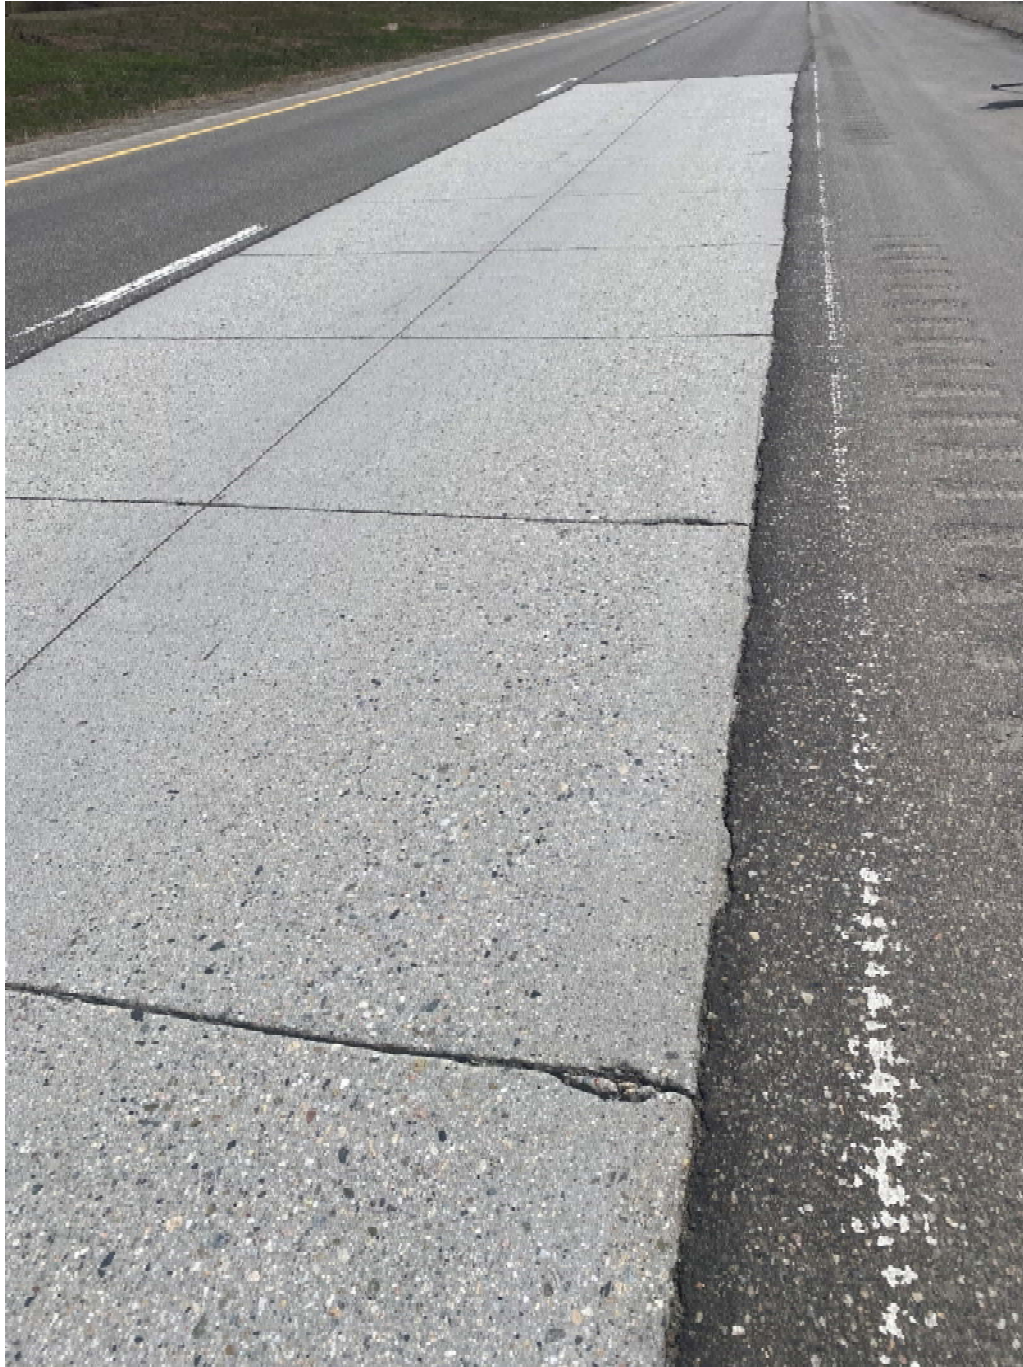
**Figure 19**  
End-Section Silica Fume Slab - 12 months  
Top concrete surface partially worn off, Scaling, Pitting and Aggregate Pop Outs, Joint Rot
