**COLORADO DEPARTMENT OF TRANSPORTATION  
INTERSTATE 70 VAIL PASS PAVING TRIAL UPDATE**

### Colorado Department of Transportation Interstate 70 Vail Pass Paving Trial Update

### **Eden's 1-Year In-Service Evaluation**

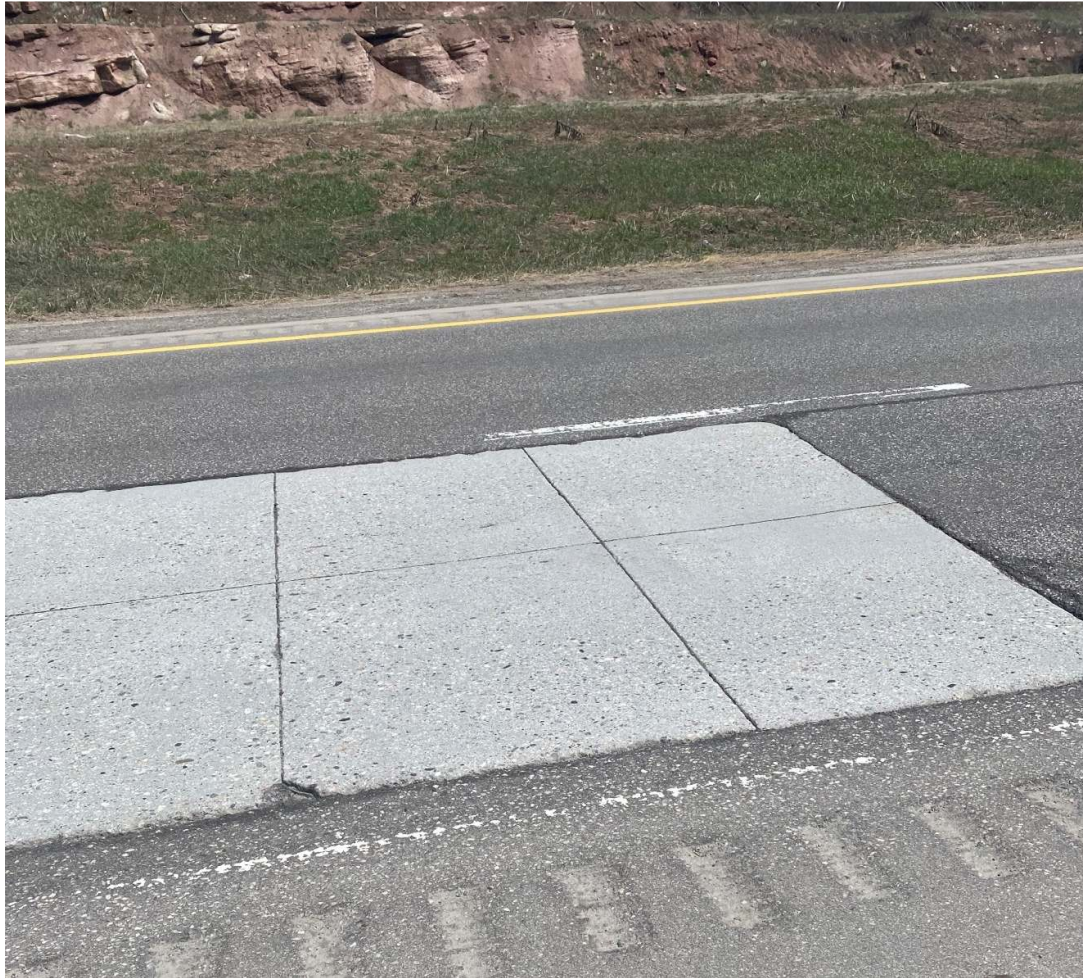
**Figure 20**

End-Section Silica Fume Slab - 12 months

Top concrete surface partially worn off, Scaling, Pitting and Aggregate Pop Outs, Joint Rot
