# Kingsgate

## **Chatree Gold Mine Overhaul Update**

## **Plant #1 Overhaul Project**

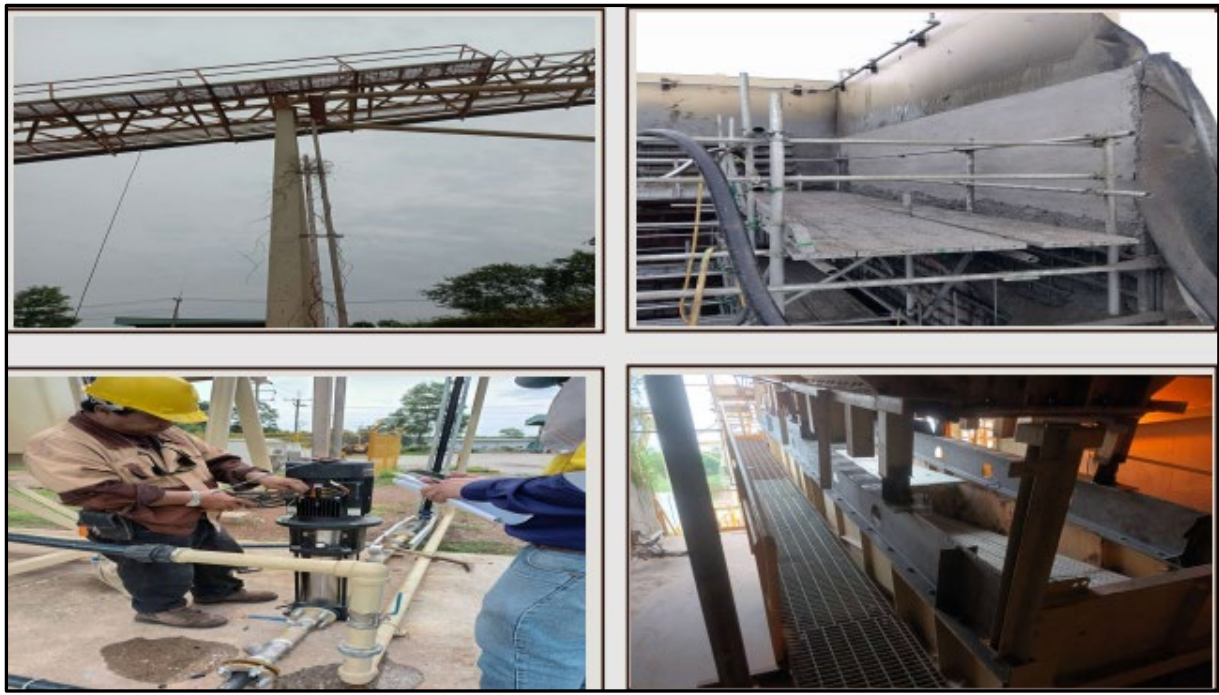
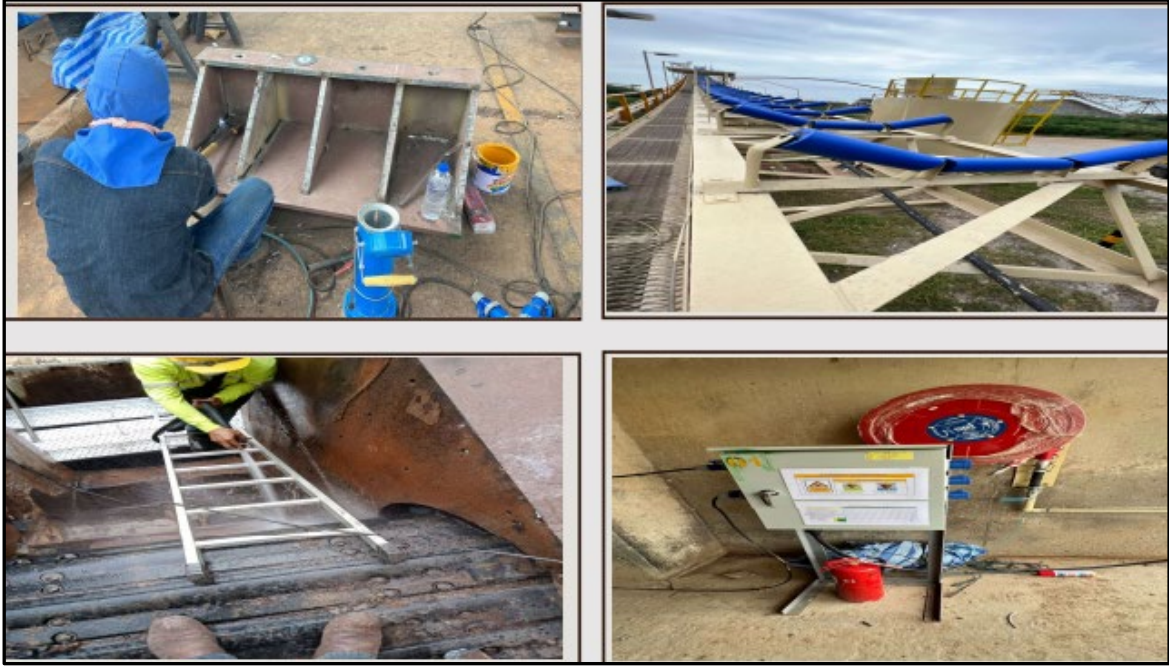
*Crushing Circuit overhaul above (left to right): CV001 repairs, ROM bin concreting, raw water pump replacement and piping, fabricating and welding the grizzly feed chute, and below (left to right): fabricating and welding the grizzly feed chute, replacing carry roller #01CV01, fabricating and welding the grizzly feed chute, electrical board safety information.*

1. Concreting the ROM bin wall;
2. Painting and repairing the raw water pipes;
3. Connecting a power source to the pump motor;
4. Sandblasting the apron feeder;
5. The installation of a temporary power panel;
6. Removing the chute and liner;
7. Replacing carry roller #01CV01; and
8. Fabricating and welding the grizzly feed chute.

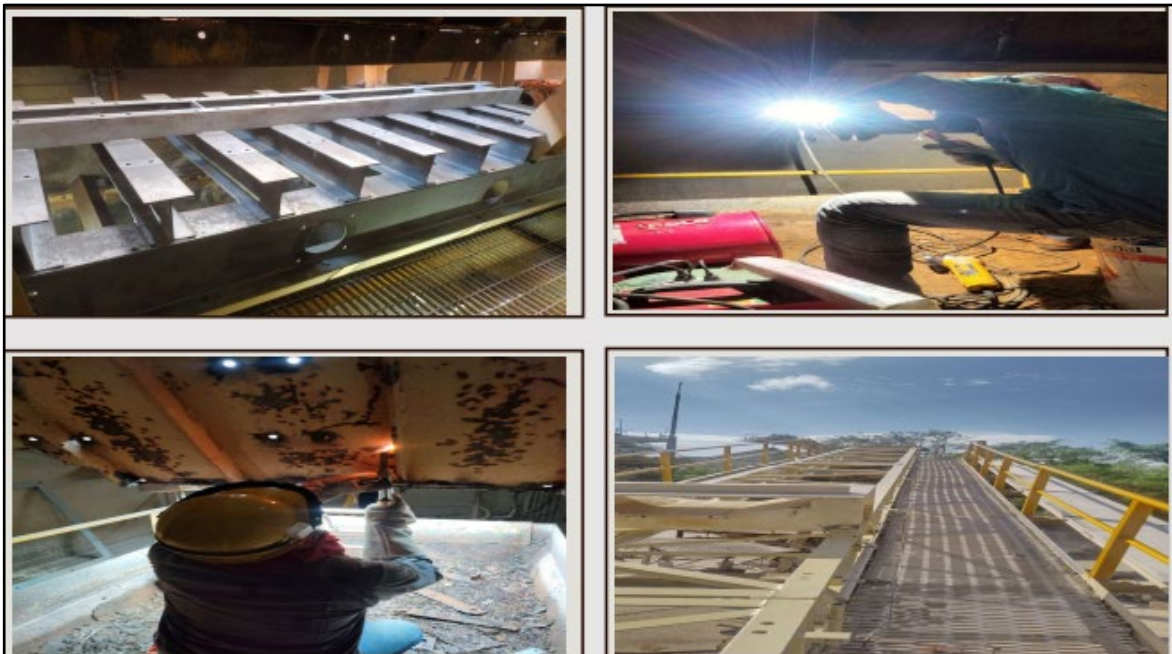
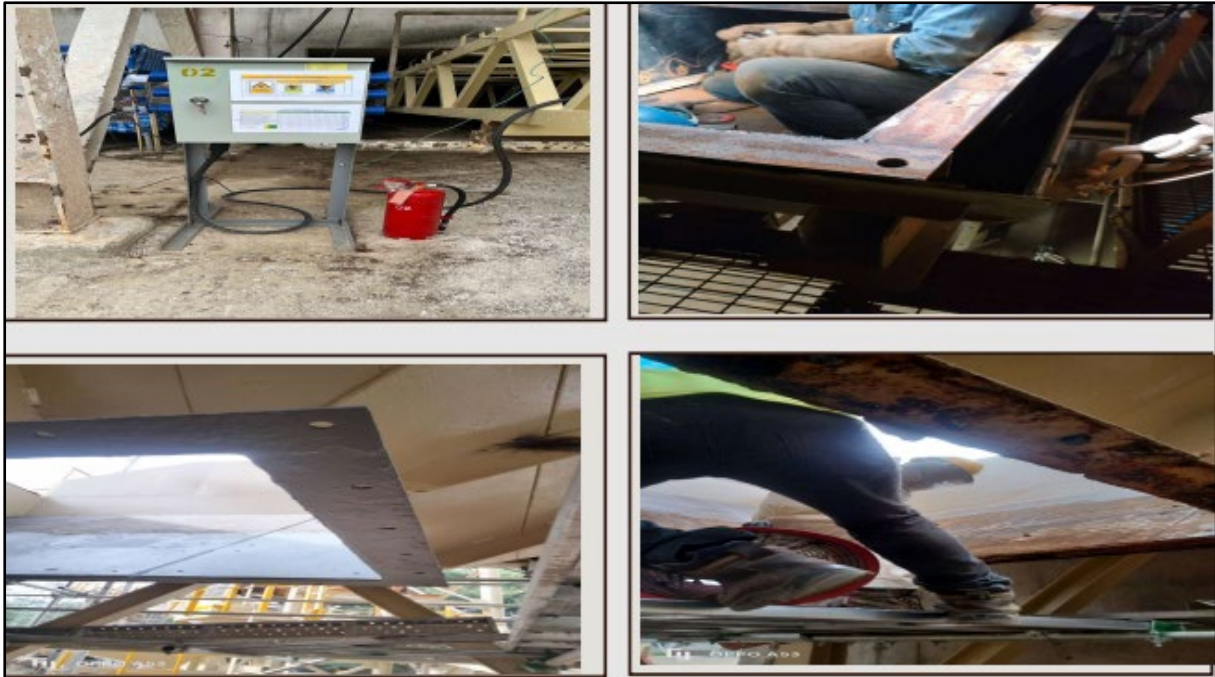
*Reclaim Area overhaul above (left to right): apron feeder sandblasting and painting, chute repairs x 2 and CV002 conveyor painting, and below (left to right): electrical safety board, feed chute repairs, apron feeder fabrication and chute repairs.*

1. Sandblasting and priming the apron feeder;
2. Continuing to paint the conveyor #02CV02;
3. Repairing chutes;
4. Repairing the damaged frame of a feed chute;
5. Continuing to fabricate the feeder; and
6. Installation of a temporary power panel.

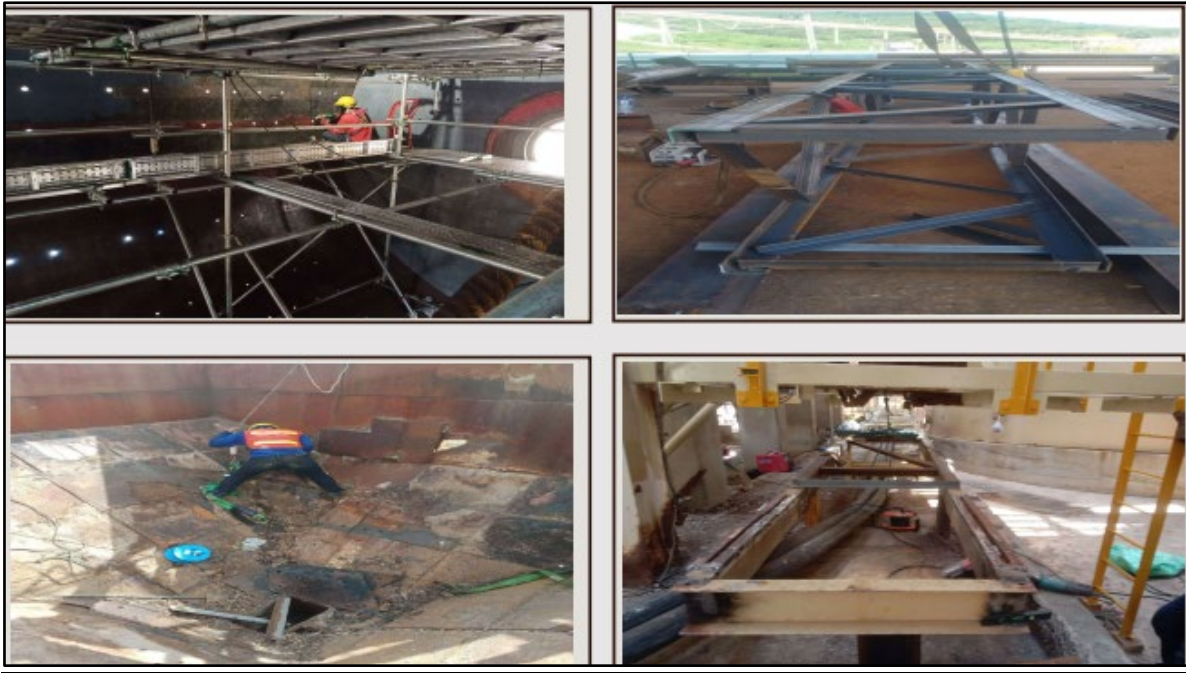
*Grinding Circuit repairs above (left to right): SAG mill rubber lining removal, structure frame for conveyor CV09, repairs to conveyor hopper and conveyor frame repairs CV04.*

1. Removing and replacing the rubber liner in the ball mill;
2. Installing scaffolding in the SAG mill;
3. Repairing conveyors #03CV04 and #03CV05;
4. Fabricating chutes and repairing hoppers;
5. Fabricating conveyor #03CV09;
6. Overhauling the motors of #04TK502, #04PU04, #04PU05
7. Installing scaffolding inside tank #04TK499;
8. Installing motors #04PU73, #04PU05;
9. Installing a temporary power panel;
10. Disconnecting the electrical control panel on the Cyclone;
11. Painting hoppers, handrails, and stairs; and
12. Removing the Cyclone and overhead crane.

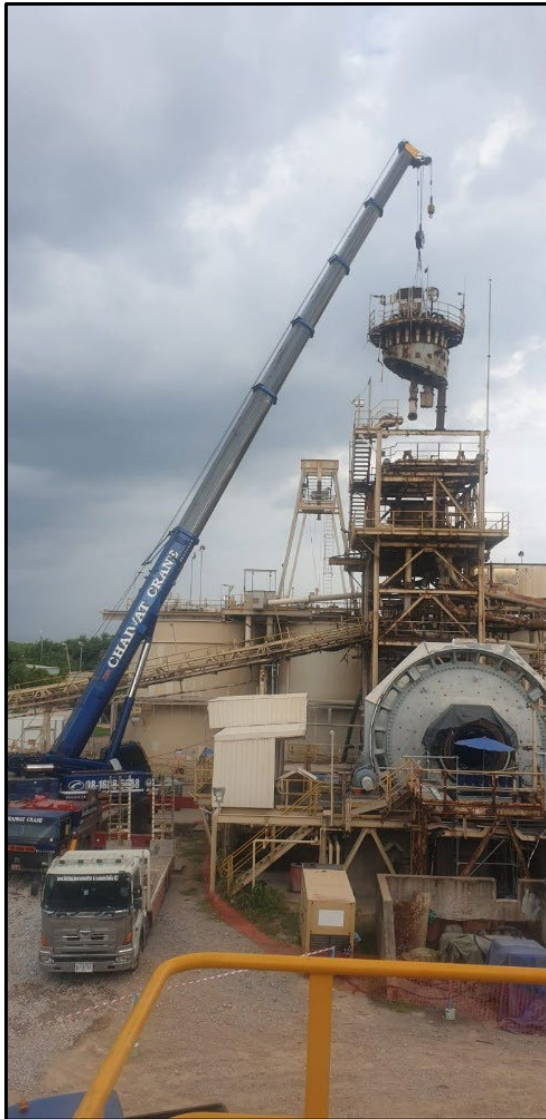
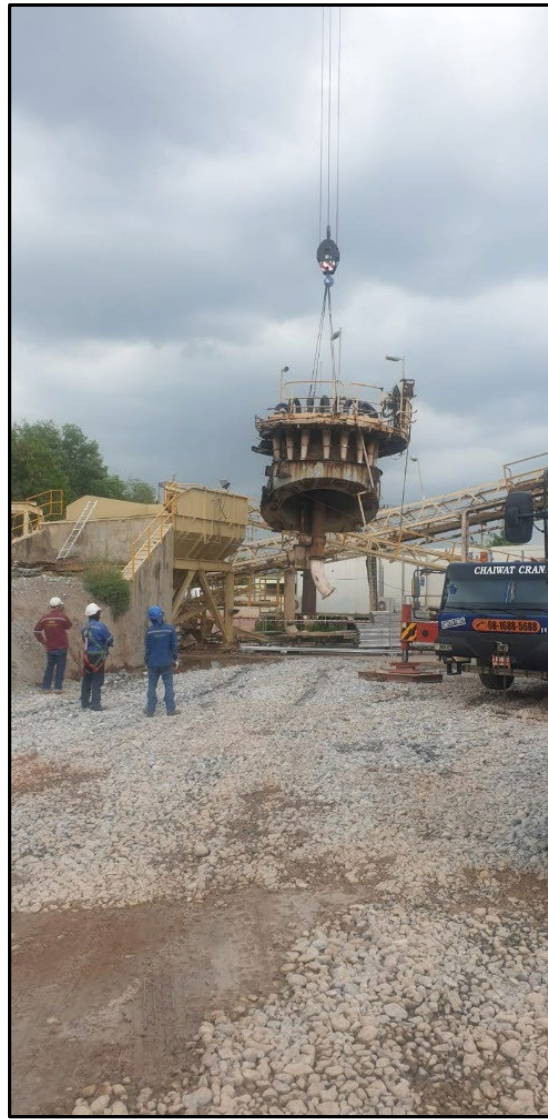
*Removal of the Cyclone separator for replacement from Plant #1.*

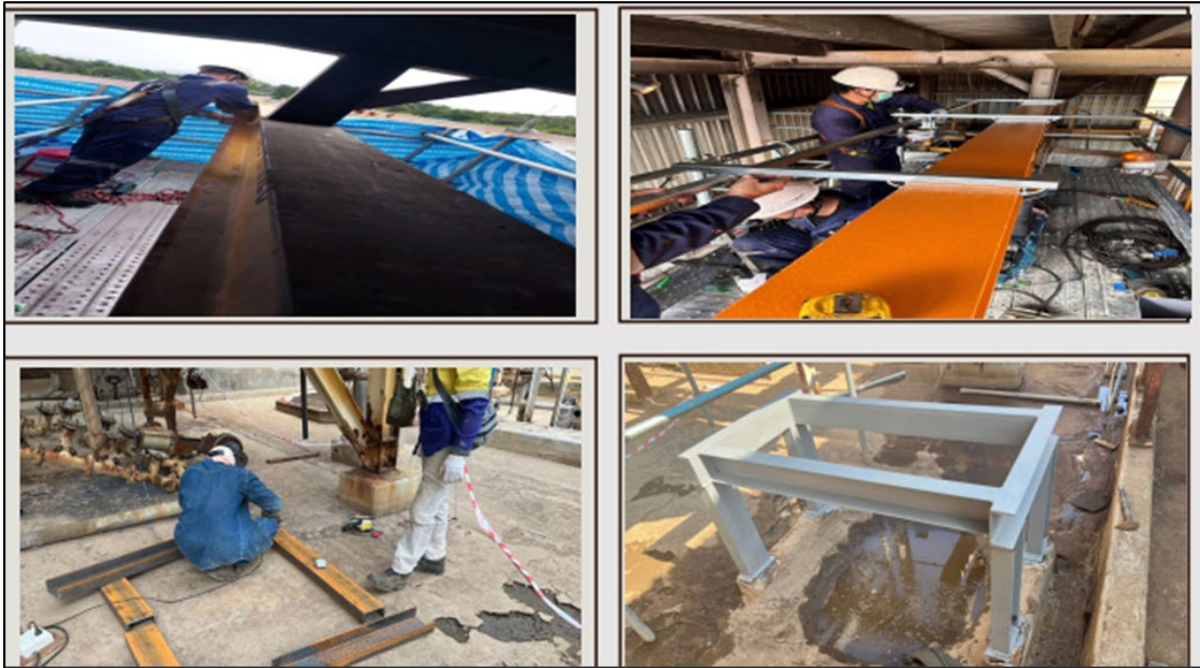
*Elution circuit repairs (left to right): structure repairs, Regain Kiln crane replacement, structure replacement and sump pump frame.*

1. Installing scaffolding for piping work;
2. Repairing the sump pump saddle;
3. Overhauling motors of #04TK502, 04PU04, 04PU05;
4. Installing scaffolding inside tank;
5. Installing temporary power panel; and
6. Fabricating support sump pump #05PU08.

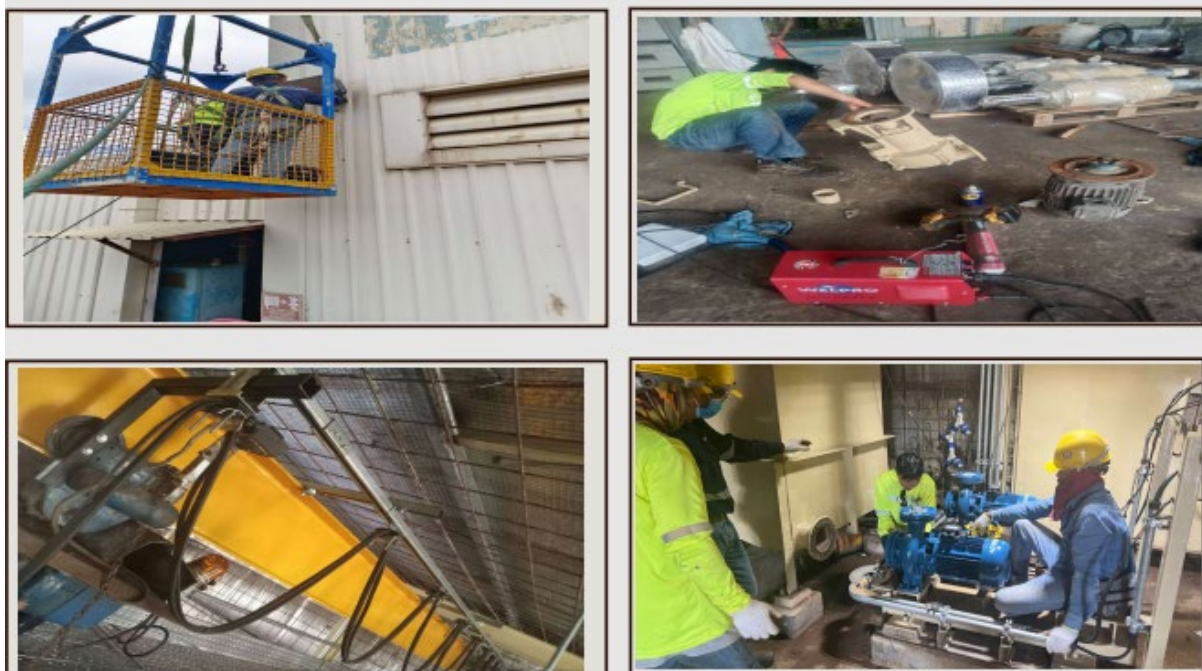
*Gold Room repairs (left to right): light replacement, overhaul of the diagram pump, new gantry crane and new gold circuit pump installation.*

1. Fabricating the raw water pipes;
2. Painting steel columns;
3. Replacing the cable tray and connected the lighting;
4. Replacing lighting and installed cable panel;
5. Overhauling overhead crane #06HT05;
6. Overhauling pump #06PU14; and
7. Installing pump #06PU58 A, and B.
