### EdenCrete® Update - Colorado I-70 Vail Pass Trial

#### Long Term I-70 - Vail Pass Paving Project Trial

# CDOT Region 3 Vail Pass Trial

**Date:** December 8, 2023  
**To:** Eric Prieve, Karen Berdoulay, ACPA, CAPA  
**From:** Golden/Peak/Mulumba - Region 3 Materials  
**Subject:** I-70 Vail Pass Concrete Pavement Test Sections Year 2 (2023) Observations

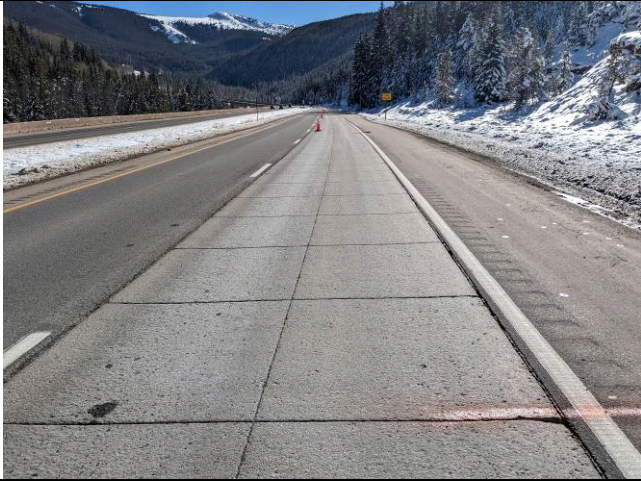
Concrete Sample Area 1, Beginning

This sample area begins 300 feet east of the beginning of the first concrete test section (MP 184.008) and extends approximately 100 feet east. The sample area contains 32 slabs that are on average 66 inches by 72 inches. Rutting in both wheel paths was measured to be 0.25 to 0.38 inches throughout the sample area. This rutting is due to chain wear and is resulting in the wearing away of the concrete paste, polishing of aggregate, and the popout of some aggregate material from the surface. In general the joints are in good condition with minimal spalling, though the joint sealant has come out of the transverse joints and some joints are beginning to fill with fines. It should be noted that the rutting in this area is trending towards the left of the lane, though most traffic appears to still be running close to the centers of the panels.

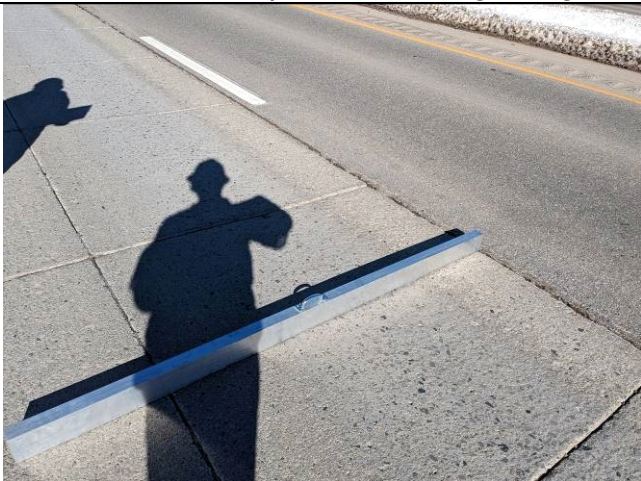
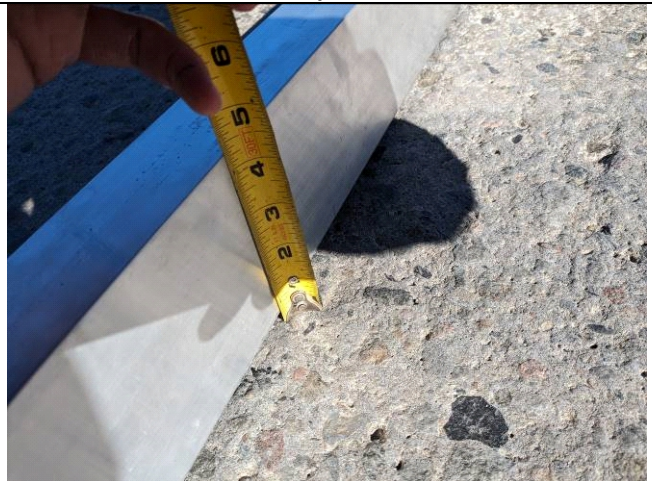
Concrete Test Section 1, Rutting

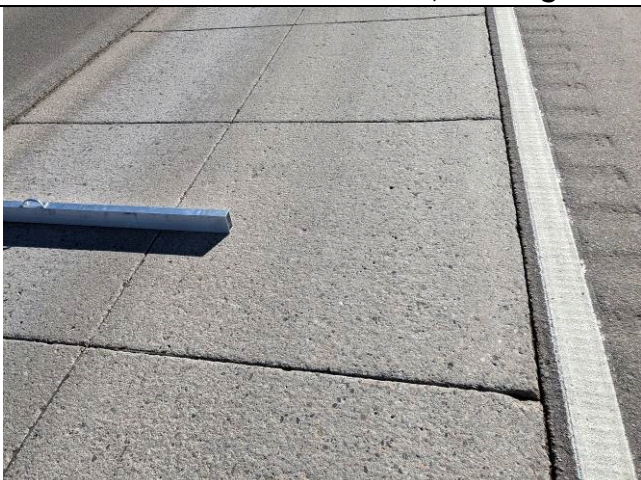
The last documented challenge was that there was slight raveling at joints due to saw cutting the joints early. This may account for the minor joint and corner spalling observed and documented in the PCI survey.

Concrete Test Section 1, Wheel Path and Minor Joint Spalling

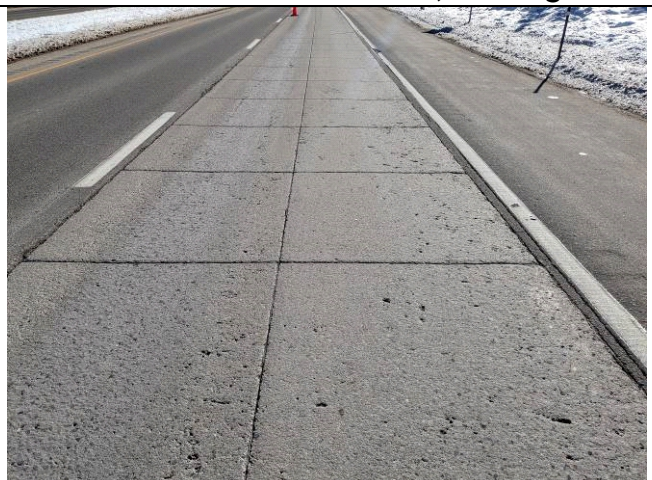
Between Concrete Sample Areas 1 and 2, Popouts

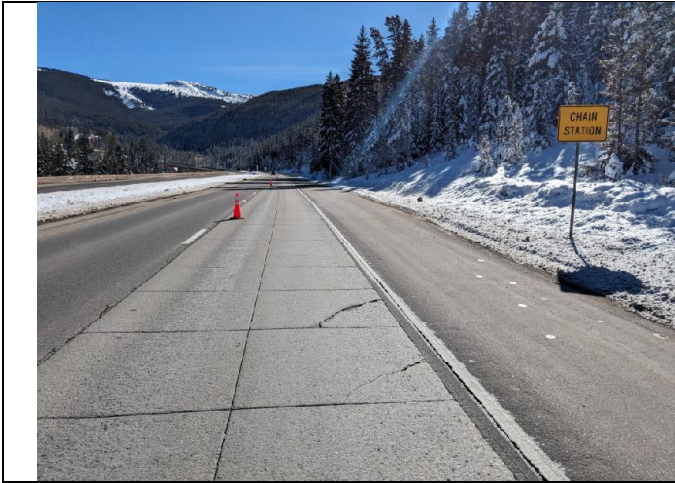
The next documented challenge was that the asphalt millings were not fully removed from the corners prior to placement of the concrete pavement. Distresses were expected to develop in this area. Corner breaks were observed at the transitions during the site visit conducted by CDOT.

Between Concrete Sample Areas 1 and 2, Corner Breaks

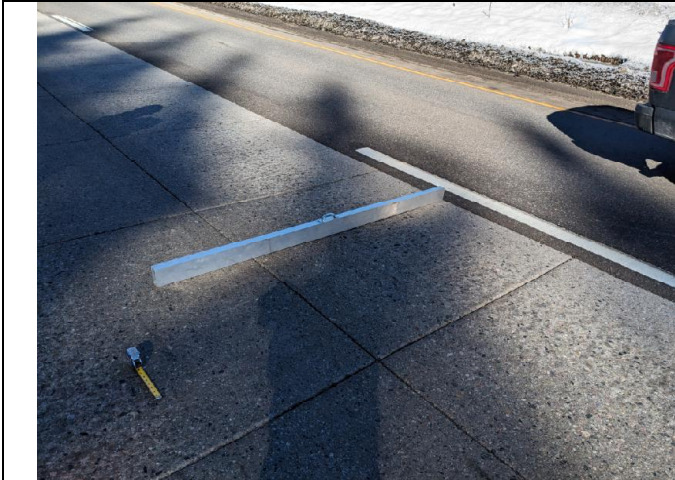
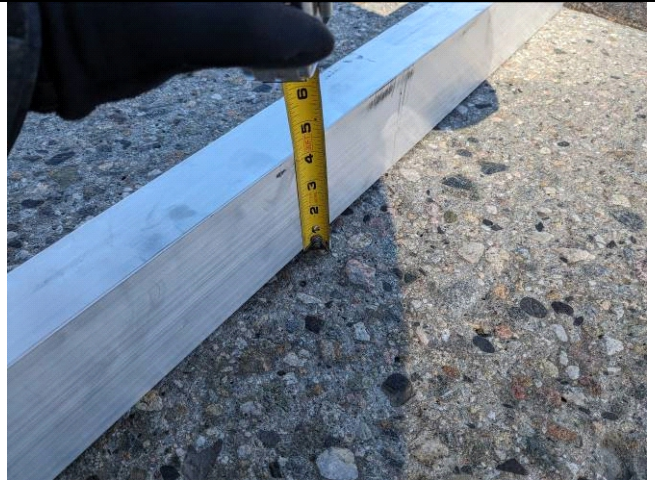
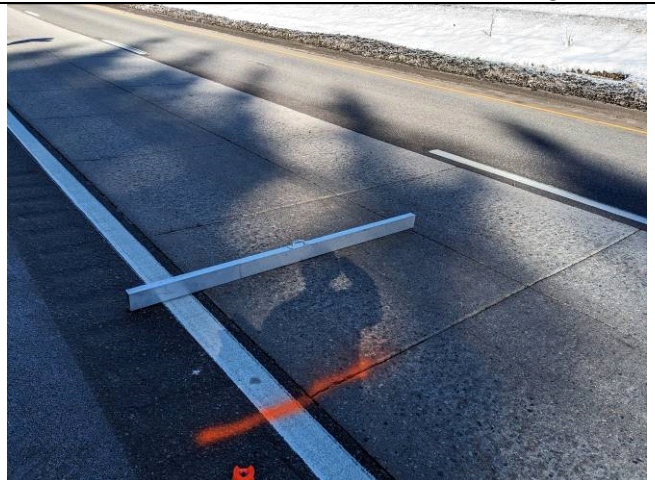
This sample area starts 200 feet west of the end of the second concrete test section and extends approximately 100 feet east towards the end of the test section. The sample area contains 32 slabs that are on average 66 inches by 72 inches. Rutting in both wheel paths was measured to be 0.25 to 0.38 inches throughout the sample area. This rutting is due to chain wear and is resulting in the wearing away of the concrete paste, polishing of aggregate, and the popout of some aggregate material from the surface. However, the joints are in fair condition with minor spalling at the joints and at corners. The joint sealant has come out of the transverse joints and some joints are beginning to fill with fines. It should also be noted that the rutting in this area is trending towards the left of the lane, though most traffic appears to still be running close to the centers of the panels.

Concrete Test Section 2, Rutting

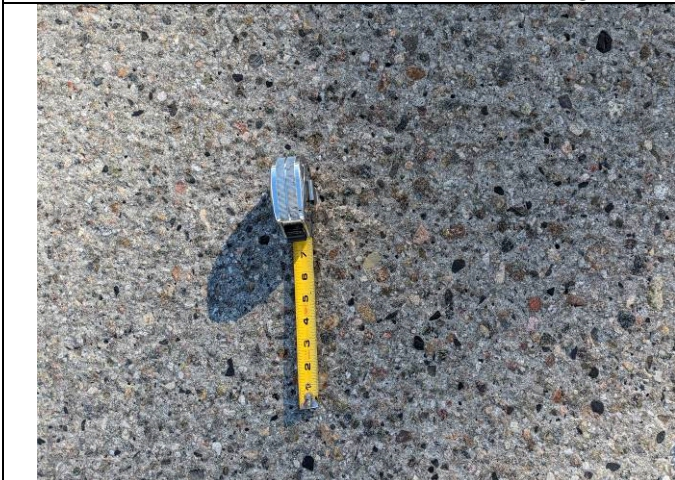
Concrete Test Section 2, Polished Aggregate

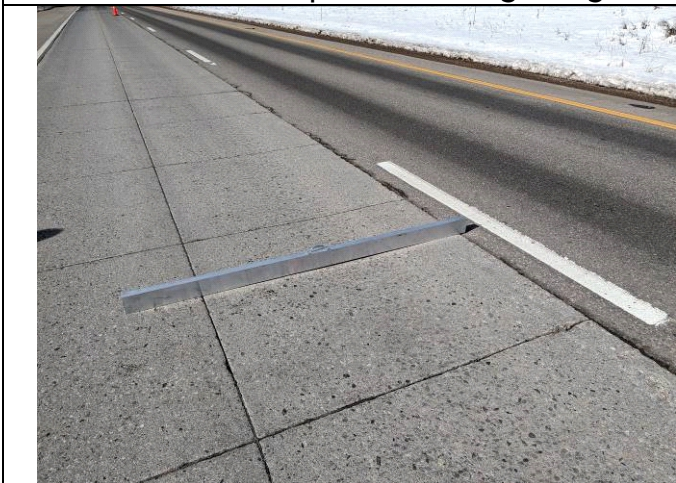
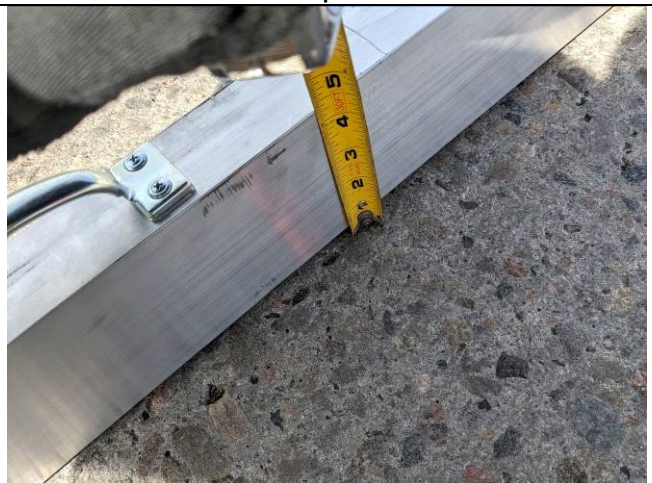
This sample area starts 200 feet east of the beginning of the third concrete test section and extends approximately 100 feet east towards the end of the test section. The sample area contains 32 slabs that are on average 66 inches by 72 inches. Rutting in both wheel paths was measured to be 0.13 to 0.50 inches throughout the sample area. This rutting is due to chain wear and is resulting in the wearing away of the concrete paste, polishing of aggregate, and the popout of some aggregate material from the surface. The inner joints are in fair condition with minor spalling at the joints and at corners. The joint sealant has come out of the transverse joints and some joints are beginning to fill with fines. The joints next to the asphalt surface are not even and are beginning to spall in many places. This is thought to be a production issue, but will continue to be monitored and was not considered in the PCI survey as discussed near the beginning of this section. It should be noted that the rutting in this

area is trending towards the right of the lane, with the main right wheel path within about 6 inches of the joint. This suggests that some traffic may be driving on the joint, especially in the winter when visibility is not ideal. So far this has resulted in the rutting in the right wheel path to be low due to the proximity to the joint and the cross slope of the road. However, as this joint is already not in excellent condition and there is potential traffic running on or near the joint this will continue to be monitored in the coming years.

Concrete Test Section 3, Rutting

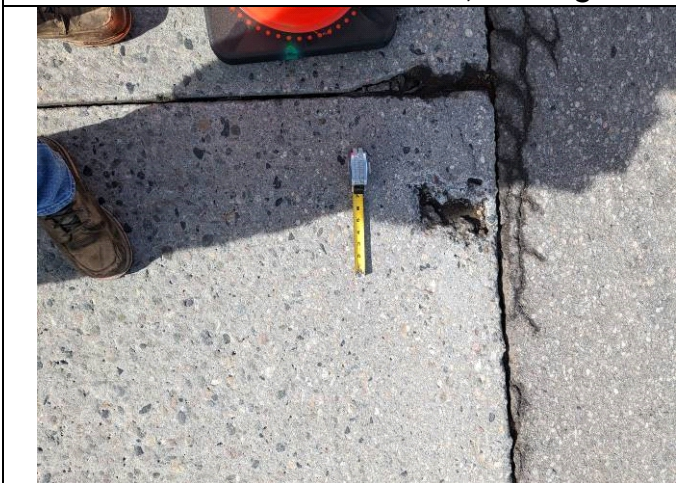
Concrete Test Section 3, Defect

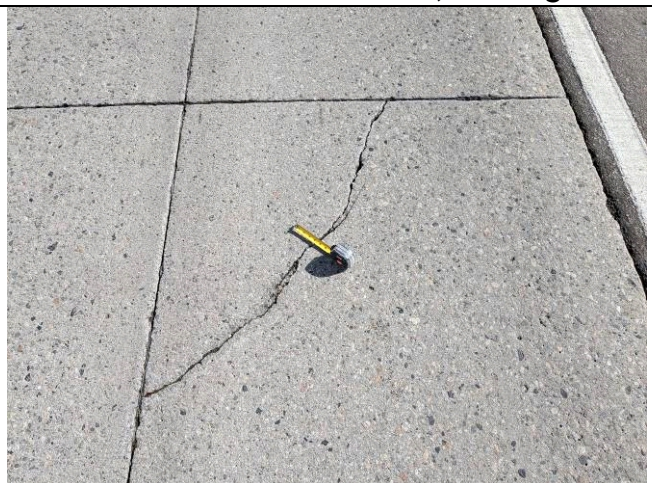
The corner break observed in the first, right panel of the third concrete test section last year has developed into a shattered slab that has been patched with some asphalt. The first panel on the right has also shattered, as well as two more in the left. Corner breaks have also developed in some of the slabs in the first 100 feet. It appears that there is a base or subgrade issue in this area that has caused these slabs to fail, though this will have to be confirmed when the slabs are replaced.

Concrete Test Section 3, Corner Break

Due to the worsening of these initial sections it will likely be necessary for some of the panels to be replaced to maintain a safe driving surface. As of now it is difficult to ascertain how much of this additional damage in the initial transitions to concrete are solely due to construction issues and how much is due to the transition between pavement types is causing additional distress. Some additional distress in the first 50 feet of the asphalt after a concrete section was observed, but not to the same level as the failed panels in the concrete sections.

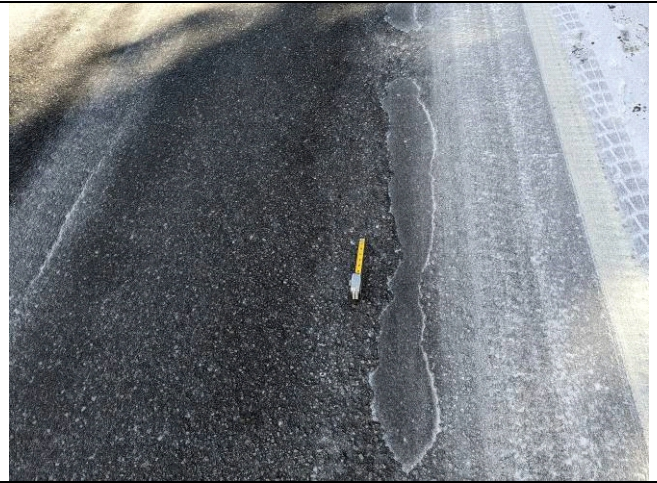
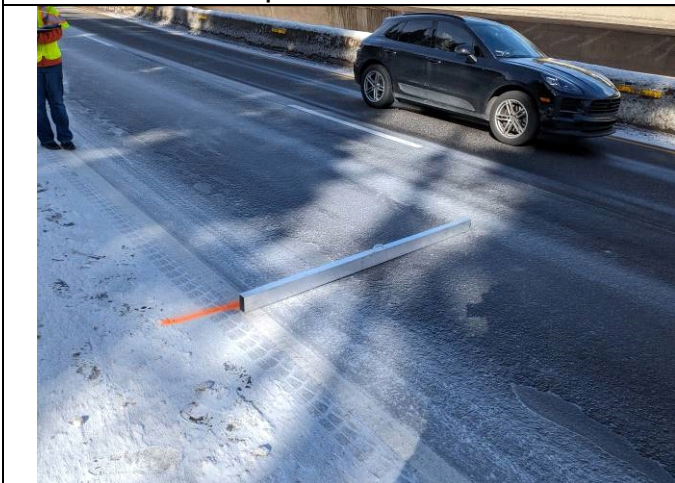
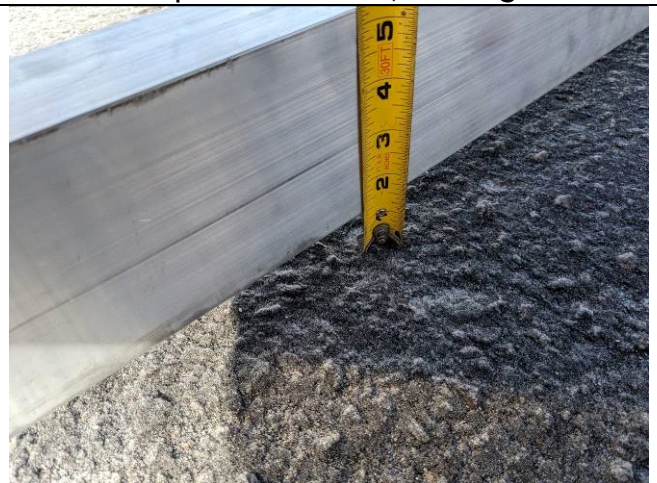
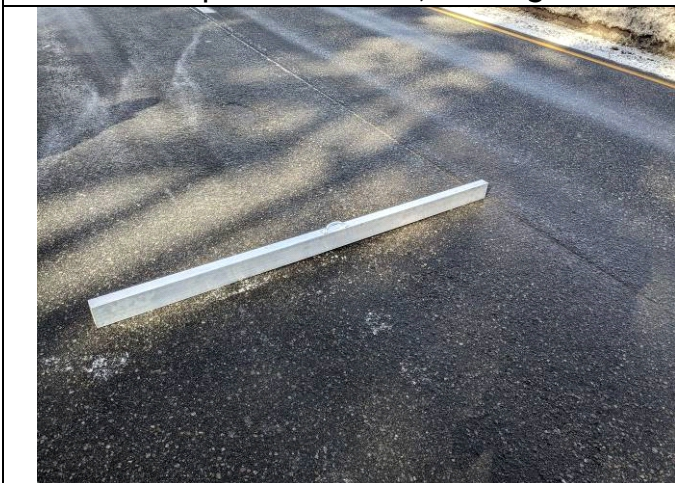
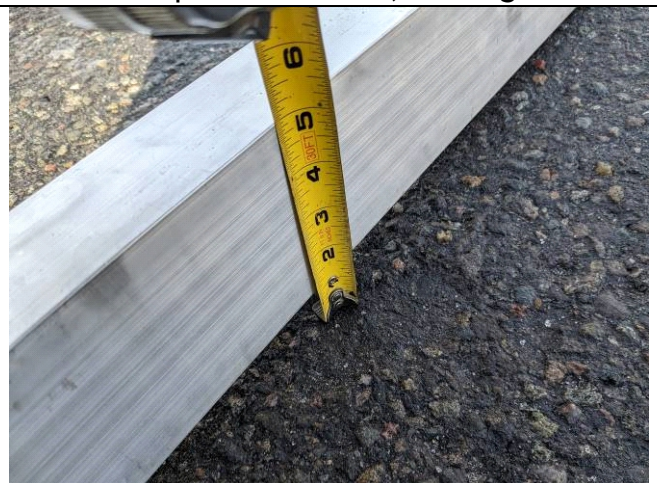
This sample area starts 50 feet east from the eastern bridge joint of F-11-AM and extends approximately 100 feet on the structure. This pavement consists of 3 inches of HMA on top of the concrete structure. As constructed plans showed this to be placed in one lift, but after observing delamination it was confirmed with Region staff that the HMA on this structure was placed in two 1.5 inch lifts. The sample area was measured to be 12 feet wide. Rutting in both wheel paths was measured to be 0.75 to 1.38 inches throughout the sample area. Similar to the concrete pavements the chain wear is resulting in the wearing of the asphaltic material and polished aggregate, though for asphalt some of the rutting may also be a result of settlement in the material, though this should not be significant for asphalt directly placed on a structure. Rutting has developed significantly in the past year, with the top layer being worn off completely in some areas resulting in some delamination of the layer at the edges. It should be noted that the sample area in this section is in the bottom of a vertical curve that appears to be in shade much of the year. At the time of the site visit this was the only area that had a minor dusting of snow remaining. This appears to be causing the pavement to wear faster in this sample area. While there was still isolated areas of delamination in the rest of the section, the largest and most frequent were in the sample area.

Asphalt Section 1, Rutting

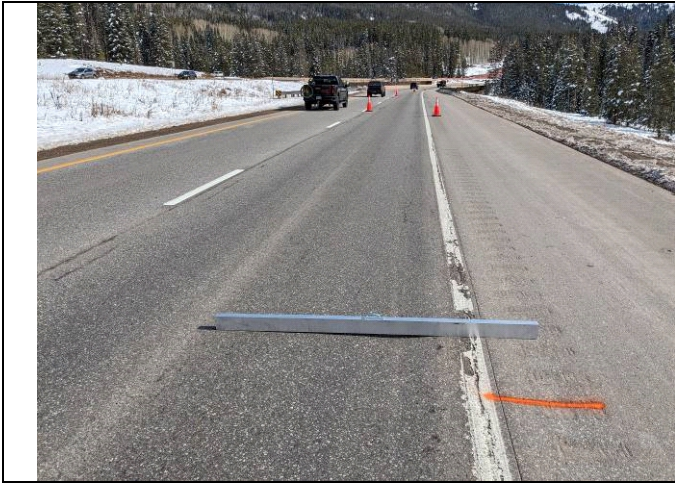
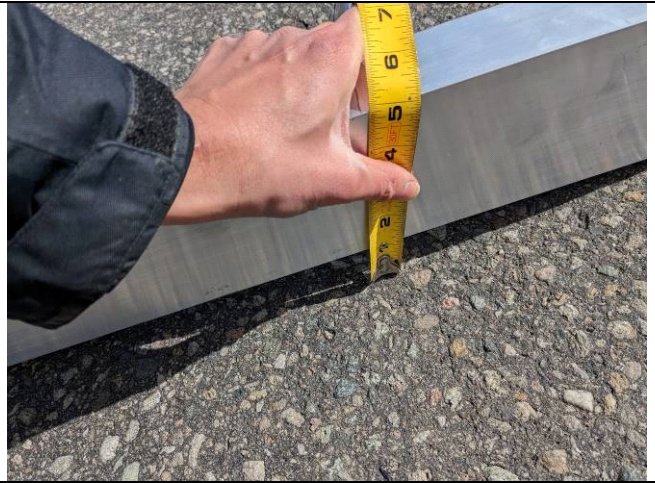
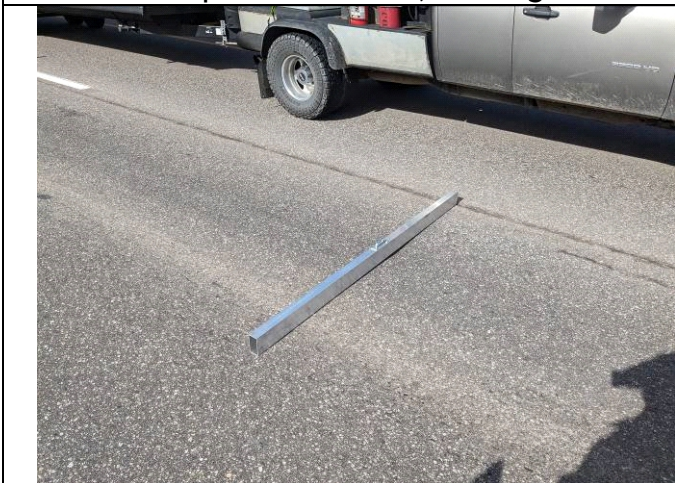
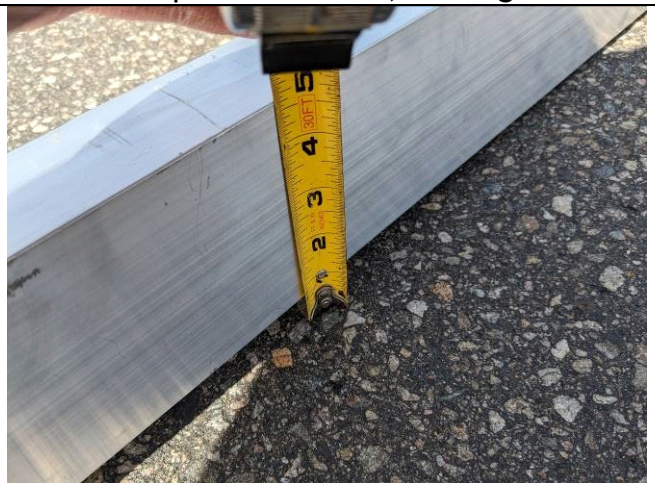
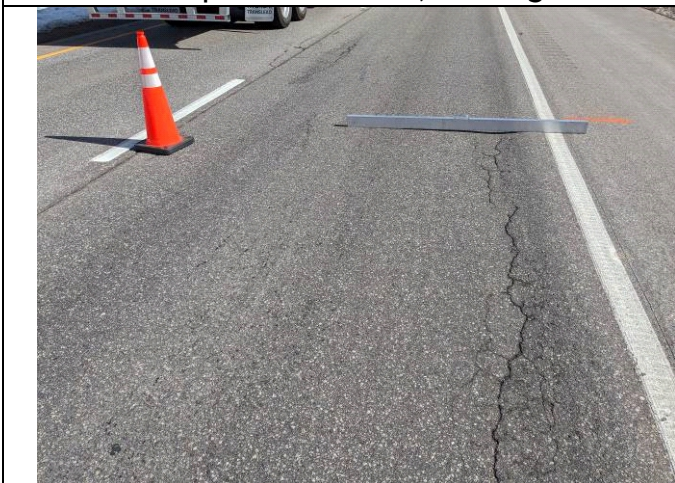
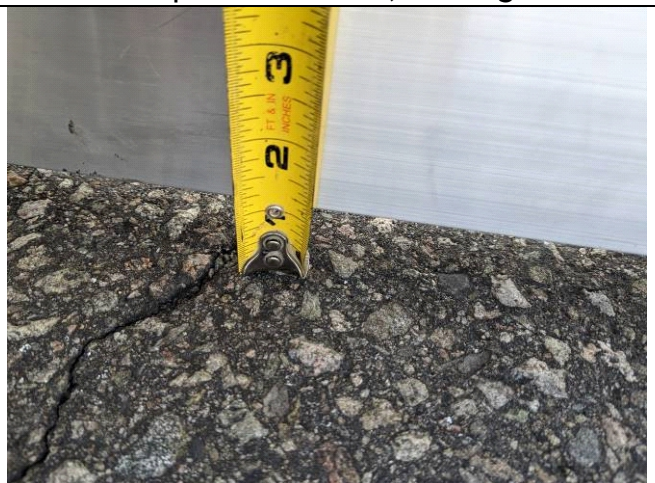
This sample area starts 100 feet east of the end of the third concrete test section and extends approximately 100 feet east. The sample area was measured to be 12 feet wide, or the width of the climbing lane. Rutting in both wheel paths was measured to be 0.75 to 1.13 inches throughout the sample area. Similar to the concrete pavements, the chain wear is resulting in the wearing of the asphaltic material and polished aggregate, though for asphalt some of the rutting may also be a result of settlement in the material and the subsurface. Longitudinal cracks have begun to develop in the wheel paths, which are suspected to be the beginning of fatigue cracking. One area of rutting was observed to have developed fatigue cracking already. It should also be noted that the rutting in this area is trending towards the left of the lane. Cracking about 0.25 inches wide was observed along both longitudinal joints, though this was not included in the PCI survey.

Asphalt Section 2, Rutting

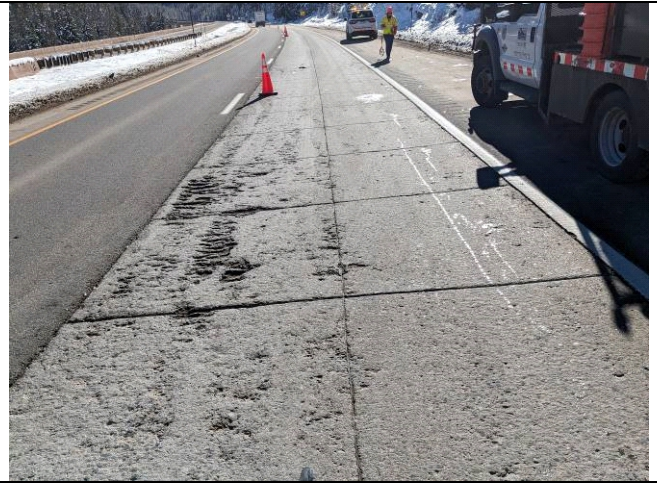
The first documented challenge is that the first concrete truck to arrive onsite was held until three trucks were onsite. The accelerator dosage was also too high, with a partial dosage at the plant and the remainder added onsite. This caused approximately the first 200 feet of the first concrete test section to be overworked with voids due to a dry mix.

The first 200 feet of the first concrete test section from MP 184.008 to 184.046 was not included as a sample area due to the known and documented challenges during construction. The first 100 feet had a high number of voids from construction with what appears to be additional popouts and wearing due to the overworking of the concrete. These have developed significantly in the past year, beginning to appear corrugated with potholes developing. The corner break in the first, left panel has continued to develop with the cracks widening and beginning to spall. These production issues are apparent for the first 200 feet or so and improve afterwards, matching more closely to the conditions described in Concrete Test Section 1.

Concrete Test Section 1, Voids First 100 Feet

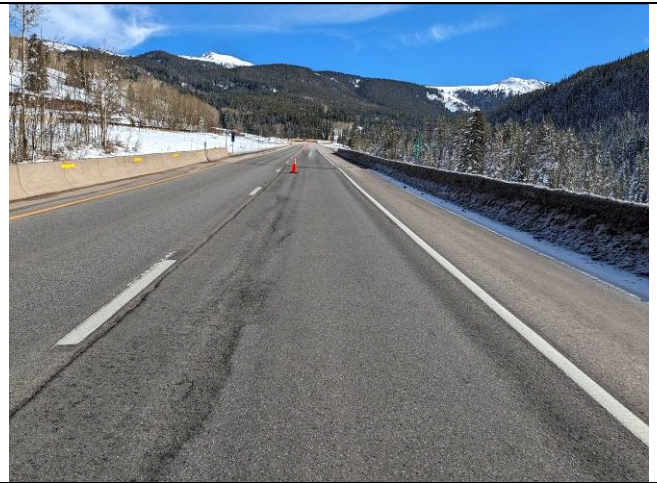
Rutting F-11-AM after Asphalt Test Section 1
