Fletcher Building dismisses BGC claims and provides detailed update on causation research to date

Auckland, 13 October 2023: Fletcher Building Limited has today issued a detailed update on the cause of the plumbing failures that have occurred in a number of homes built in Perth during the period 2017 – 2022, along with the activities Iplex Australia is undertaking to support industry and homeowners in finding the right solution.

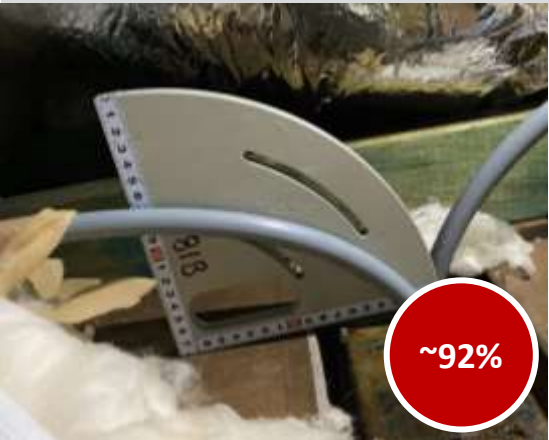
1 OVER-BENDING

The Iplex Pro-fit Technical Guide states that the minimum bending radius be 10 times the outside diameter of the pipe. If this is not possible an IPLEX Pro-fit® elbow should be used.

Pipe overbent

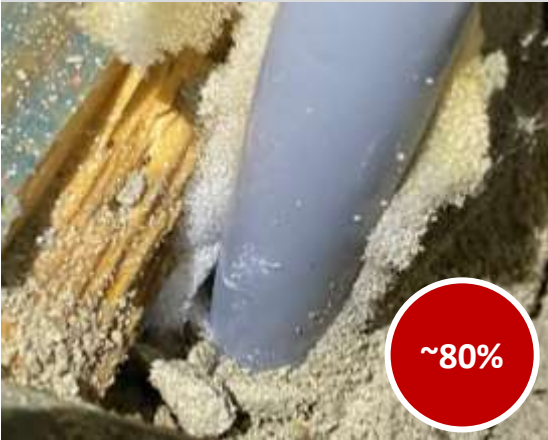
2 INADEQUATE MOVEMENT

Iplex installation instructions state that care must be taken during install to allow for potential thermal movement of the pipe. Additionally, Australian standards require pipes to be supported with adequate brackets, clips or hangers with defined maximum spacings.

Pipe fixed in the wall through rigid mortar

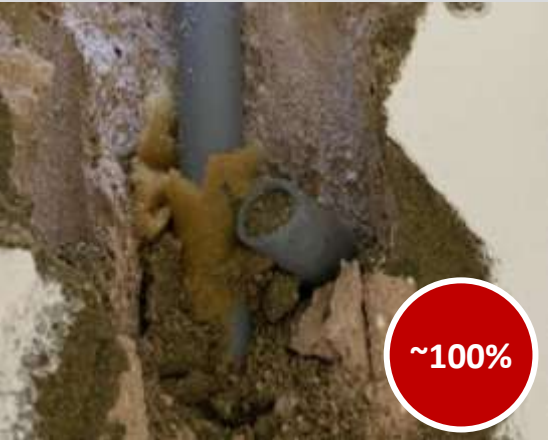
3 POOR LAGGING

Plumbing standard AS/NZS 3500.1&4 and Iplex installation instructions state that pipes in chases shall be continuously wrapped with an impermeable flexible material.

Lagging not impermeable (and at times non-existent)

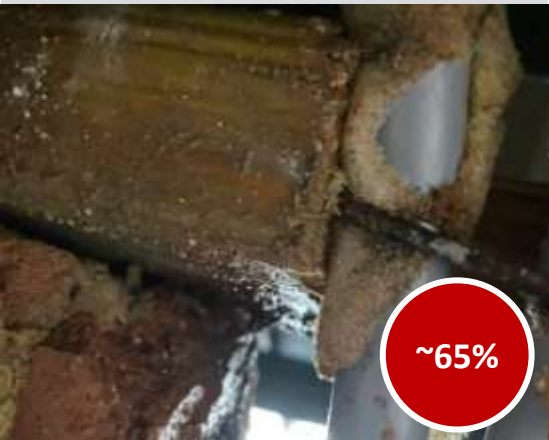
4 DAMAGE / WORKMANSHIP

Plumbing standards AS/NZS 3500.1&4 and Iplex installation instructions note that care should be taken to ensure pipes are not damaged during normal building activities.

Pipe bend across metal nail and kinked, resulting in a stress point

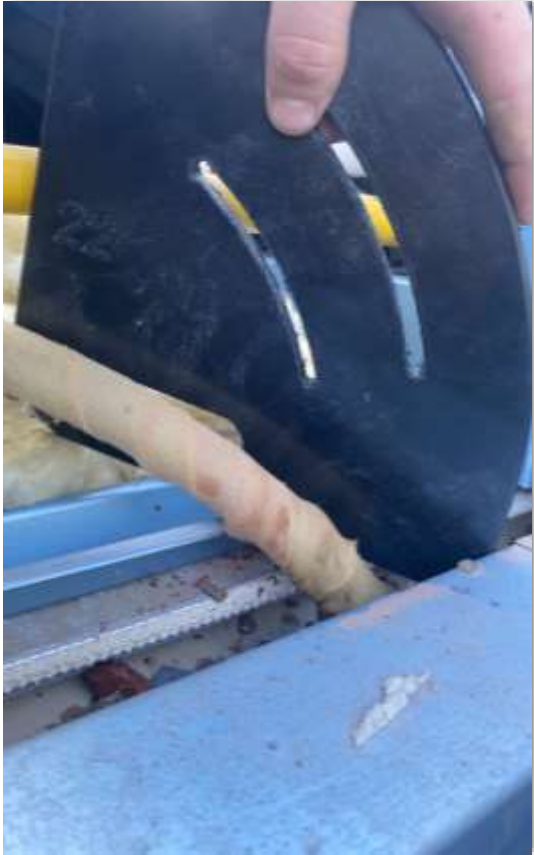
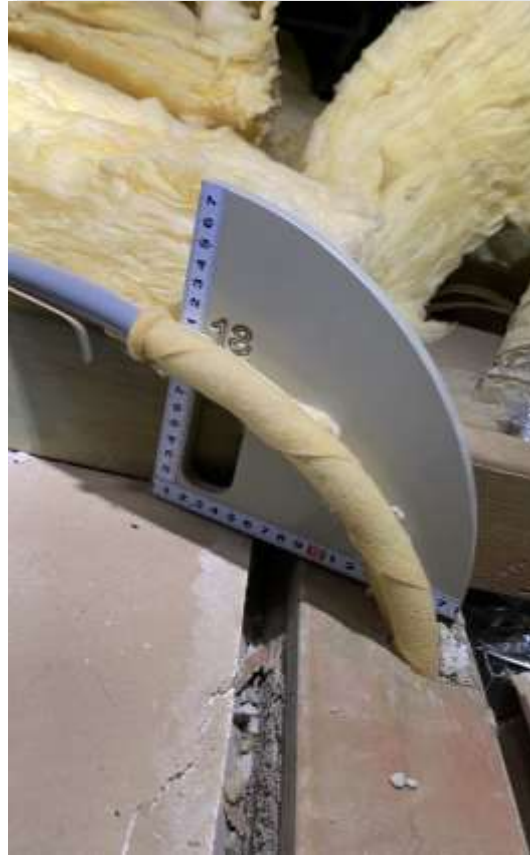
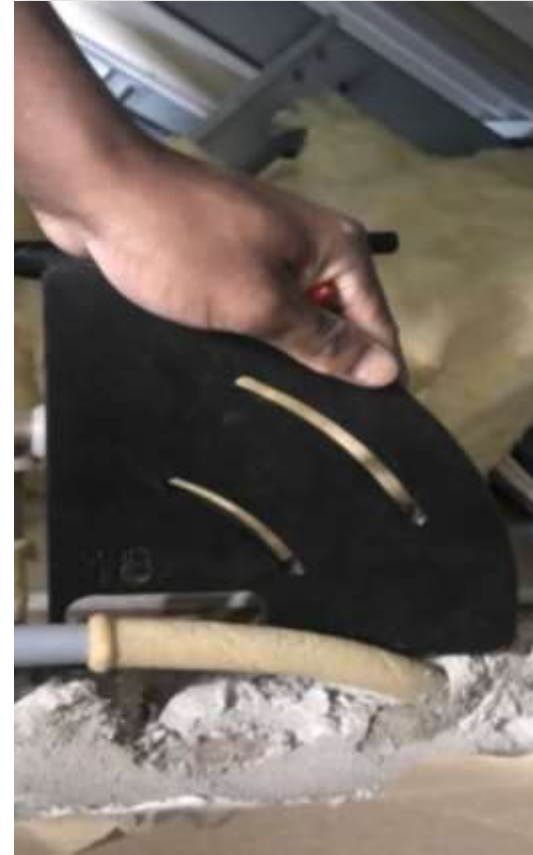
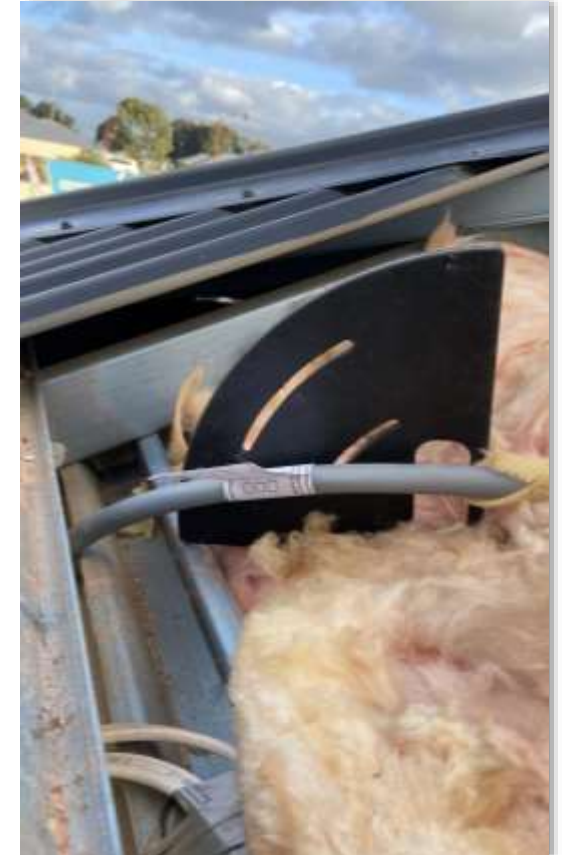
~92% of homes we have inspected / repaired have had non-compliant radial bends

Minimum bending radius must be 10 times the outside diameter of the pipe. All of the pipes shown here have been over-bent

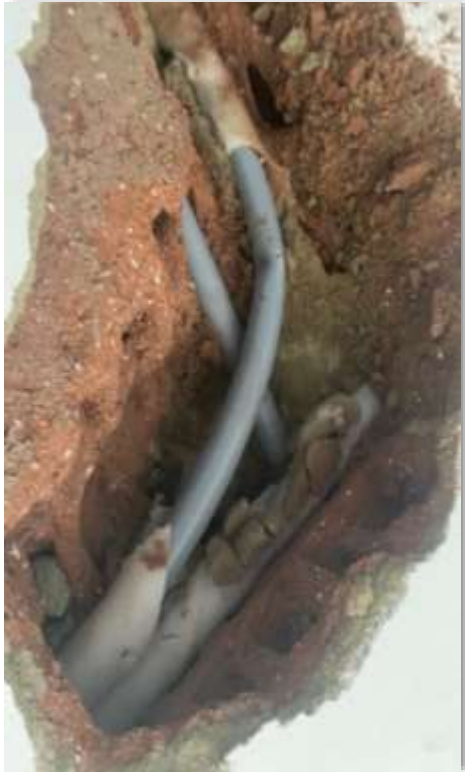
*Kinked or damaged pipes,
pipes overlapping; tight bend
on back pipe*

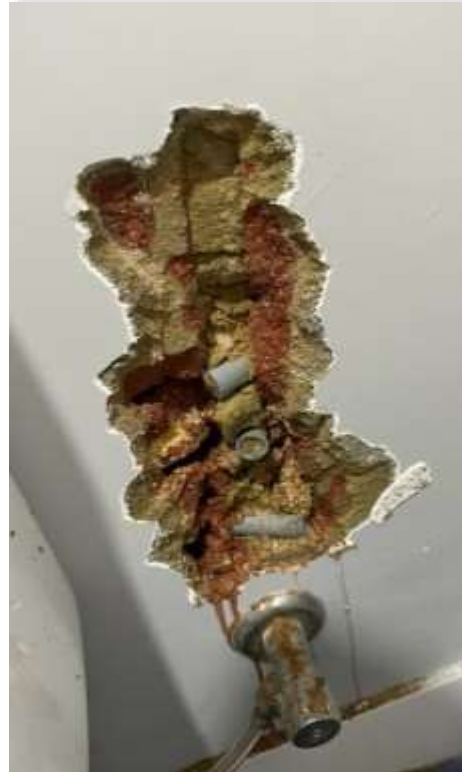
*Pinch/pressure point caused by
pegging creating localised high
stresses*

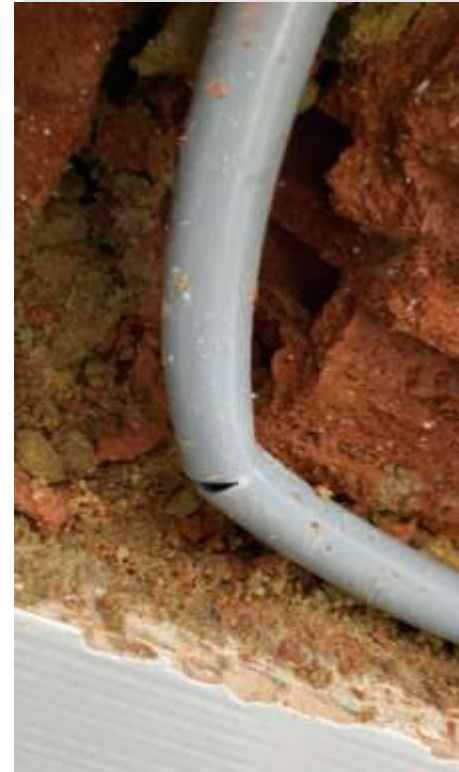
*Kinking or damaged pipe not
replaced per guidelines*

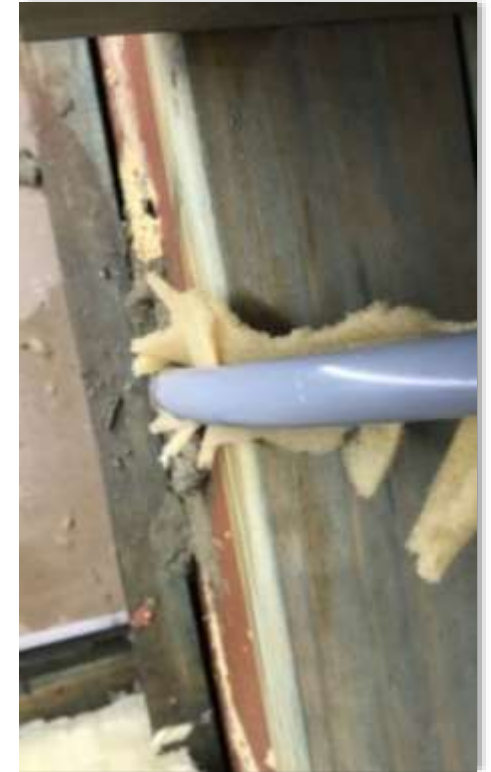
*Pulled hard against timber not
allowing for lineal thermal
expansion per guidelines*

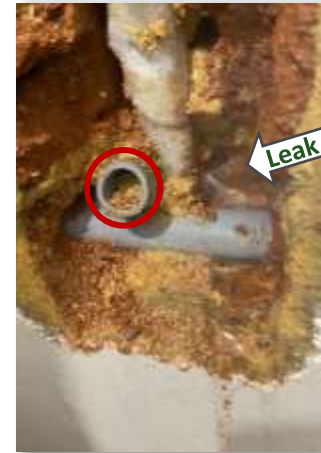
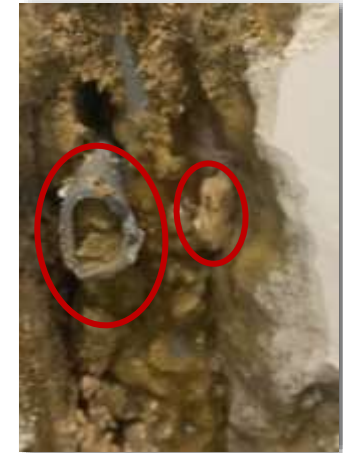
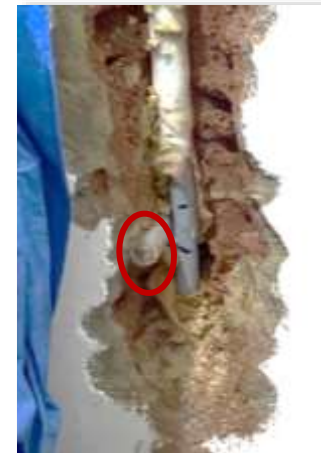
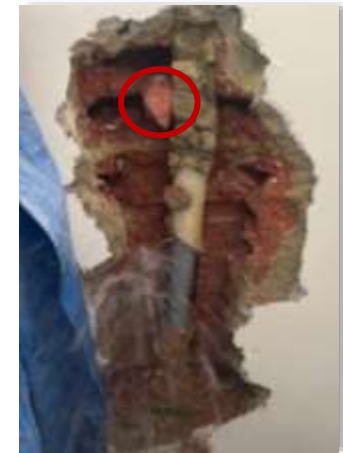
'Pegging' is a process that uses a fixed object to hold the pipe during installation which that installation instructions require to be removed prior to the system being put into service.

Inadequate movement and damage to pipe caused by pegging left in chase

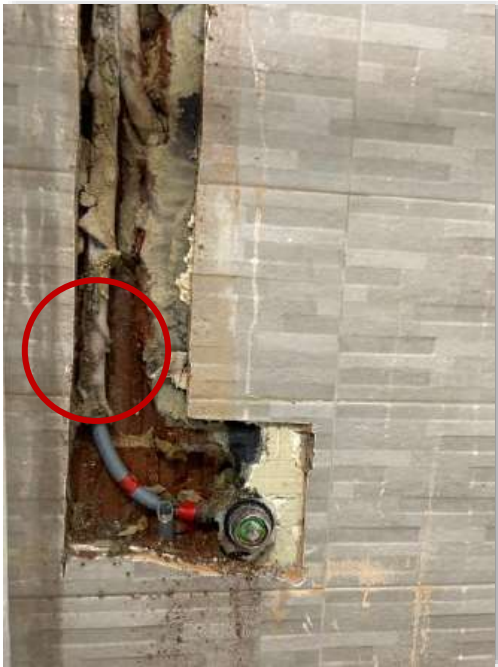
Lagging material (wrapping around pipe), which appears to be permeable – this is not compliant with the relevant Australian Standard

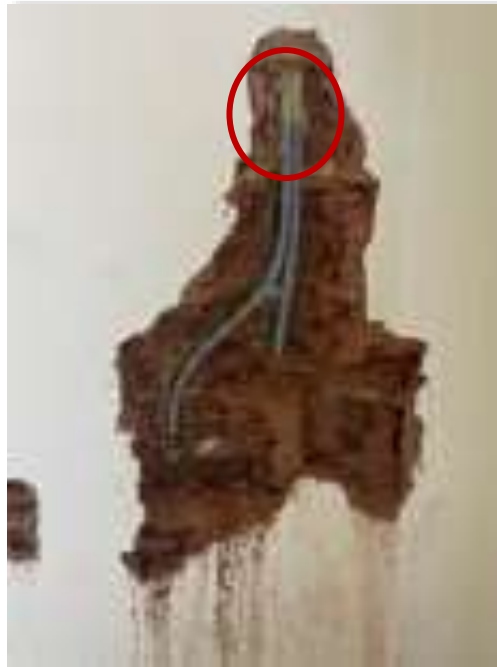
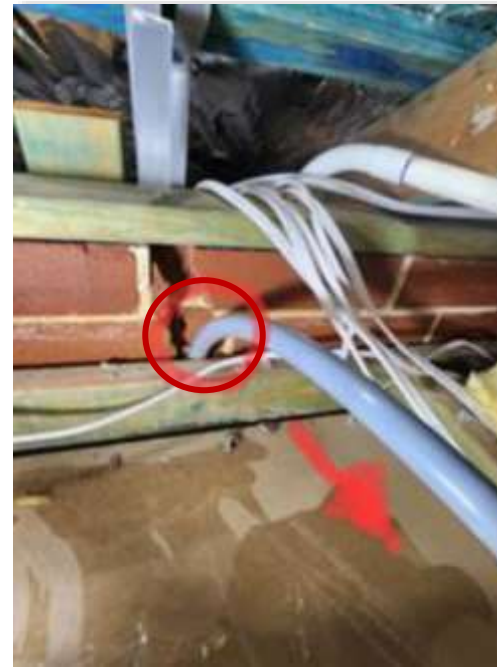
The bend of these pipes are likely to be outside of Iplex Pro-fit instructions (too tight), placing stress on the pipes

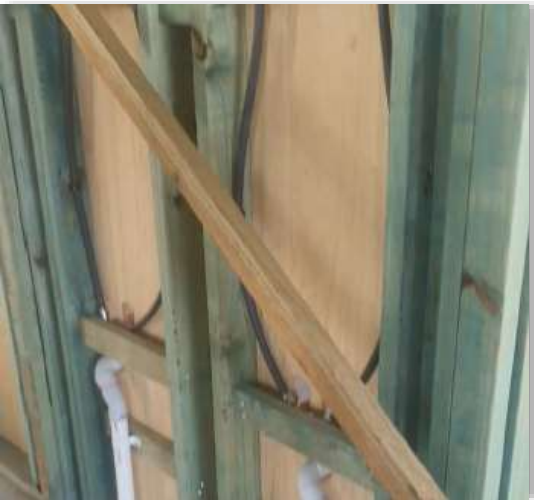
Timber frames allow the pipe to be installed within the open space of the wall cavity, allowing for **adequate movement due to thermal expansion and contraction**, while still being supported with sufficient clipping.

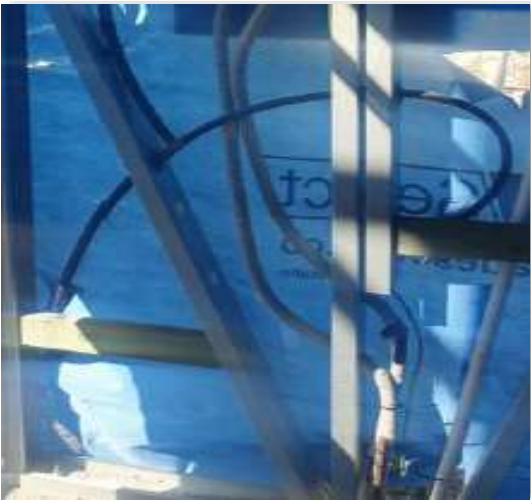
While tight bends are still visible in these images, the pipes are able to **freely expand and contract within the open wall cavity** during expected regular changes in the pipe's temperature and pressure (e.g. water hammer).

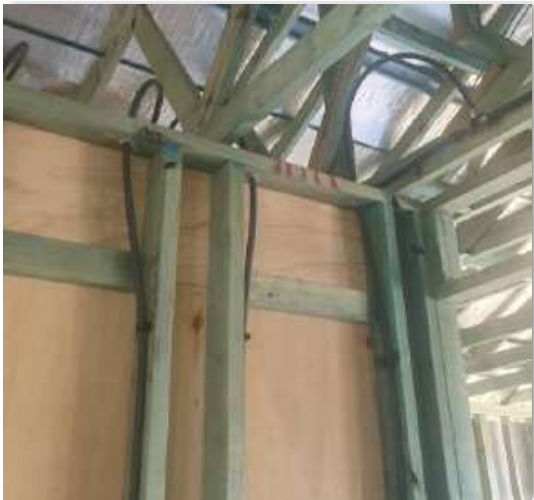
Holes cored in the top plate allow for **adequate movement** of the pipe due to thermal expansion and contraction without being held tightly by a mortar fill.
