17 January 2019

MRV METALS PTY LTD OPERATIONAL UPDATE

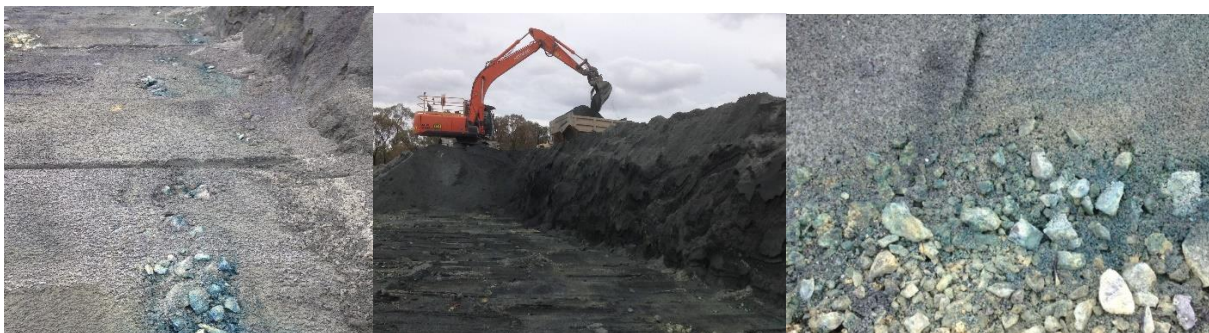
The following photo's are the result of our investigations into the issues in the Heap Leach 4:

The market will note, the blue green Copper Sulphate clearly identifiable in the sub-base of the heaps, which in recent time it is now apparent have essentially acted as a copper strip. Whilst the Company has highlighted in prior announcements our desire to investigate the Copper as a by-product to our operations, as a secondary leach or dual recovery processes, the issues faced are somewhat premature and problematic.

These actions in an attempt to reduce the water balance in the 2015-2016 period has essentially striped areas that were high pH of agglomerated lime, cement and natural pH levels, and generated in sections of HL4, highly acidic areas which were in essence undertaking a Copper stripping process. Hence in the subbase of the heaps which forms the irrigation and filtration channels for the heap leach process, is bound by high levels of Copper Sulphate and highly acidic areas of AMD. Until these areas are dealt with, the heaps in certain areas will continue to produce significant acidic AMD, which is a direct result from irrigating with AMD from the waste rock dump, and exponentially increasing the problem across the site, which occurred from early 2015 through to late 2016.

The Company has taken the opportunity whilst stripping back Heap Leach 4, to inspect the sub base and the liner integrity and we are satisfied the heap structurally is in good order and repair for leaching, however the need to undertake a flush of the under base is underway and we are expected to recommence stacking in the next week. Whilst these actions have been highly detrimental to our operations and left the site with significant inventories of AMD, we are confident that whilst we have been removing ore and correcting it, when replaced, it will be of an alkaline nature and thereby be immediately amenable to leaching.

This activity will add time and cost to our restart of HL4, and whilst this was not anticipated, a large quantity of the prior harm caused has been pH corrected in the upper levels of the heap by MRV Metals Pty Ltd over the last 9 months, and now it becomes a bulk earth movement process to remove, remediate and replace, so as to move into leaching as quickly as possible.
