SRK TEAM IDENTIFY NUMEROUS STOCKPILES AND UNTAPPED MINERALISATION**HIGHLIGHTS**

Hardey Resources Limited's (ASX: HDY) ("HDY" or "the Company") Board has received a brief report from SRK Consulting and Condor Prospecting that highlight key initial findings from the field trip.

NELLY VANADIUM MINE SITE VISIT UNDERWAY

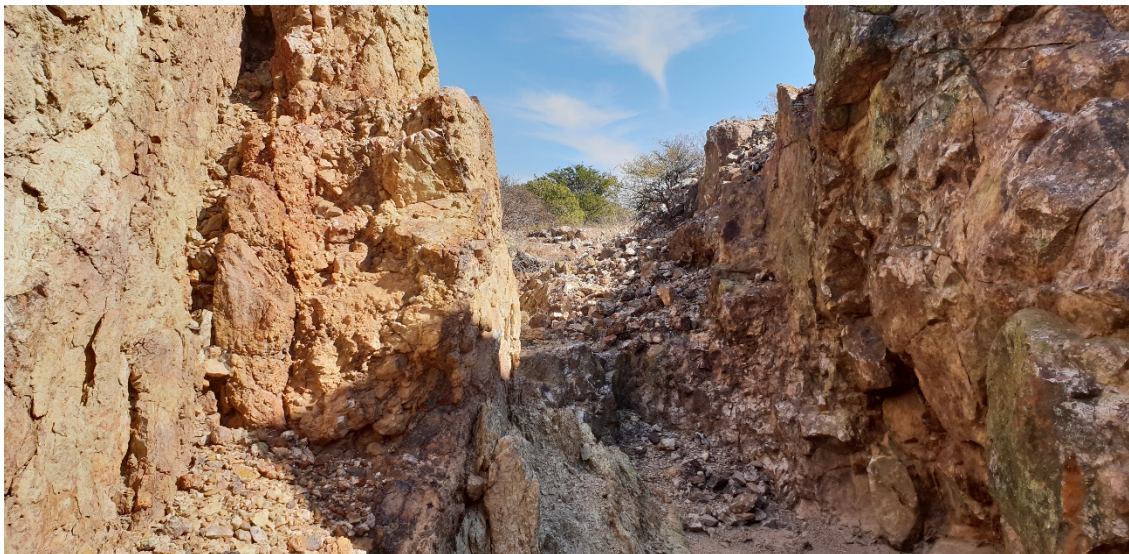
PHOTO 1: MAIN OPEN PIT AT NVM

Viewing to the south-west of the main open pit (Photo 1), the host rock (schist) is left and unexploited vein on the right part. The vein comprises bluish, greenish and yellowish minerals that may be from the vanadates family. Notably, oxidation is covering the quartz and veinings.

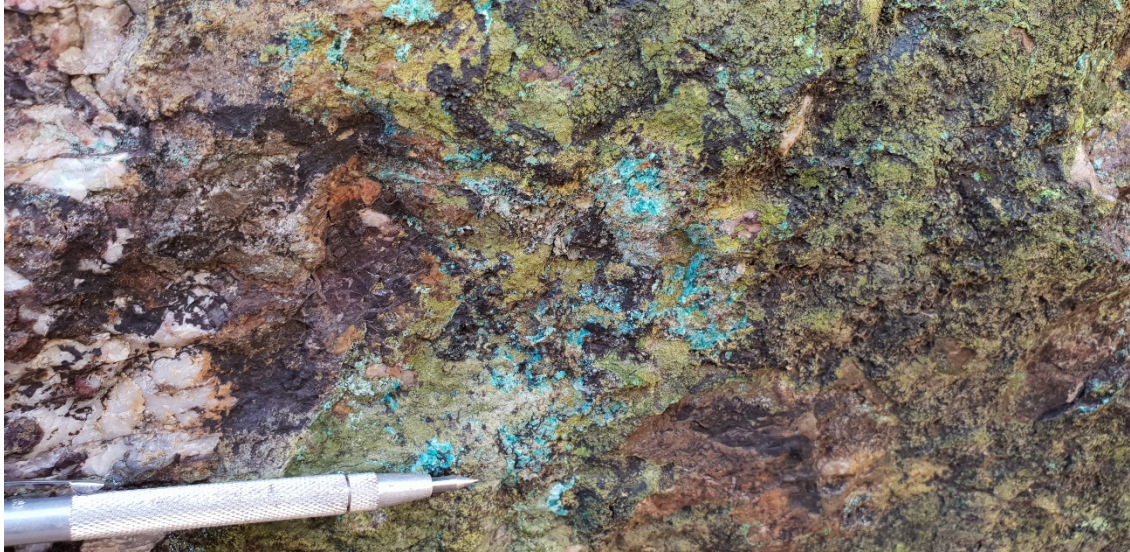
PHOTO 2: VANADATES WITHIN OPEN PIT

A closer look at the vein in the main open pit (Photo 2), shows yellow and greenish minerals which may be vanadates. The blue minerals are from copper and oxidized veins and may be hematite carrying copper and zinc minerals.

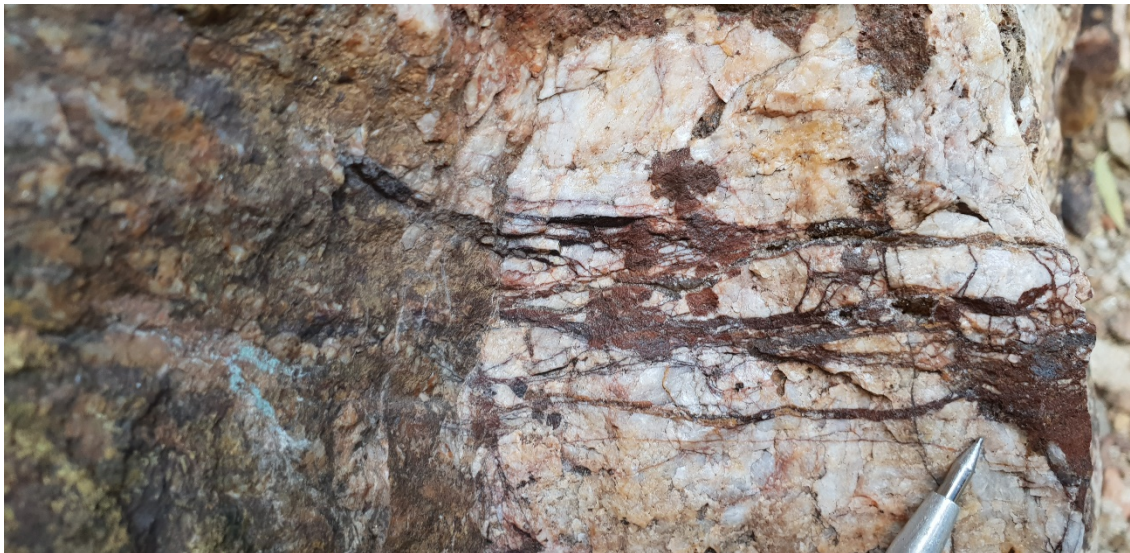
PHOTO 3: INTENSE VEINING IN QUARTZ IN OPEN PIT

Another picture of the vein in the main pit (Photo 3), shows intense veining in quartz and some iron mineral crystals in the centre. The bluish minerals on the left may be vanadium minerals.

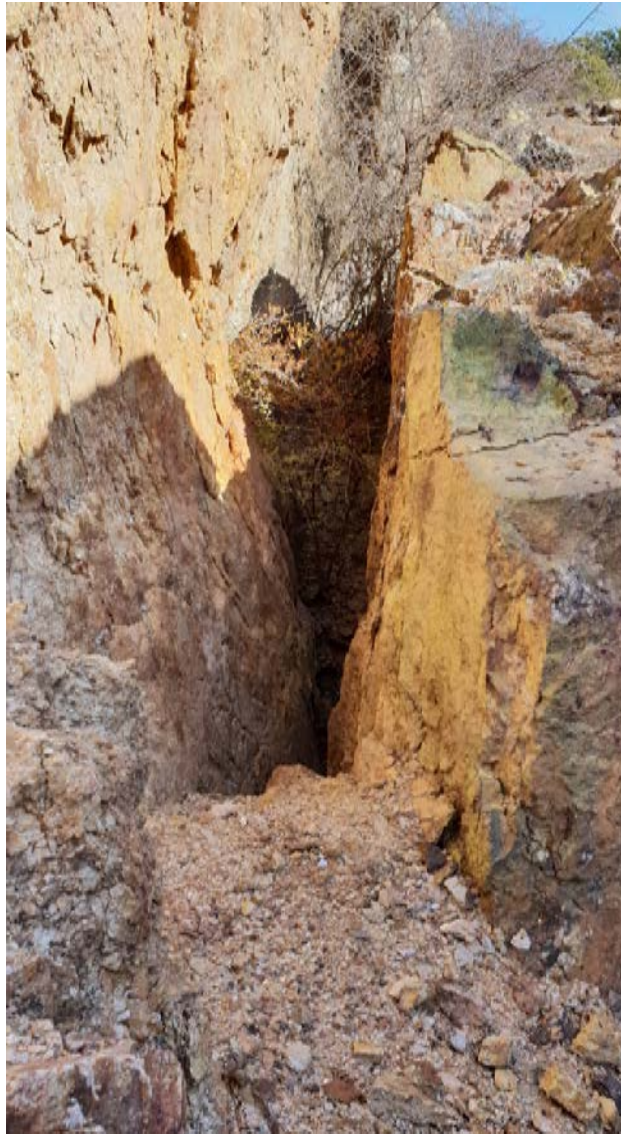
PHOTO 4: HOST-ROCK & VEIN

Incremental pictures of the main open pit show contact between the vein and the host rock, with the vein on the right and the host rock, which is a schist, on the left (Photo 4). From a different viewpoint, the north-east shaft (Photo 5) was used to access different levels of the mine. On the right of the level located in the centre of the picture is the ladder miners used.

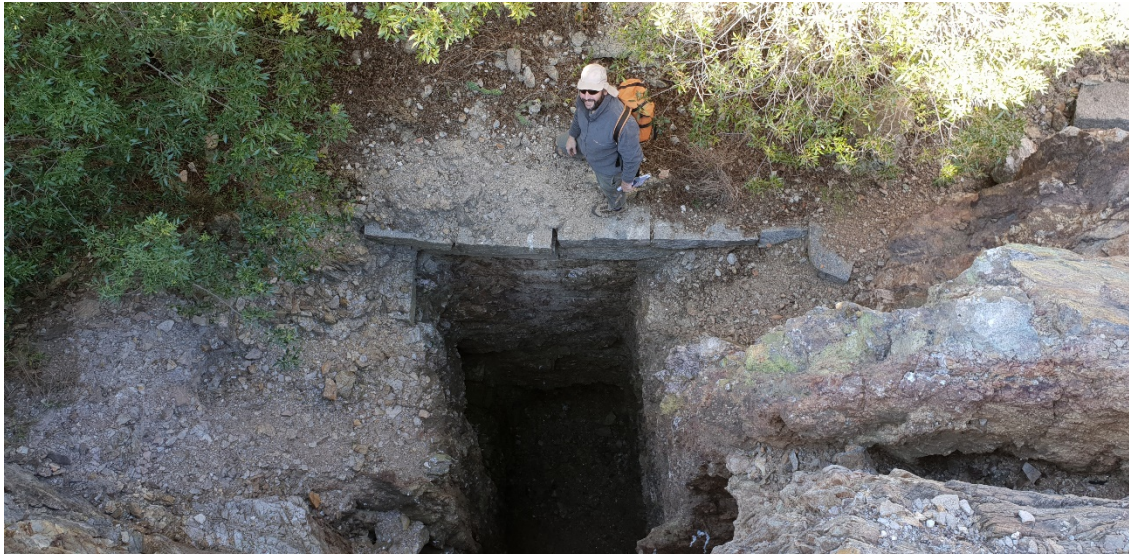
PHOTO 6: UNEXPLOITED MINERALISATION ON NORTH-EAST SHAFT

Another view from the north-east shaft to the mine (Photo 6), shows on the right side a portion of the vein left by the historic miners. It is >1m wide and yellow/green/blue minerals visibly present.

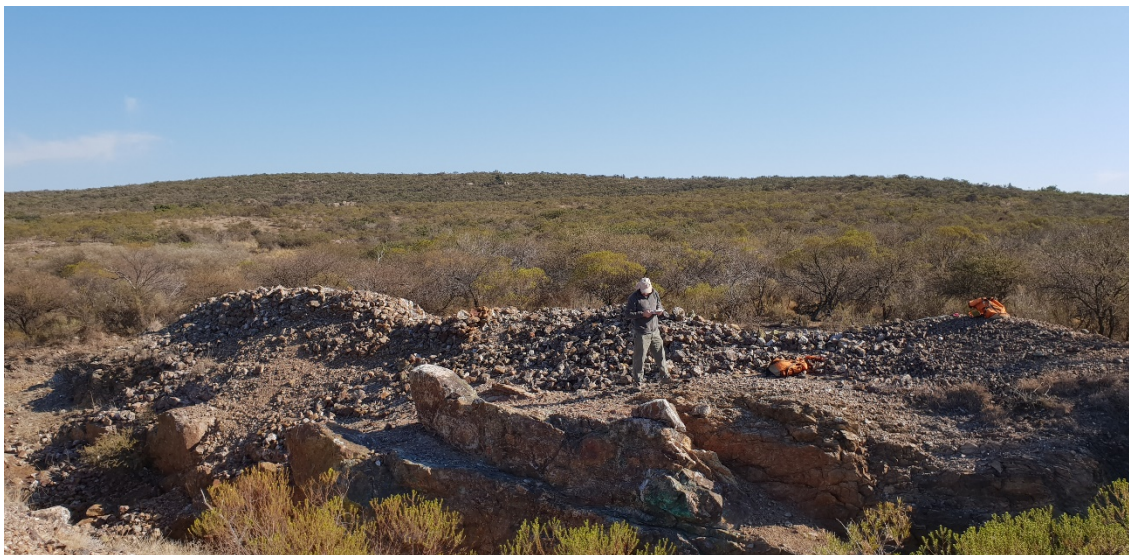
PHOTO 7: UNEXPLOITED MINERALISATION ON NORTH-EAST SHAFT

This picture (Photo 7), which is on the north-west side of the main pit, shows the main stock pile and unmined vein that is >1m wide.

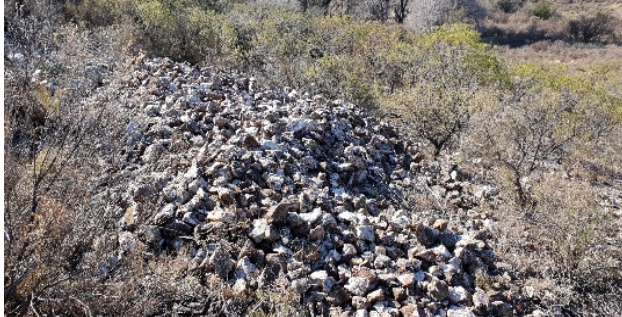
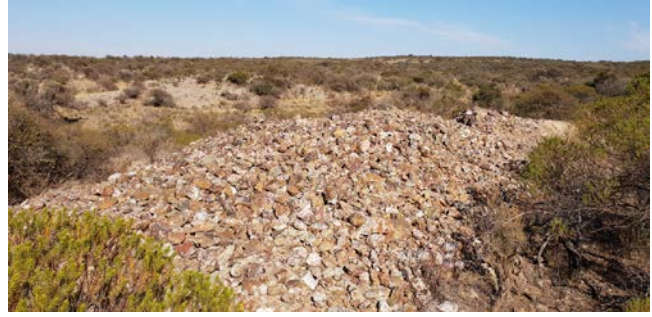
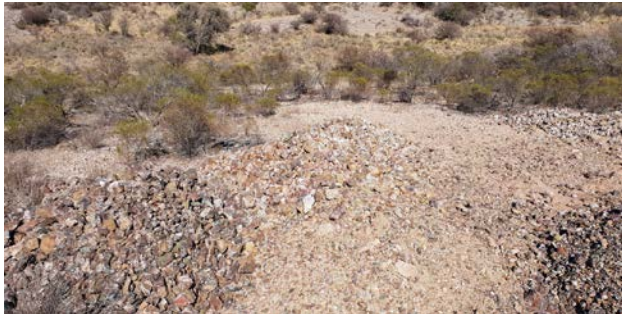
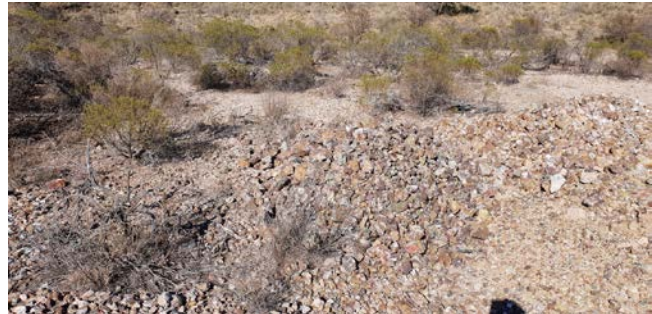
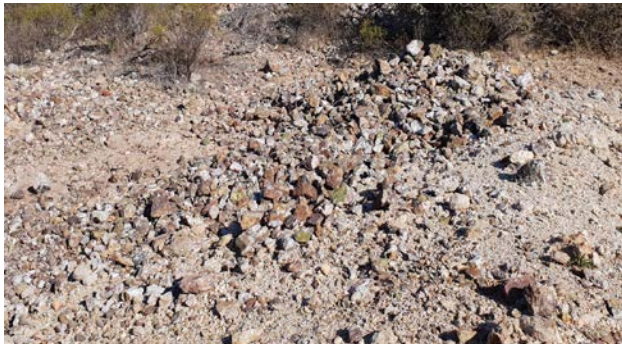
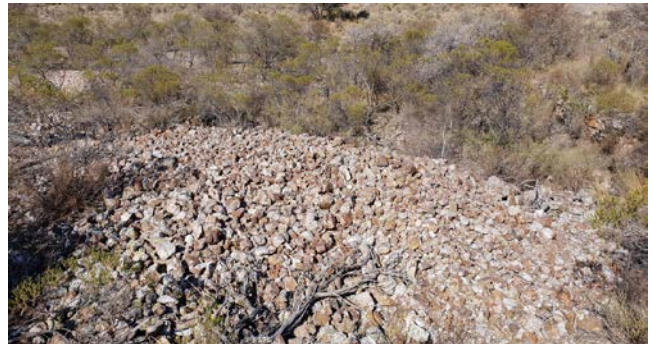
PHOTO 8A-F: STOCKPILES 2-4 and 7-9

Confirming the extent of stockpiles around the main open pit, Photos 8A-F highlight six that can be readily exploited if bulk sampling and metallurgy results are positive.

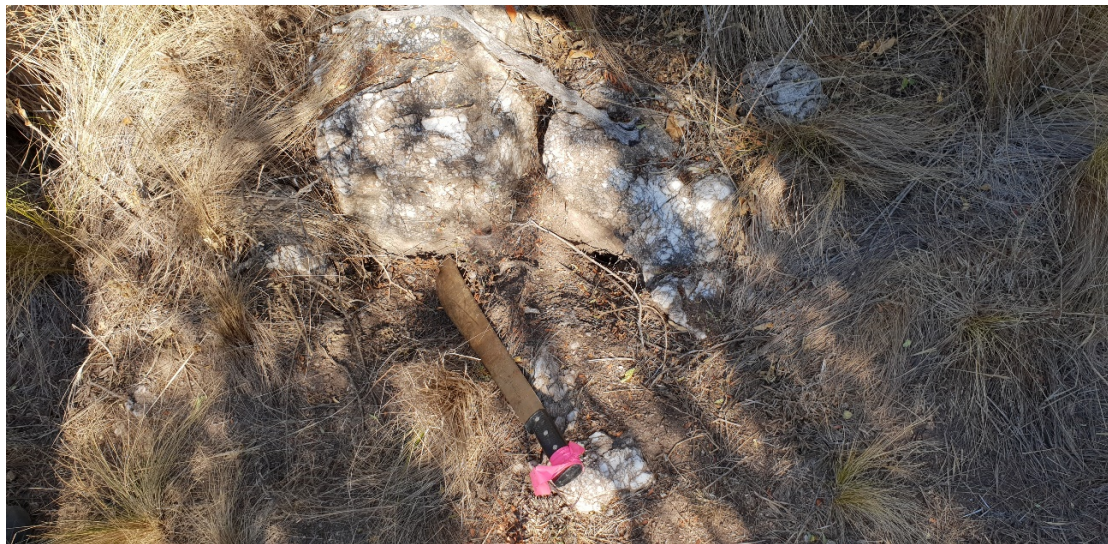
PHOTO 9: VEIN OUTCROPPING 200M SOUTH-WEST OF MAIN OPEN PIT

A clear picture of the vein outcropping (Photo 9) that is 200m south-west of the main open pit. It shows the vein has minor veinings with oxidation and minerals. Next to this is a historic working that is surrounded by breccia clasts from the vein. Interestingly, the clasts within the breccia are silicified.

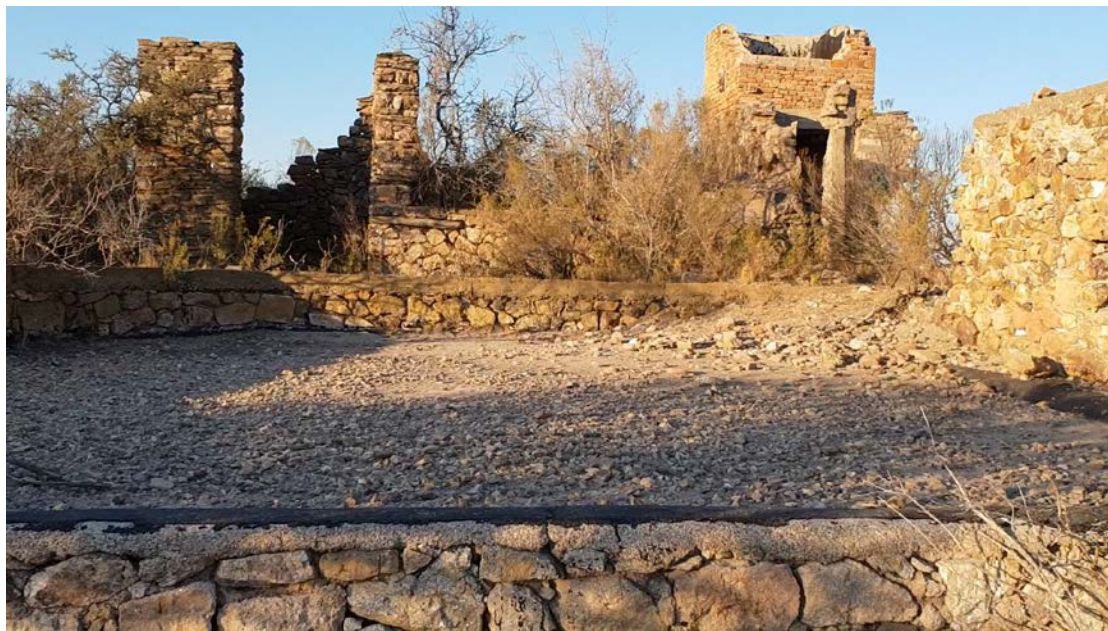
PHOTO 10: HISTORIC PROCESSING FACILITY

The historic processing plant (Photo 10) where vanadium pentoxide was produced.
