ASX / MEDIA ANNOUNCEMENT

ASX: NCZ

CENTURY MONTHLY DEVELOPMENT UPDATE - MAY 2018

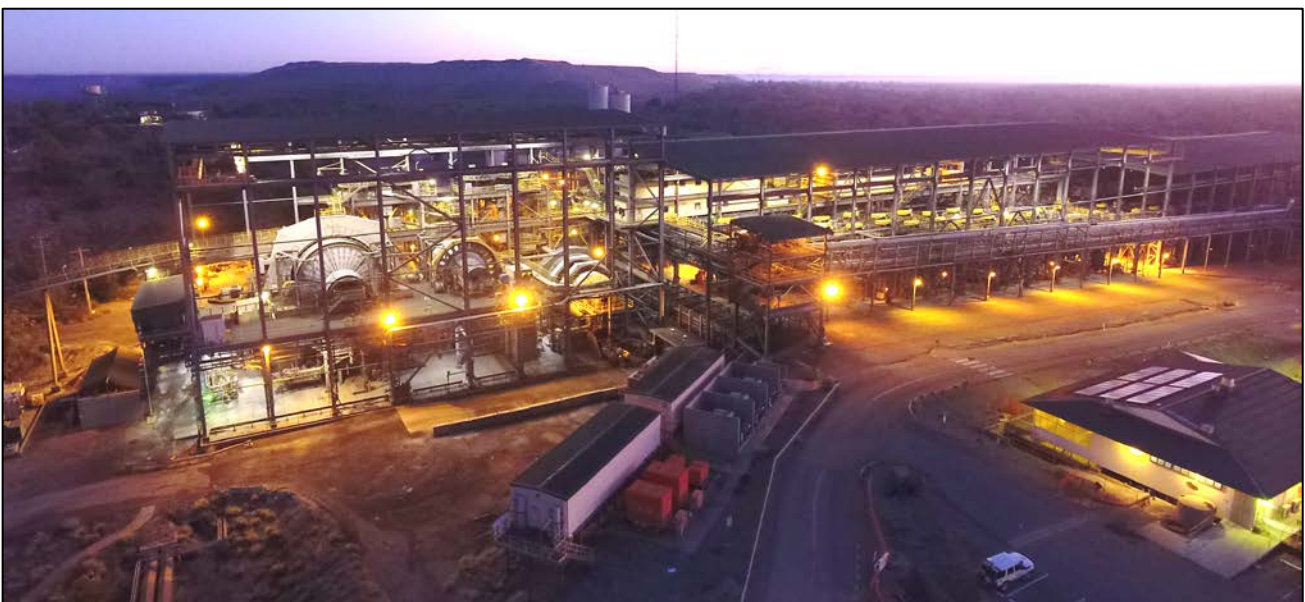
Figure 1: Century Processing Plant refurbishment well advanced with commissioning due in July 2018

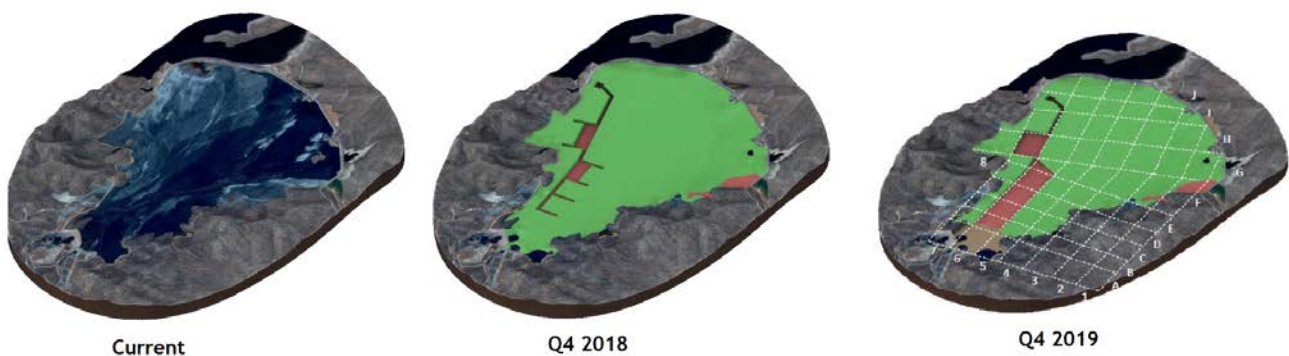
Figure 2: Hydraulic mining plan over the next 15 months, with location of the the tailings slurry receival sump shown in the top left corner of each map (section I7 on the 'Q4 2019' above)

- Tailings Receival Sump excavation for the install of the Slurry Winning Pontoon continuing with 30% completed to date
- Earthworks for hydraulic mining operations and administration areas completed, with concrete civils works due for completion in June
- Tailings transfer pipework installation underway, connecting the tailings slurry pumping infrastructure to the existing pipework leading to the Processing Plant
- Continuing offsite fabrication of hydraulic mining equipment including Slurry Winning & Water Winning Pontoons, with initial deliveries due early June
- 11kV powerline from site to tailings facility nearing completion, with 24 of 44 poles erected and fully strung
- Tailings feed preparation works (adjacent to Century Processing Plant) continuing, with concrete civils now complete

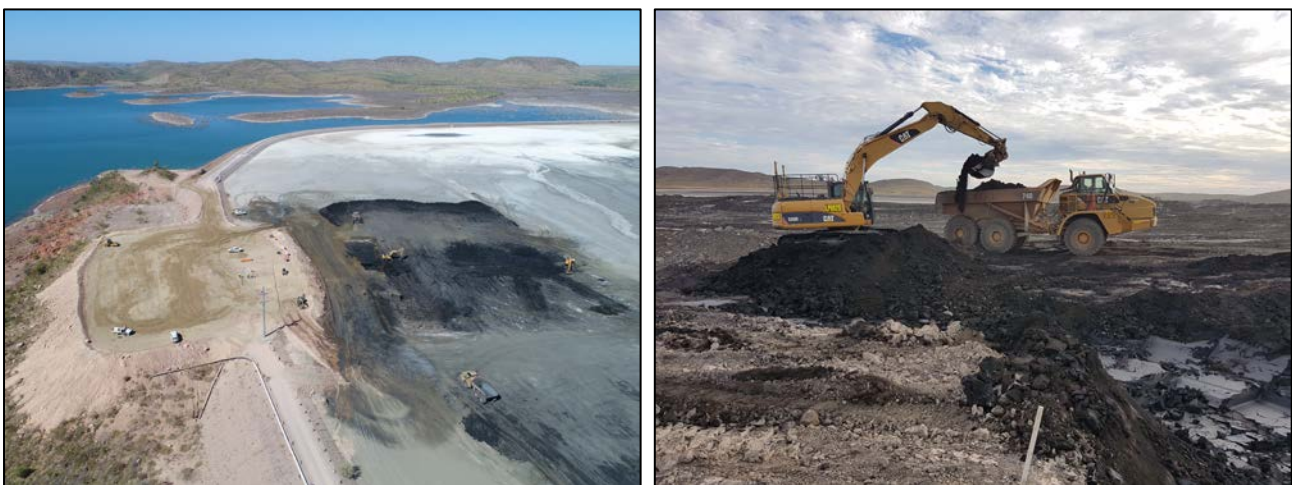
Figures 3 & 4: Aerial view of the hydraulic mining area with evaporation dam in the background (left) and Tailings Slurry Receival Sump excavation activities (right)

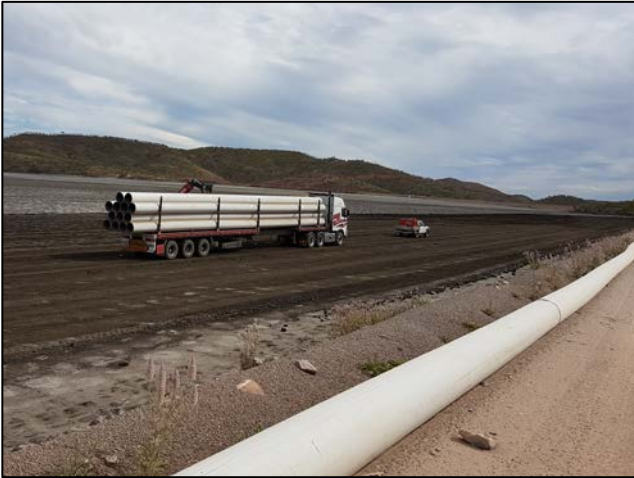
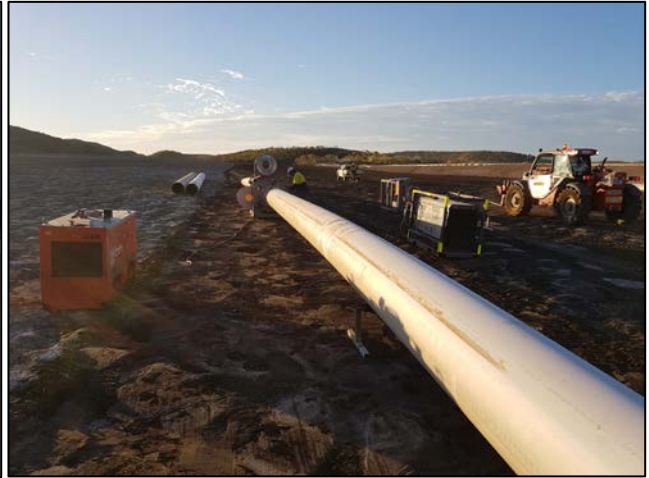
Figures 5 & 6: Delivery and installation of tailings transfer pipework to transport slurry to the Processing Plant

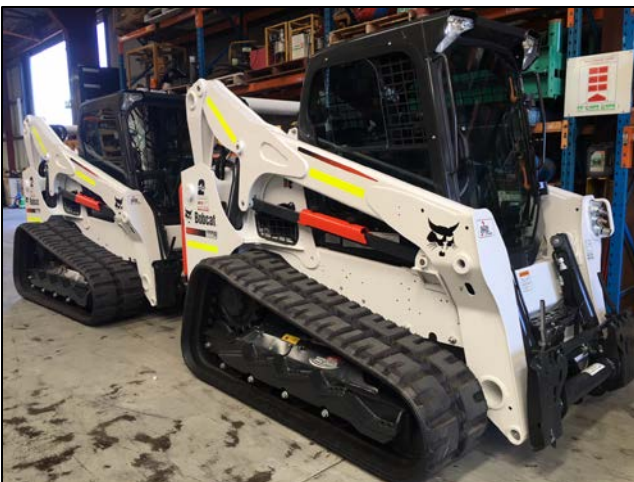
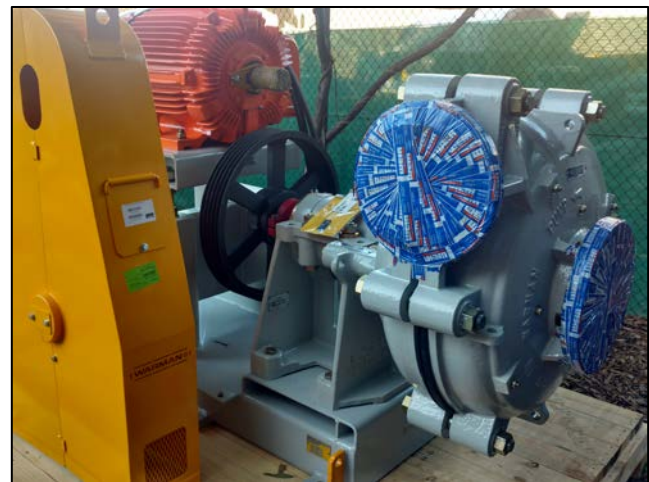
Figures 7 & 8: Hydraulic mining bobcats to be mounted with water cannons for operations (left) and Warman Slurry Pumps fabricated and ready for shipment to site (right)

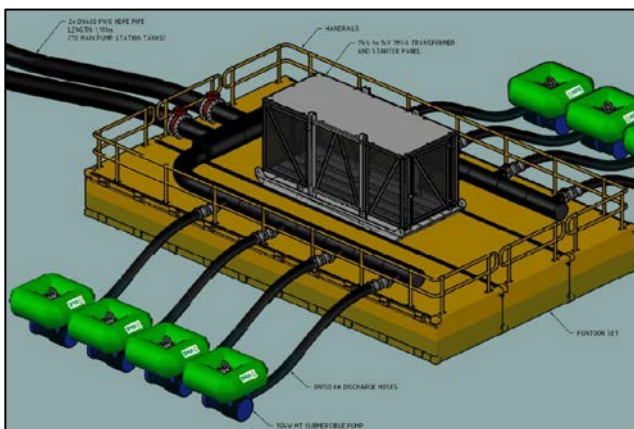
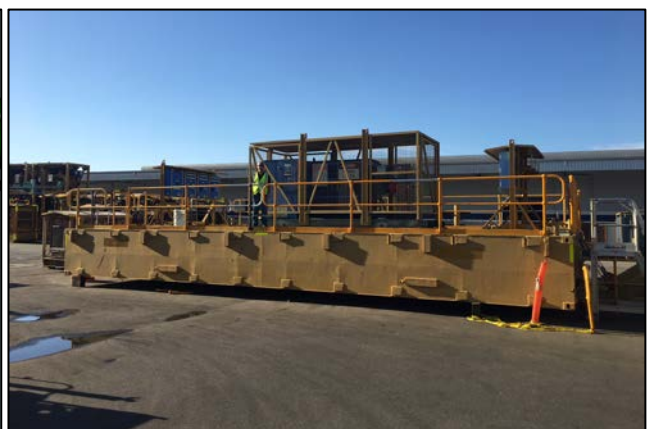
Figures 9 & 10: Design of the Water Winning Pontoon for extraction of feed water from the Evaporation dam (left) and fabrication of the pontoon in Perth nearing completion for June delivery (right)

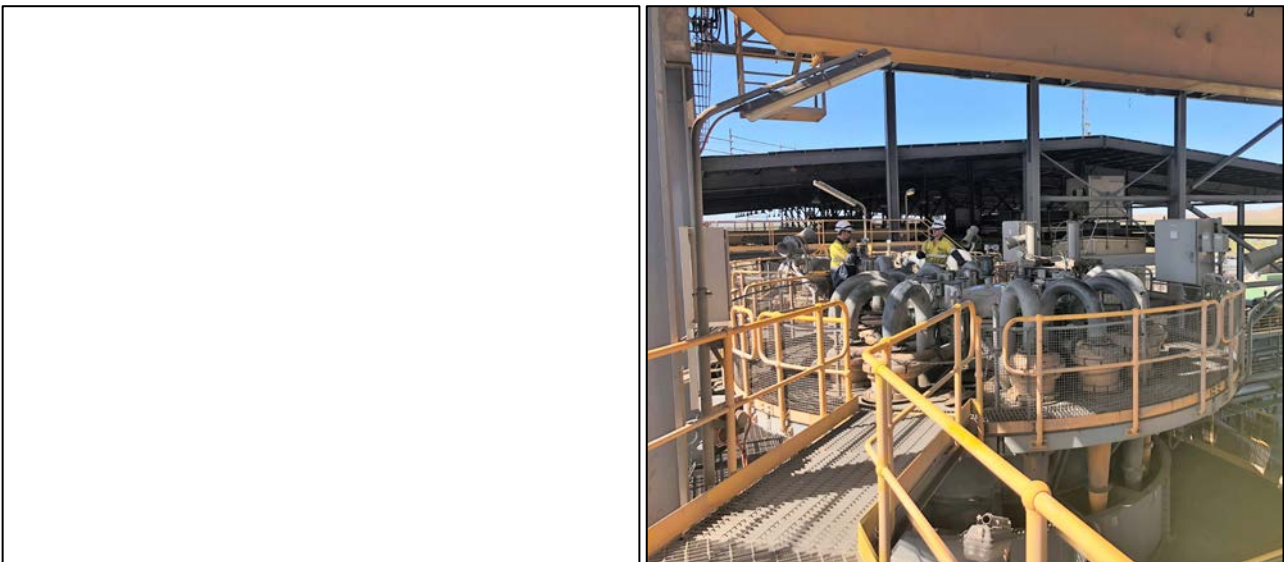
Figures 11 & 12: Feed Cyclones and Float Cell mechanical and electrical testing completed, including a 2 hour performance run of all Float Cell motors

- Average of ~110 Sedgman & Ausenco contractors on site during the month of May
- Ball mill inspections, lube system refurbishment, trommel panel change out and initial inching run completed, ready to receive first fills for final load testing in July
- Feed cyclone and Float cell motor mechanical and electrical inspections complete
- Float cell clean out and inspection completed with only minor repairs to select cell liners and cone replacements required (to be completed in June)
- Full control system replacement continuing on schedule - 68% complete to date
- Offsite fabrication of pipework modifications and feed preparation equipment continuing
- Ancillary thickener sand blasting and painting underway

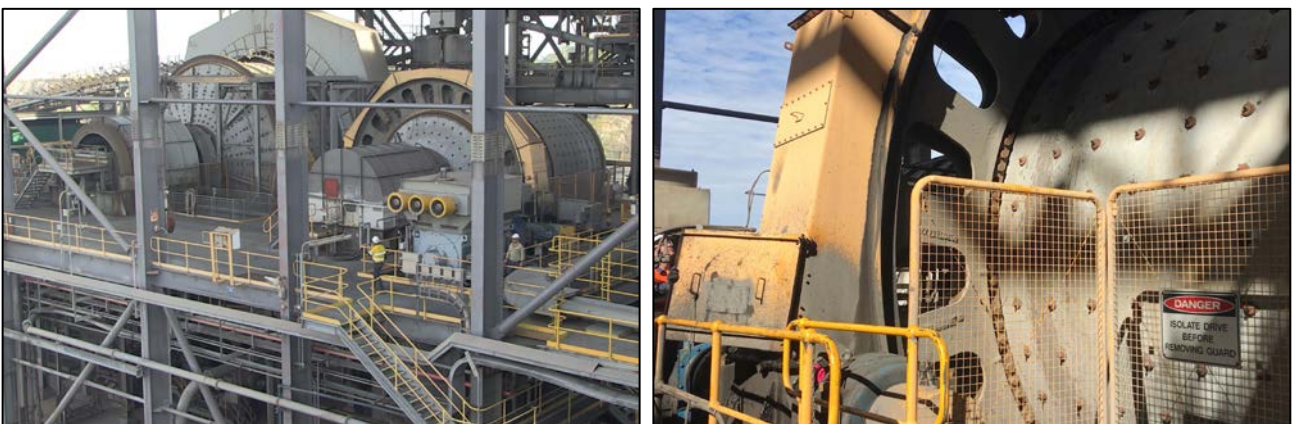
Figures 13 & 14: Ball Mill inspection, refurbishment and inching run completed in preparation for commissioning in July on receipt of first fills of grinding media

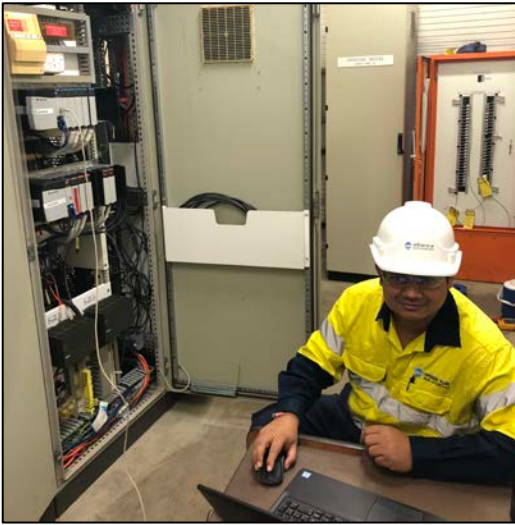
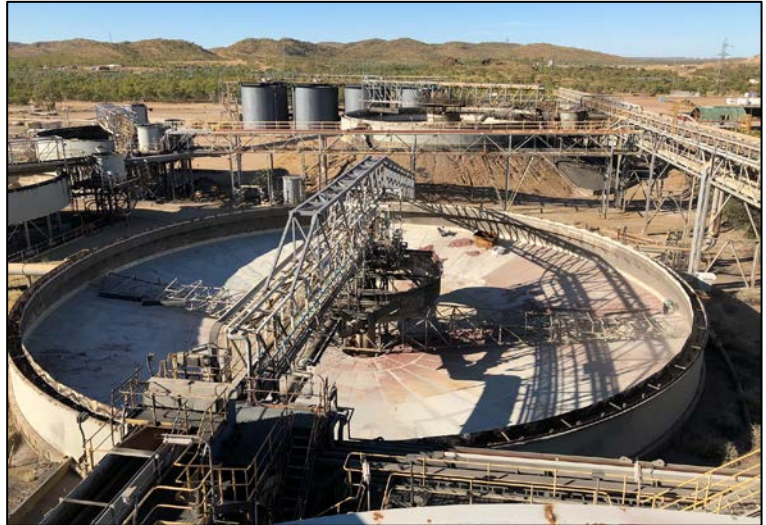
Figures 15 & 16: Plant control system installation and point-to-point testing underway (left) and sand blasting and repainting of thickeners prior to water commissioning activities (right)

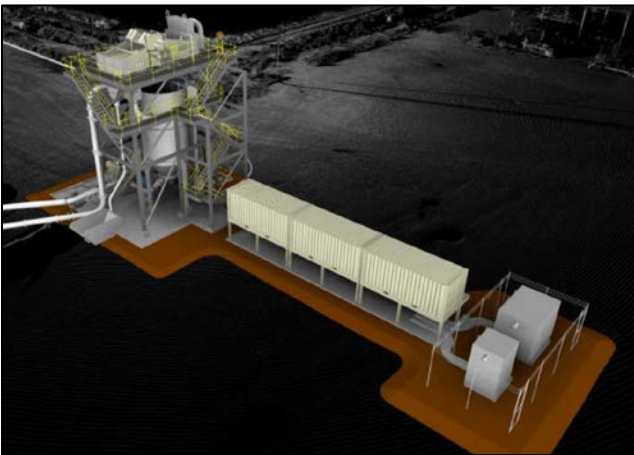
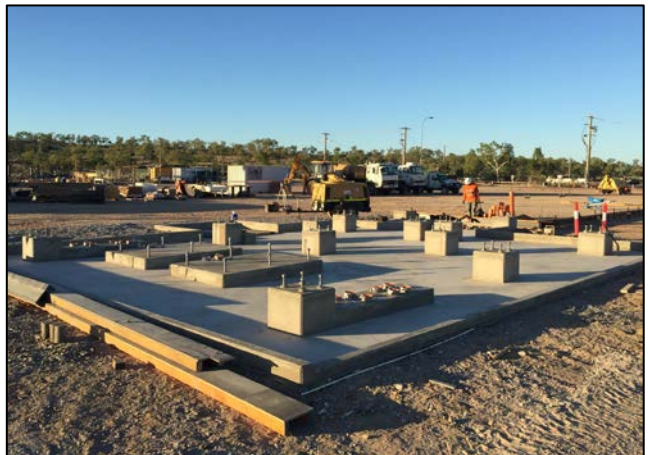
Figures 17 & 18: Tailings Feed Preparation area design overlaid on full site 3D lidar survey (left) concrete works nearing completion for the area (right)

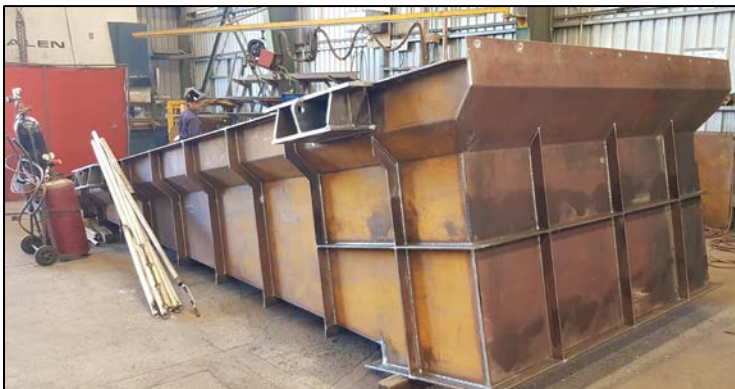
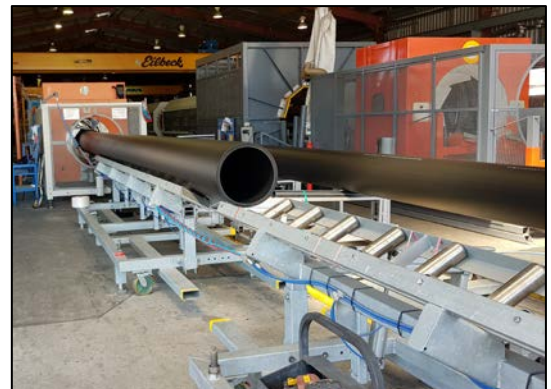
Figures 19 & 20: Offsite pipework and equipment fabrication for Century Processing Plant refurbishment

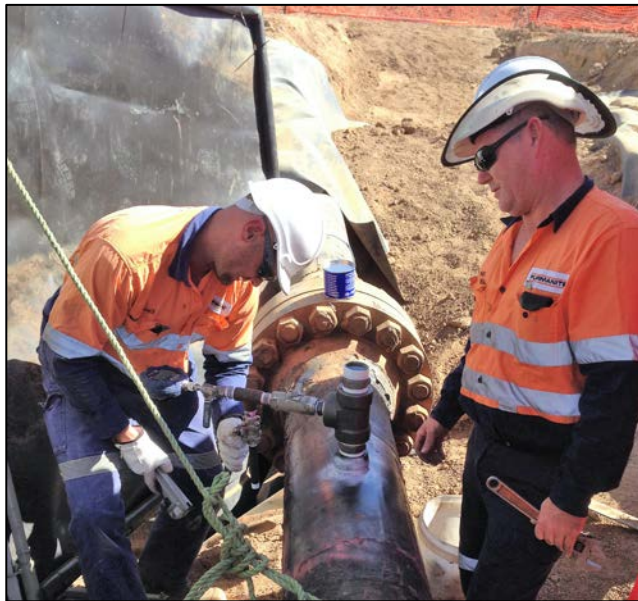
Figures 21 & 22: Initial pipeline 'hot tapping' for localised draining, controlled removal and capture of water (left) and Process Plant & Pipeline Superintendent Chris Portelli with the extracted cleaning pig (right), allowing for water commissioning activities to begin in June

- Slurry pipeline cleaning pig removal program successfully completed, with pipeline commissioning process to be completed in June
- Port equipment inspections and general maintenance continuing in preparation of the restarting of operations
- Dredging underway in the Gulf of Carpentaria at the mouth of Norman River to allow year round access for concentrate shipments

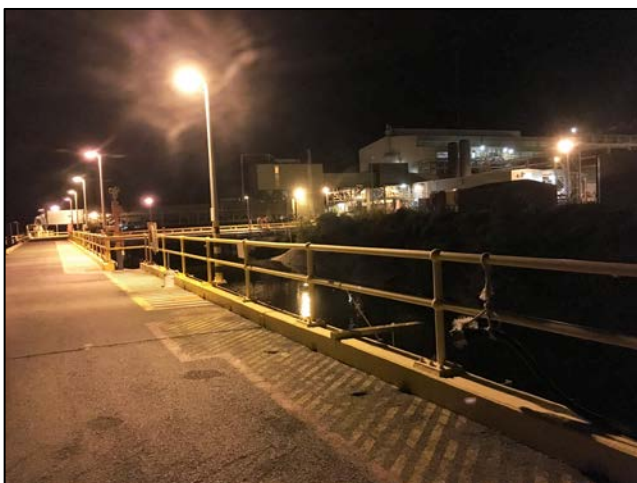
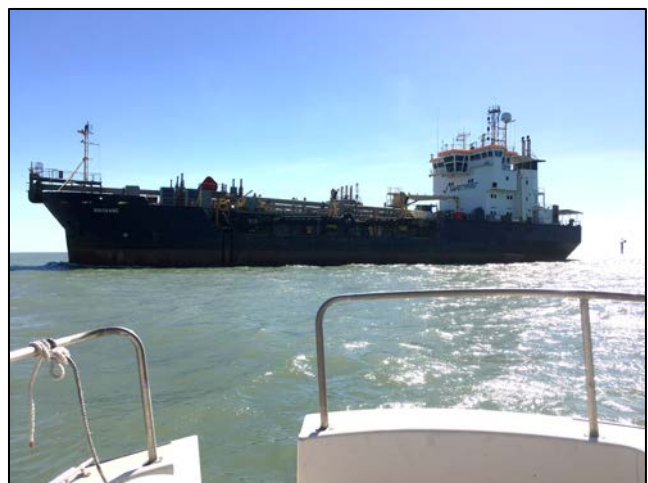
Figures 23 & 24: All lighting re-established at the Karumba Port Facility including wharf area (left) and dredging activities underway in the mouth of the Norman River (right)
