ASX/JSE RELEASE: 2 February 2018

Detailed Engineering Assessments Confirm Integrity of Main Hoisting Shaft at Prieska Zinc-Copper Project, Northern Cape, South Africa

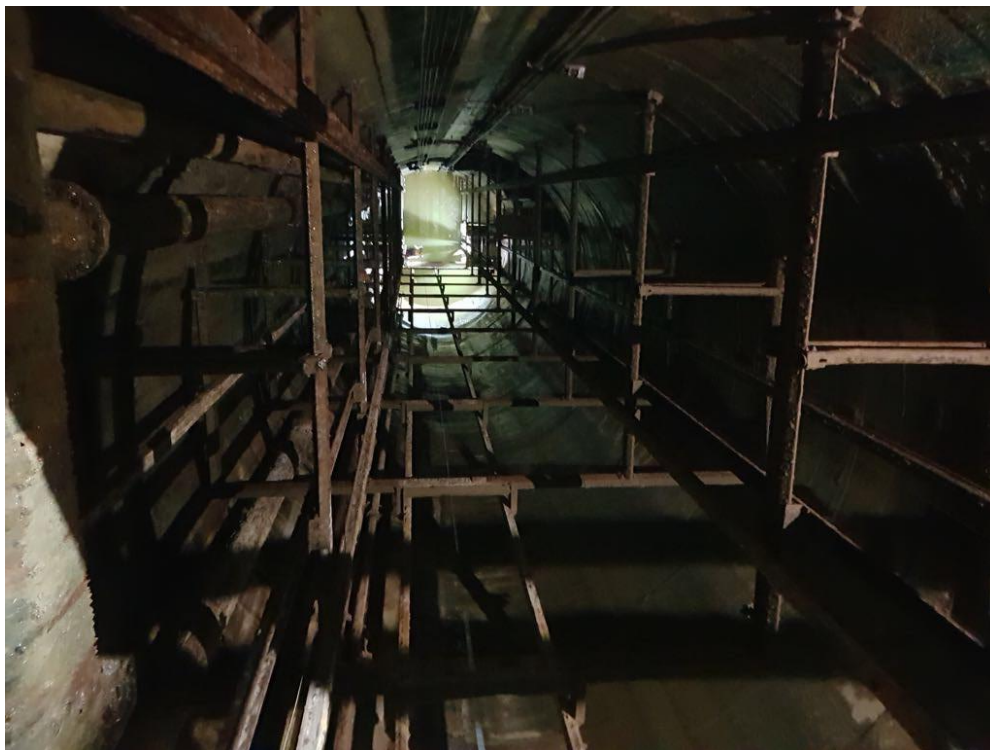
The shaft is concrete-lined with an inside diameter of 8.84m. The shaft steelwork consists of a lattice of buntons and dividers that are configured to provide two compartments to house rock hoisting skips and a central compartment to house a square cage to transport men and materials (Figure 3).

Figure 3: (Top) Plan-view schematic showing the configuration of the Hutchings Shaft and (Bottom) photograph of the Hutchings Shaft taken in January 2018 showing a similar plan-view perspective, with the accumulated water at the 350m Level.

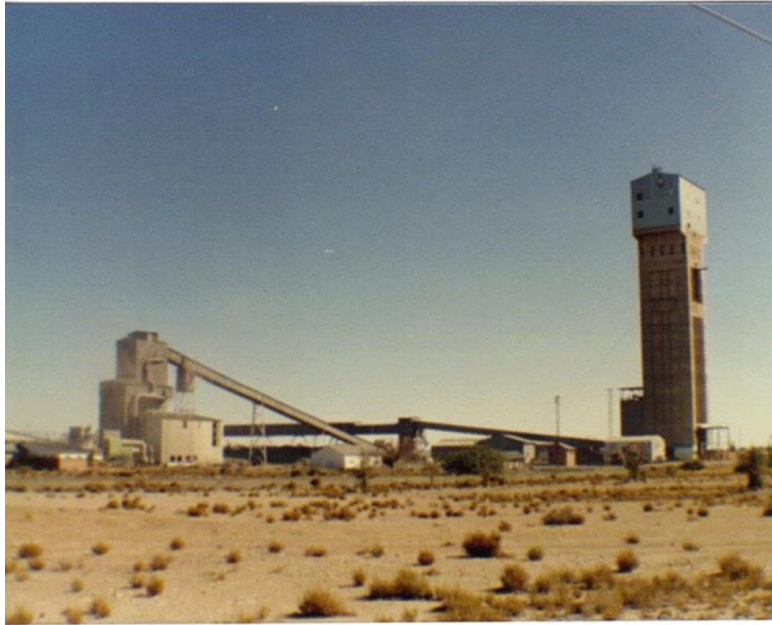
The shaft barrel is topped by a rectangular concrete headframe which is 68.6m high (Figures 4 and 5). The shaft operated with a Koepe-type winder mounted on top of the headframe to hoist the rock skips and a separate, ground-based, double-winder to lift the people and materials cage.

Figure 4: Hutchings Shaft and winder room during historic mining operations (1971 to 1991).

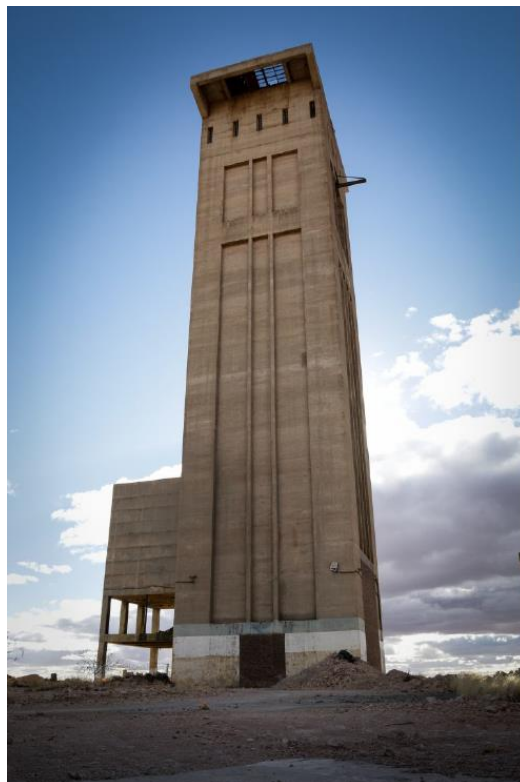
Figure 5: The Hutchings Shaft headframe, standing 68.6m high (2017).

Detailed civil and structural assessment of the concrete headframe will be conducted once winder selection and proposed placement is completed.

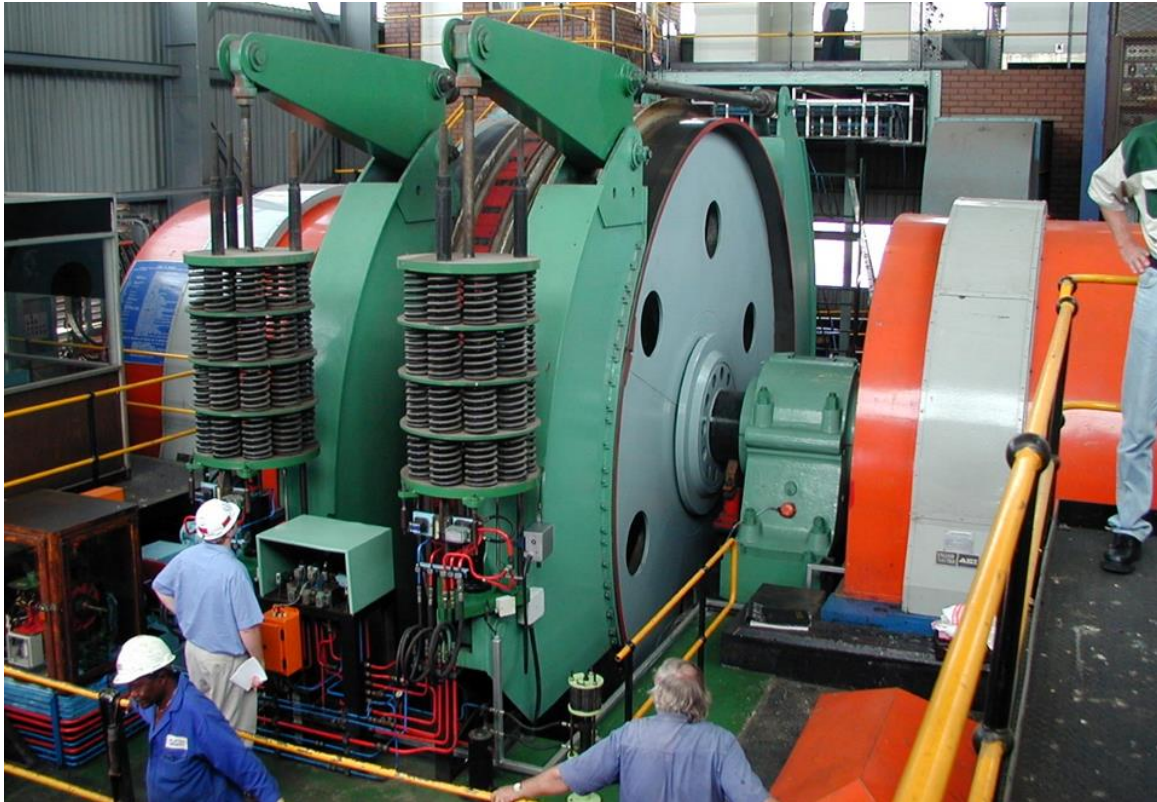
The winder room on top of the concrete tower was removed and most of the shaft equipment dismantled and sold. The original winder is still in use at a mining operation in South Africa (Figure 6)

Figure 6: The original Hutchings Shaft rock winder in use currently at a South African mining operation.

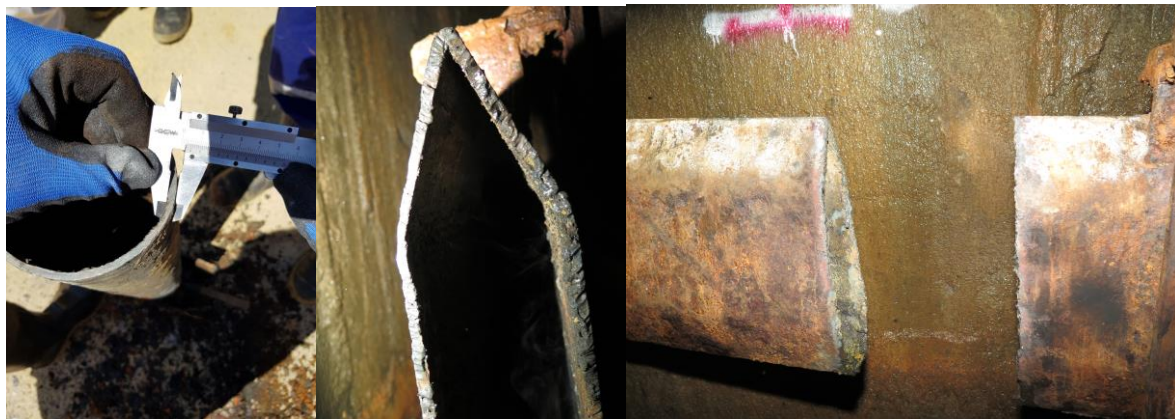
Figure 8: (LHS) Divider from submerged Bunton Set number 81 tested steel thickness to 5.0mm; (Middle) section through retrieved Bunton (RHS) location where bunton section was removed.

- Shaft steelwork recovered from underwater has been unaffected by being submerged and shows no signs of added deterioration compared to similar steelwork from above the waterline.
- As expected, secondary light steelwork and pipework is compromised by corrosion and will be replaced.

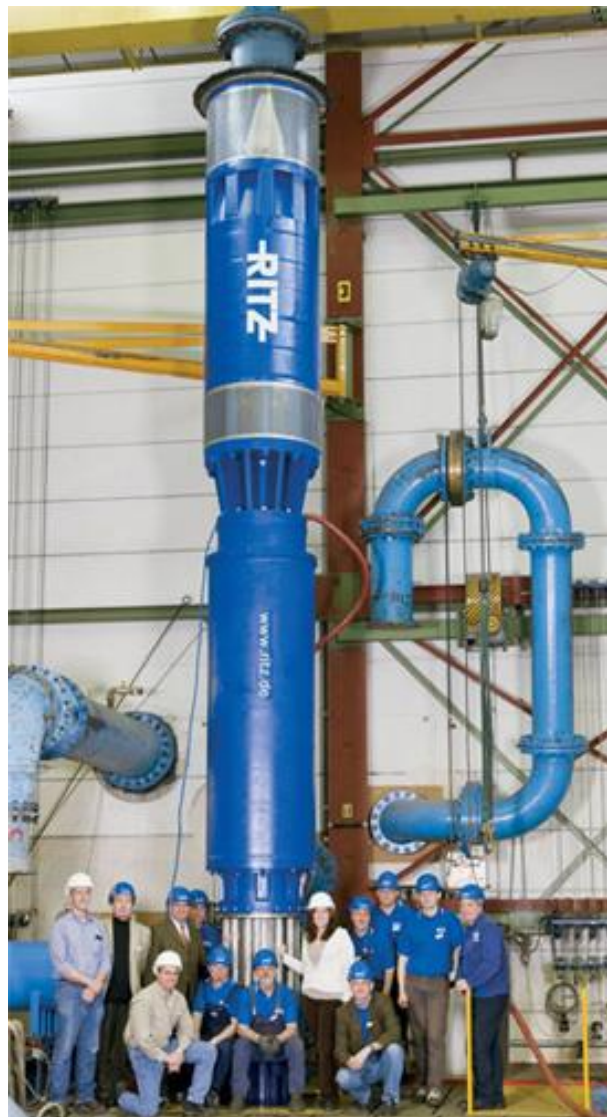
Investigations into the most practical manner to dewater the mine are well advanced. The favoured dewatering approach is the use of a large submersible pump, lowered to the bottom of the shaft on its pipe column and capable of pumping the water from the bottom of the shaft in a single lift. Available models of such pumps can operate at pumping rates of up to 1,300 m³/hour, which could completely dewater the mine within nine months, (see Figure 9 for example). The pump and rising main could be placed in the shaft such that the assembly does not interfere with concurrent shaft refurbishment works.

Figure 9: A Ritz pump recently used for mine dewatering at an operation in the Democratic Republic of Congo.
