12 April 2021

Saki Drill Pad and Trench Site Inspections Ahead of Fieldwork

Drill Pad Site Investigation:

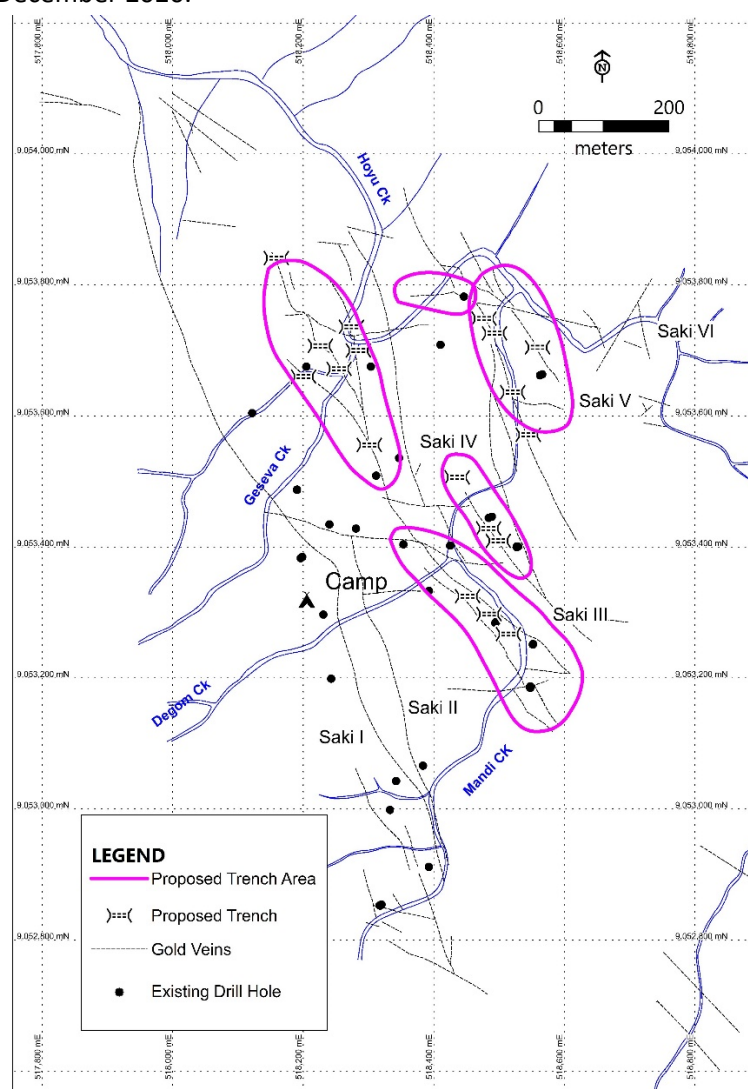
Figure 3: Saki Prospect Vein System and Proposed Trench Sites

During this inspection of drill pad sites, a series of proposed trench sites were also inspected (Table 1) to ensure their location is suitable to sample and define mineralised Saki vein extensions (Figure 3). Due to a landslide in December 2020, geologists are currently revising the location of trench and drill pad sites at the Saki V vein to a safe location away from the landslide area, which was inspected by Frontier geologists with MRA Officers in late December 2020.

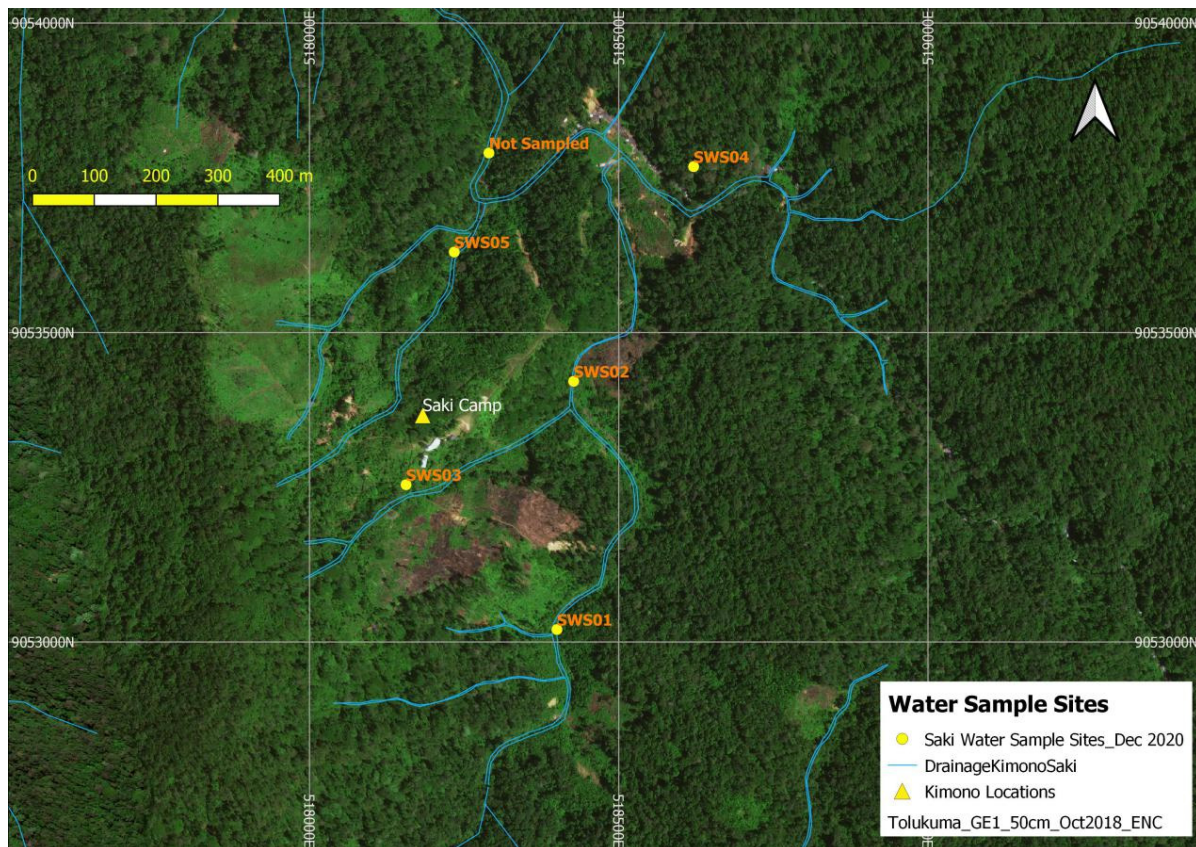
Figure 3: The Five Water Quality Sites Sampled Saki

Five water sampling sites were proposed to be sampled at Hoyu Lower, Hoyu Upper (SWS04), Geseva (SWS05), MandiDegom (SWS02) and Mandi Upper (SWS01) creeks (Figure 1). The Lower Hoyu sample site was not accessible and instead Degom Creek (SWS03) was sampled upstream from the Saki camp (Figure 2). All samples were analysed at the SGS Environmental Laboratory in Port Moresby, Papua New Guinea for general water quality testing.

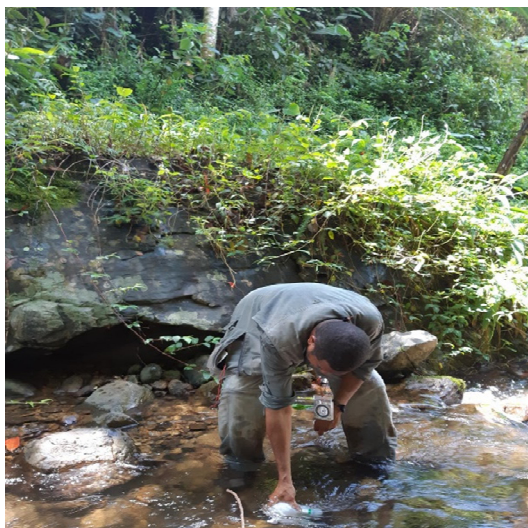
Samples were mainly taken in a pool area where the water is deeper so any fine solid particles have settled to the bottom (Photos 4 and 5). Prior to sampling the water, the plastic water container is rinsed with the in-situ water first and then sampled and returned to the camp and stored in the esky supplied by SGS laboratory for dispatch back to the laboratory.

Photo 4: Container Rinsed in Mandi Creek

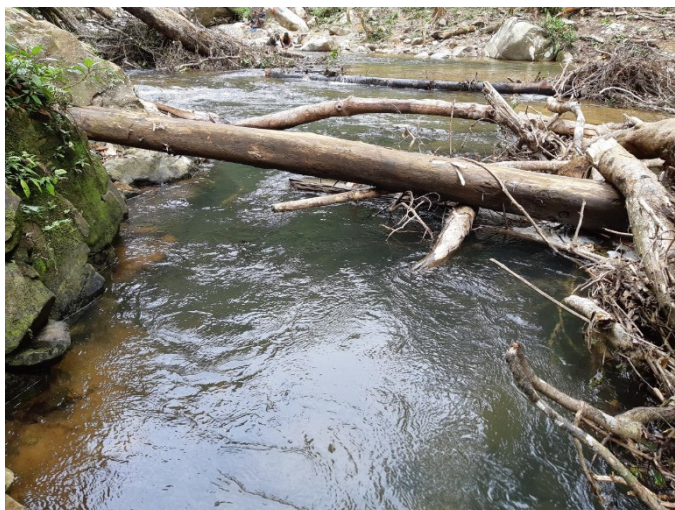
Photo 5: Sampling Site in Upper Hoyu River
