SRK TEAM IDENTIFY NUMEROUS STOCKPILES AND UNTAPPED MINERALISATION**HIGHLIGHTS**

Hardey Resources Limited's (ASX: HDY) ("HDY" or "the Company") Board has received a brief report from SRK Consulting and Condor Prospecting that highlight key initial findings from the field trip.

NELLY VANADIUM MINE SITE VISIT UNDERWAY

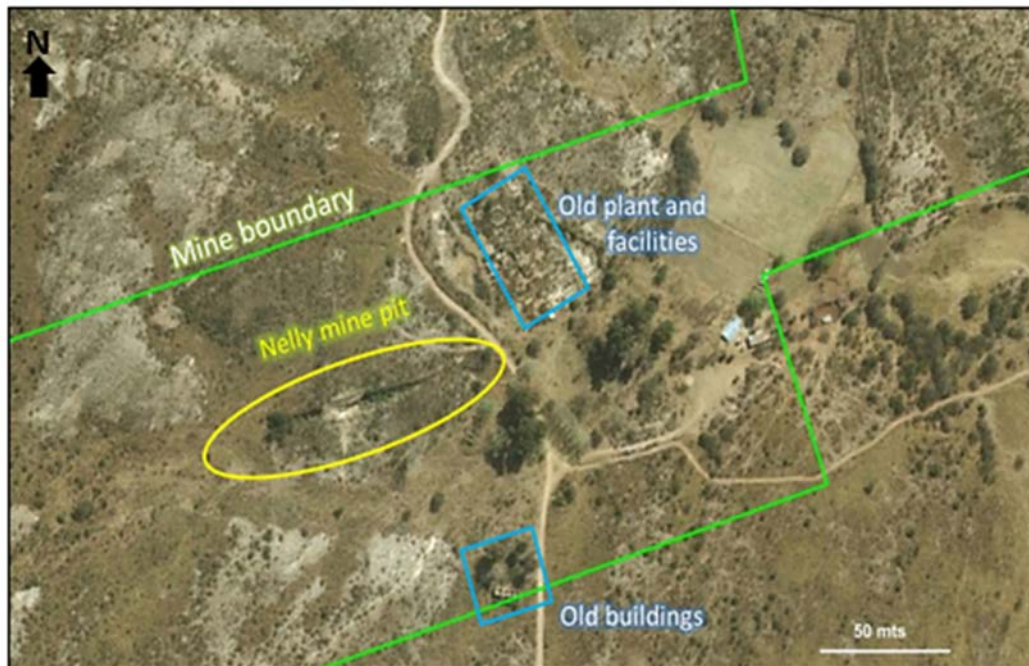
FIGURE 1: CLOSE UP SATELLITE IMAGE OF NVM

- To provide context, the initial focus of the visit was performed on the region which extends south-west from the road that passes through the project area (Figure 1). Pre-site checks comprised reviewing regional geology, verifying accessibility and availability of power/water to the project area.
