Fletcher Building dismisses BGC claims and provides detailed update on causation research to date

Auckland, 13 October 2023: Fletcher Building Limited has today issued a detailed update on the cause of the plumbing failures that have occurred in a number of homes built in Perth during the period 2017 – 2022, along with the activities Iplex Australia is undertaking to support industry and homeowners in finding the right solution.

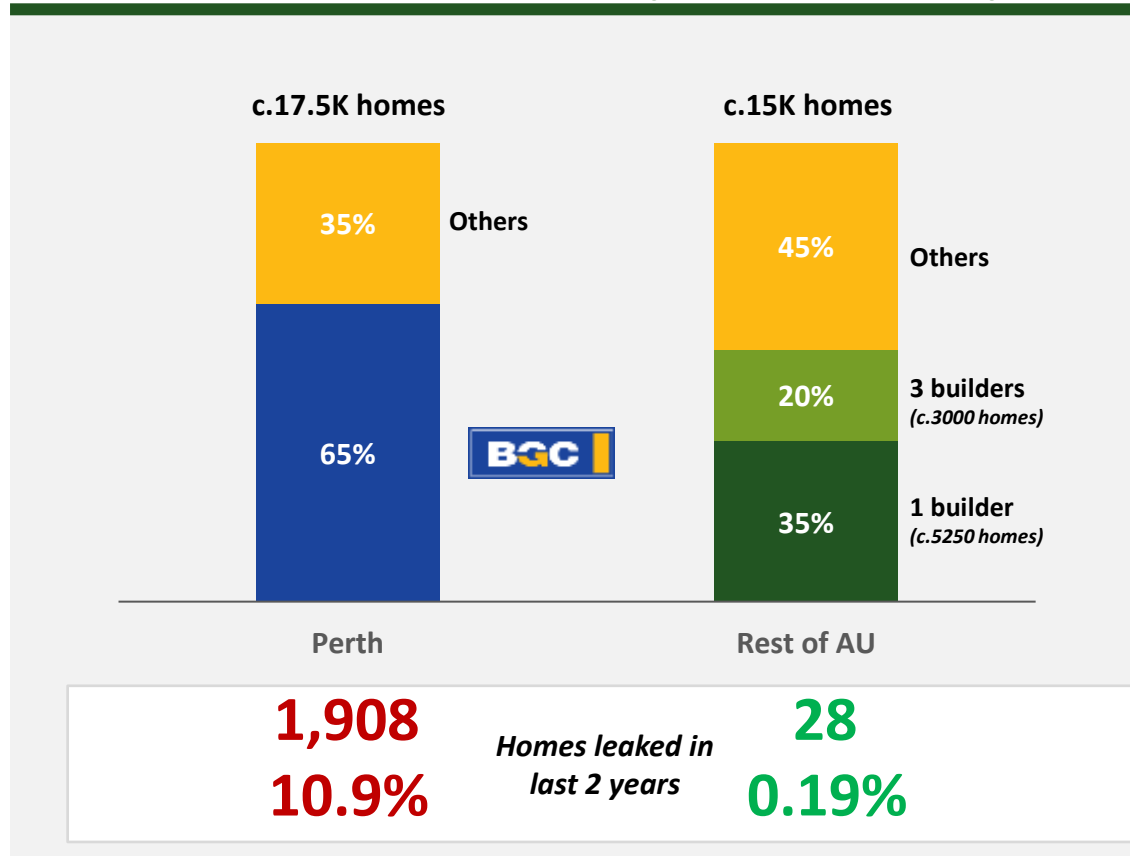
Homes built with Pro-Fit (mid 2017 – 2022)

- Similar volumes of Pro-Fit sold in Perth and rest of AU from 2017-2022
- Iplex has reached out to all our merchants and major plumbers / builders on the East Coast – they report no abnormal leak rates

- **Over the last 2 years, we have been made aware of only 28 homes in the rest of AU that have been impacted by plumbing failures involving Iplex pipe in homes built since mid-2017.**

- **Of these 28 homes, only 1 was determined to have a manufacturing defect with 8 yet to be determined/tested**
- BGC is misrepresenting the role of the failures it refers to in Victoria. These are known to Iplex and captured in our data. All tests completed on samples provided so far from that builder have not found any manufacturing fault.

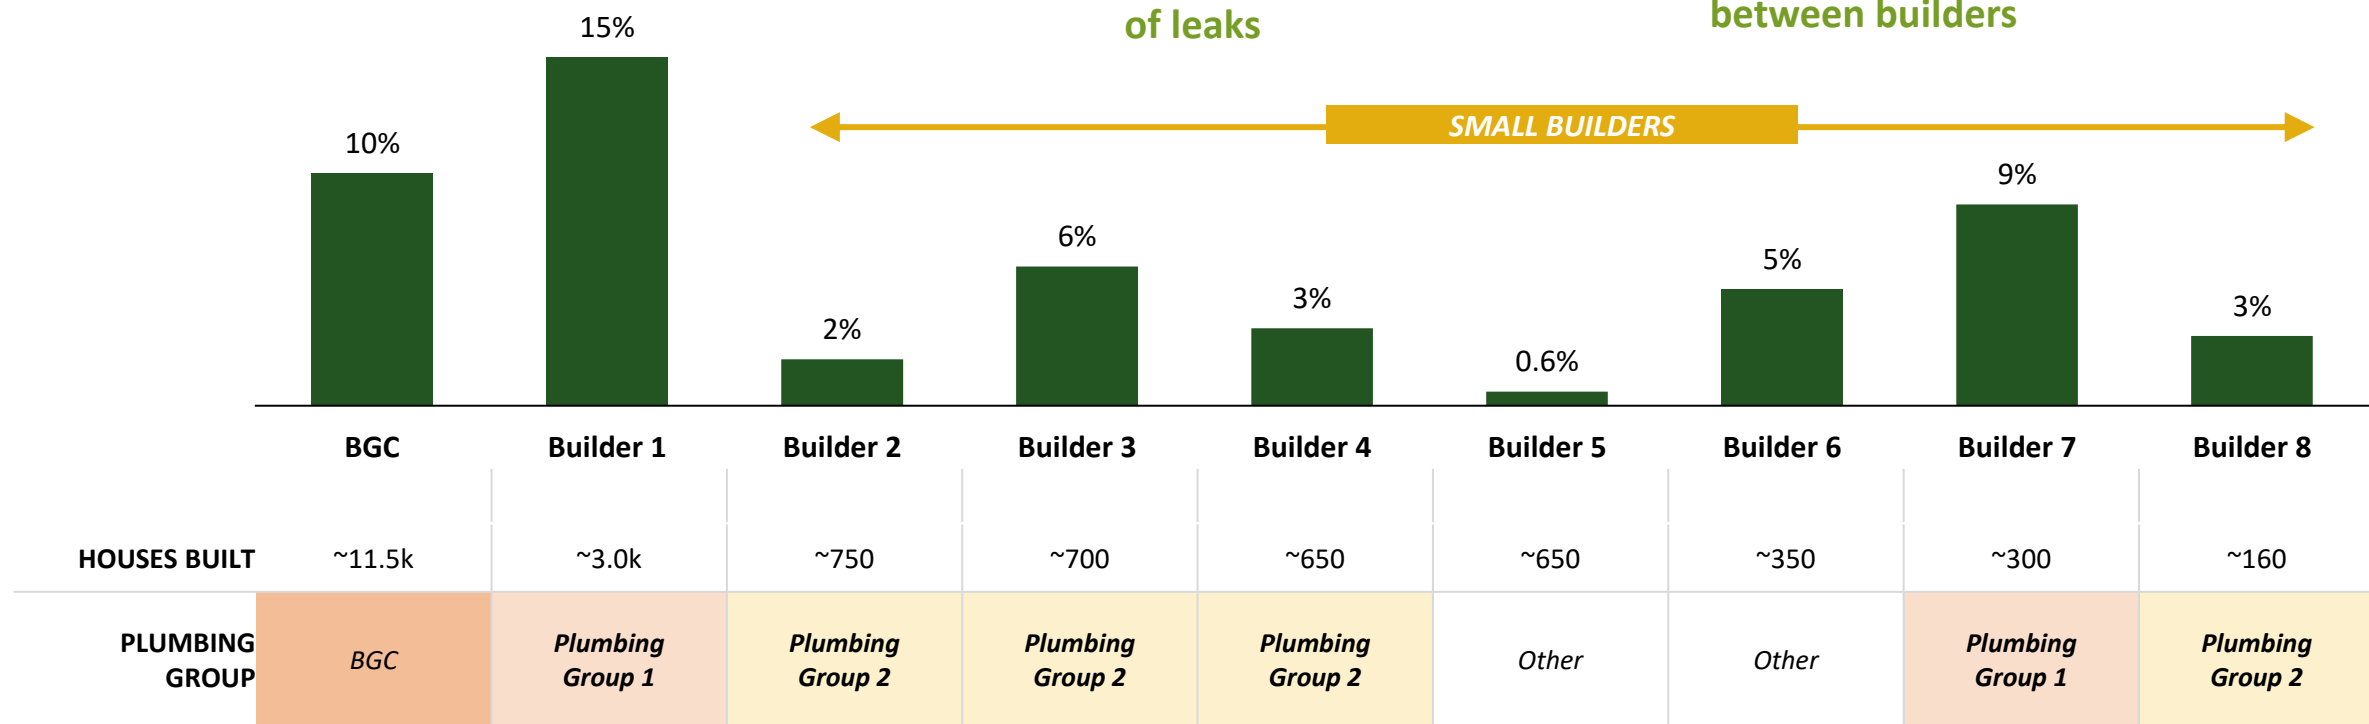
Plumbing failure rates

The abnormal plumbing failure rates are only occurring in the Perth area but rates of failure are very different across participants

1 BGC and two plumbing groups account for 94% of leaks

2 Significantly different plumbing failure rates between builders

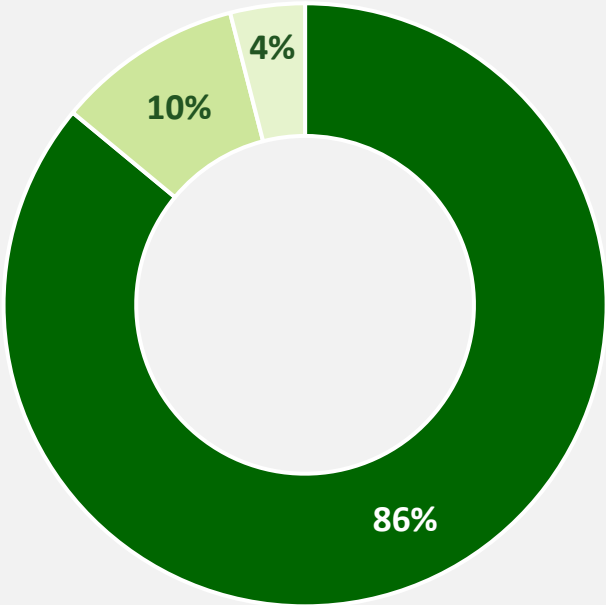
Plumbing installation failings seen across home inspections

96% of homes have at least 1 installation failure. 86% have multiple installation failures

■ 2+ plumbing installation failures ■ 1 plumbing installation failure ■ Other issues

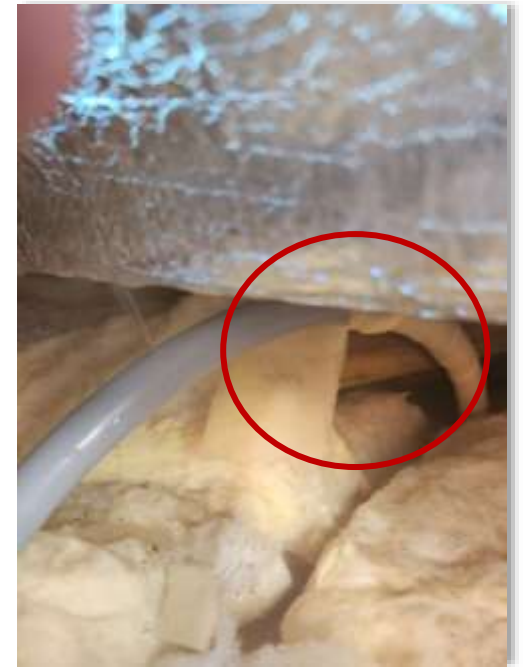
The bend of these pipes are likely to be outside of Iplex Pro-fit instructions (too tight), placing stress on the pipes

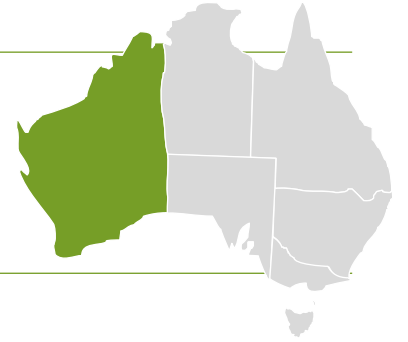
POOR INSTALLATION PRACTICES THAT ERODED OVER TIME

- We know that poor installation can result in a shortened lifespan of pipe (rather than instant failure), which can take time to identify
- Critical analysis of market practice is required, as we believe the quality of installation has eroded at a time when (some) larger home builders were seeking to reduce costs
- Questions need to be raised as to whether the cost model for these plumbing groups rewards speed without quality oversight.

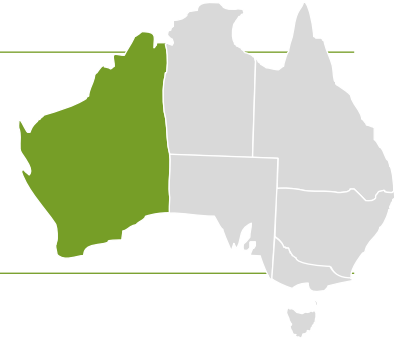
ELBOWS NOT USED FOR TIGHT BENDS EVEN THOUGH REQUIRED BY BUILDING DESIGNS

- The Iplex Pro-fit Technical Guide states that the minimum bending radius be 10 times the outside diameter of the pipe. If that is not possible, an IPLEX Pro-fit® elbow should be used.
- Iplex's investigations reveal that inadequate numbers of Pro-fit elbows may have been purchased by Plumbers in Perth.
- Perth has the lowest ratio of elbows to pipe purchased in Australia.

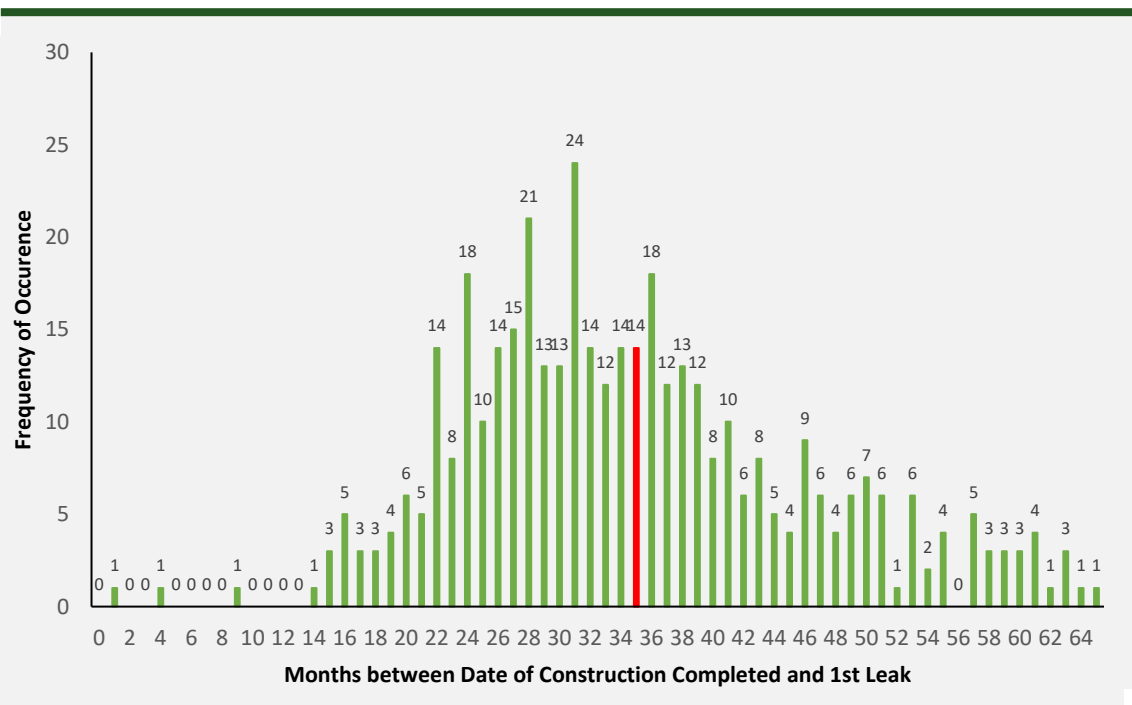
Time from construction completed to 1st leak (in months)

- Graph shows the average period of time from house build date to a home's first leak is 35 months
- Houses are unlikely to leak after 5 years have past the construction date

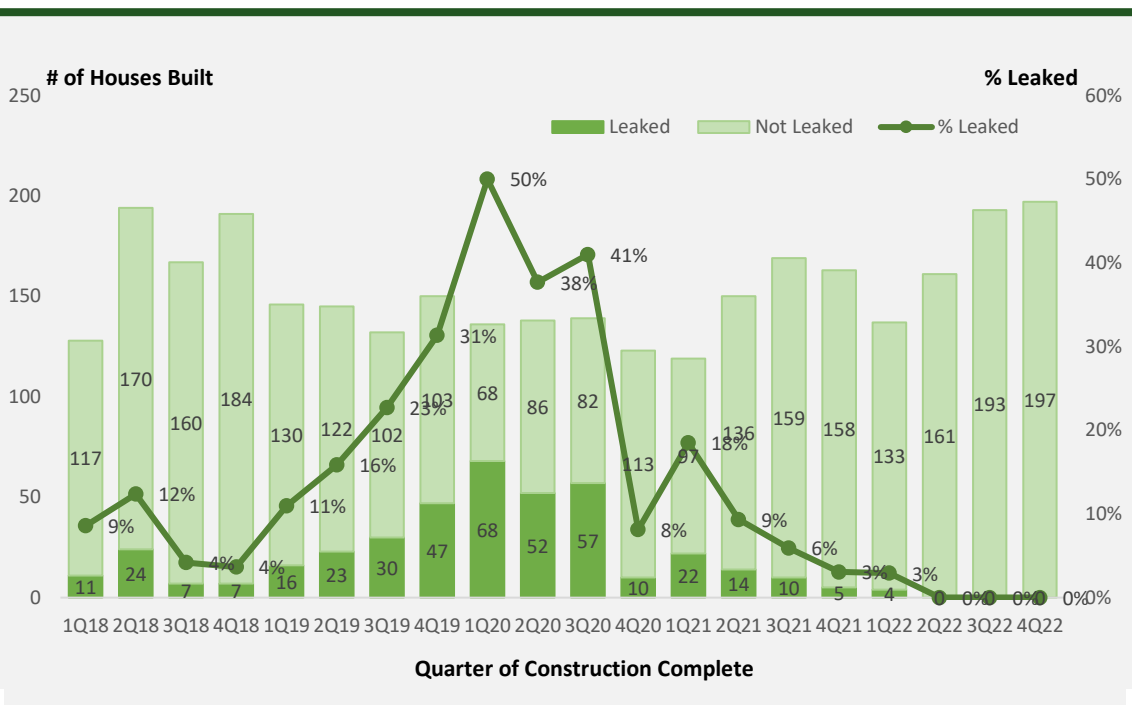
Leak rate by house build period

- Graph show which houses have leaked and not leaked by construction period
- House built between 4Q19 and 3Q20 have a much higher leak rate (financial years)
- Homes built prior to 4Q19 are leaking at a much lower rate and those that have not been affected have a low probability of leaking

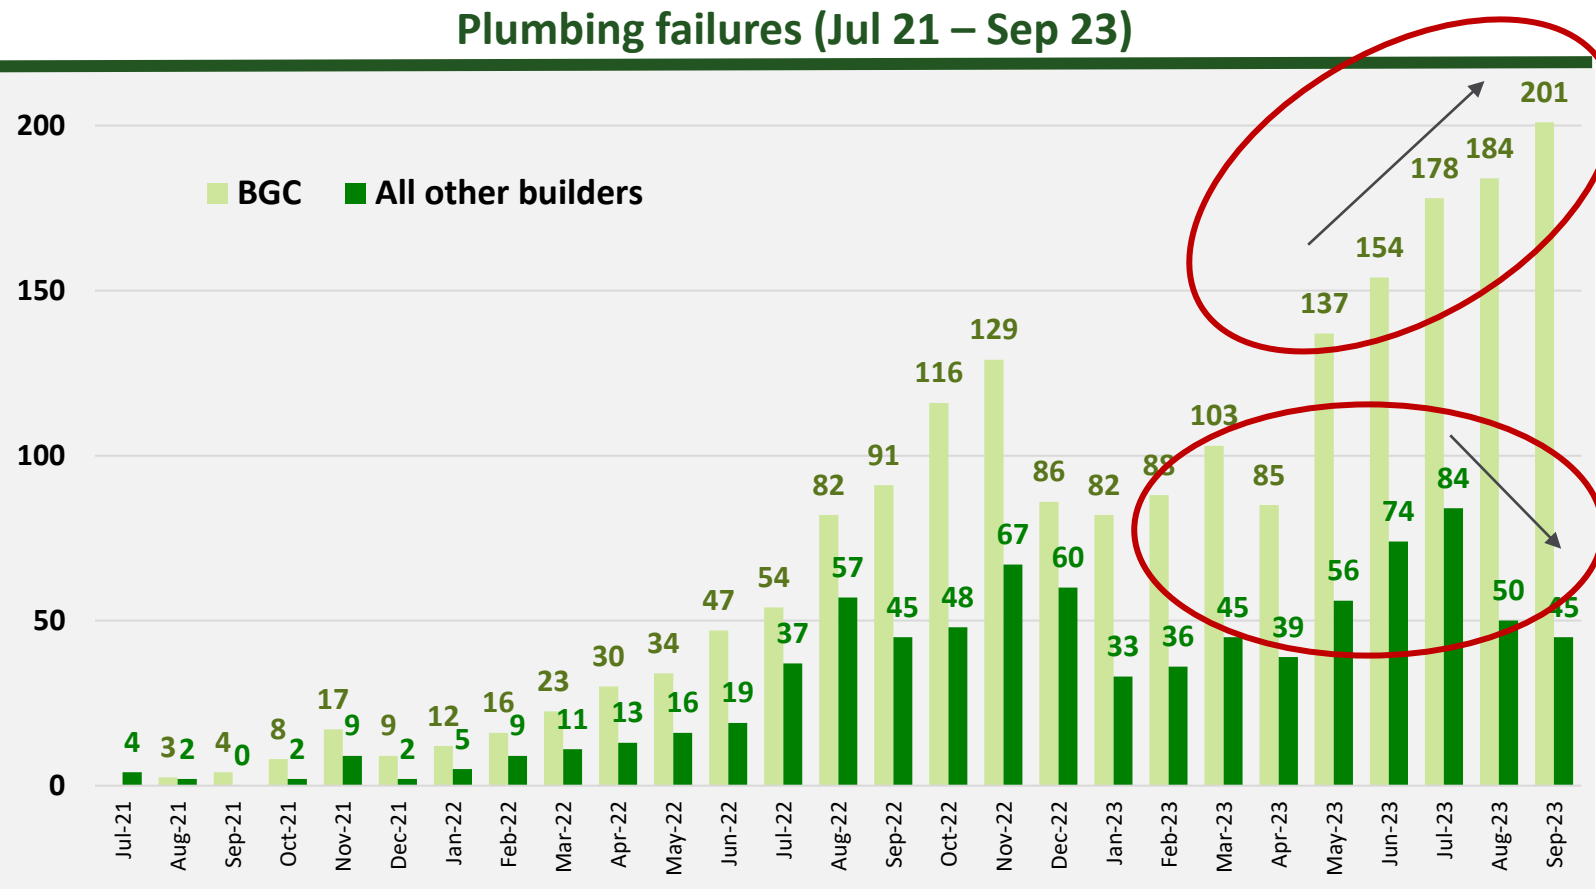
Failure rates in non-BGC homes outside appear to be on a different trajectory

- BGC claims the situation is getting worse and we are only seeing the tip of the iceberg
- We are seeing the opposite trend with other builders who we are working with
- We have been proactively funding the replacement of ceiling pipes for 5 months now with Delstrat. BGC was provided the same offer, but declined.
- The builders we are working with have seen a ~46% reduction in leaks since July
