**CMD Gold Mine, Andacollo, Chile**  
**Independent Technical Report**

**Lachlan Star Resources**

Effective Date: 1<sup>st</sup> April 2012

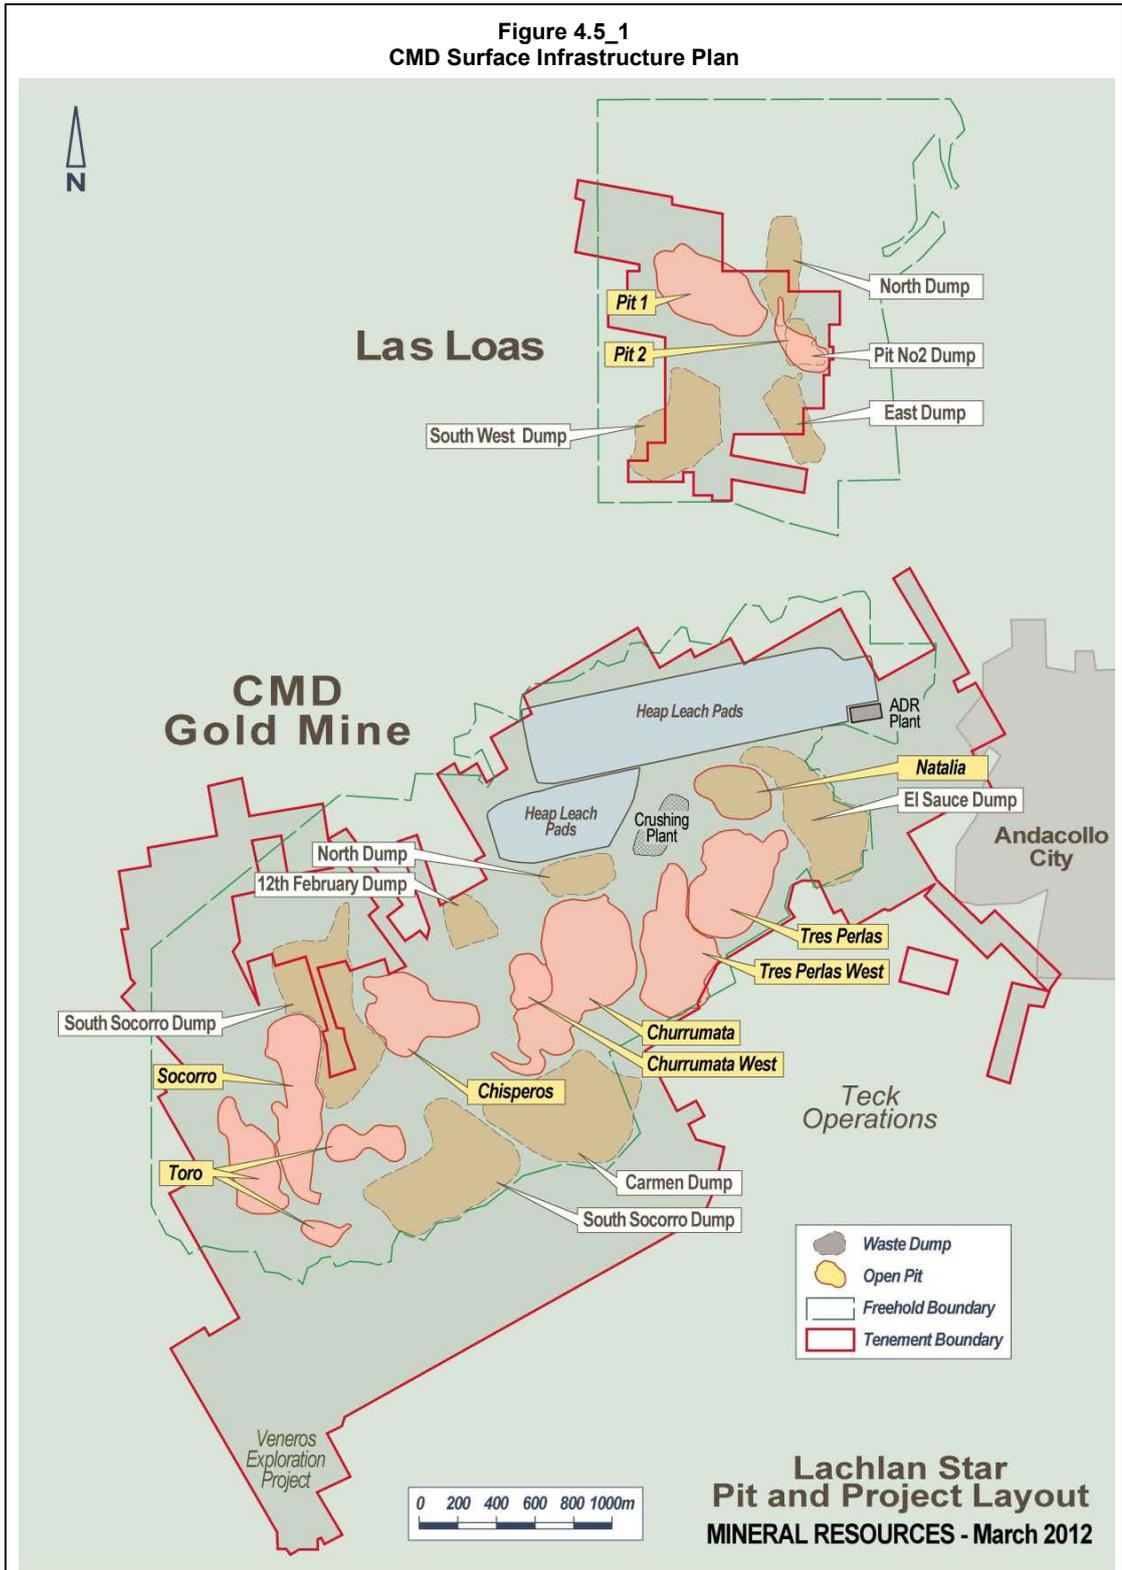
Figure 4.5\_1  
 CMD Surface Infrastructure Plan

Figure 4.5\_1 is a plan identifying CMD's surface infrastructure.

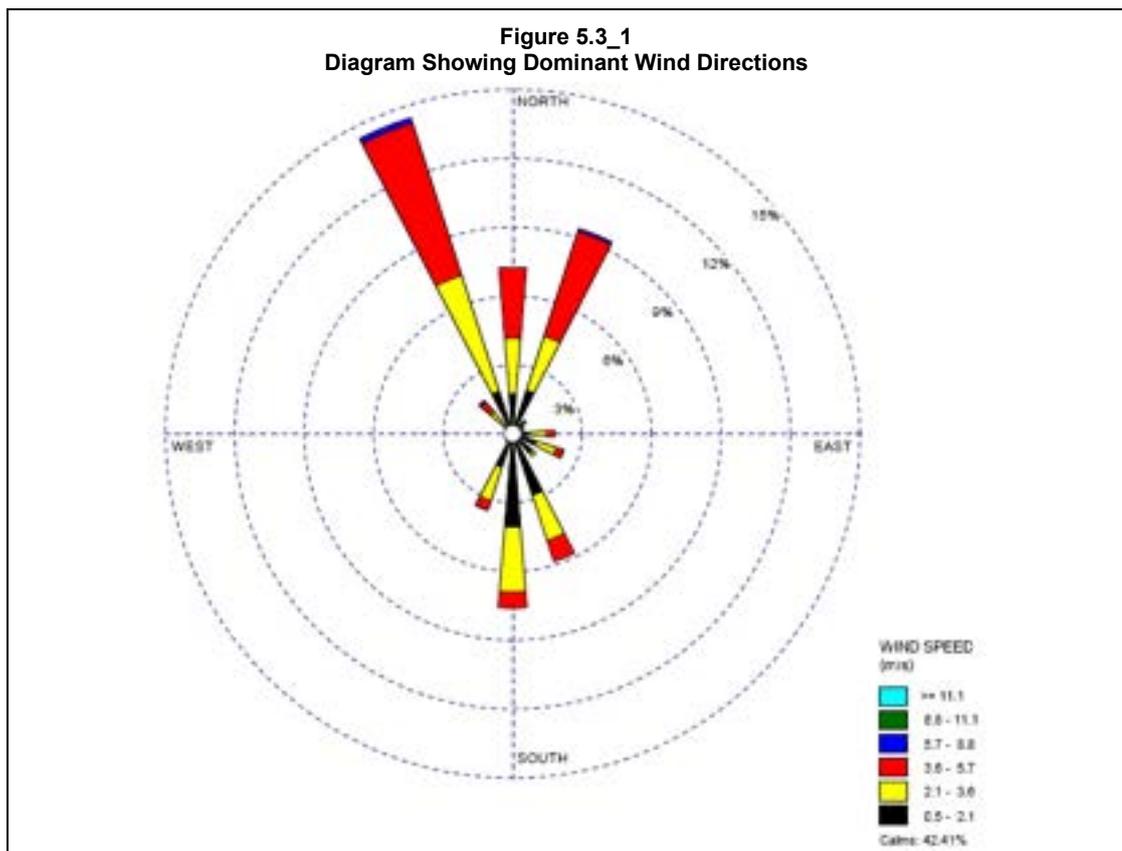
Figure 5.3\_1 shows wind direction measurements during 2000 at the mine site illustrating that the most frequent wind directions are north-northwest to north-northeast. Wind speeds are generally low with 42.4% of the time no wind at all, an average wind speed of 1.7m/s and a maximum measured wind speed in 2000 of 7.1m/s.

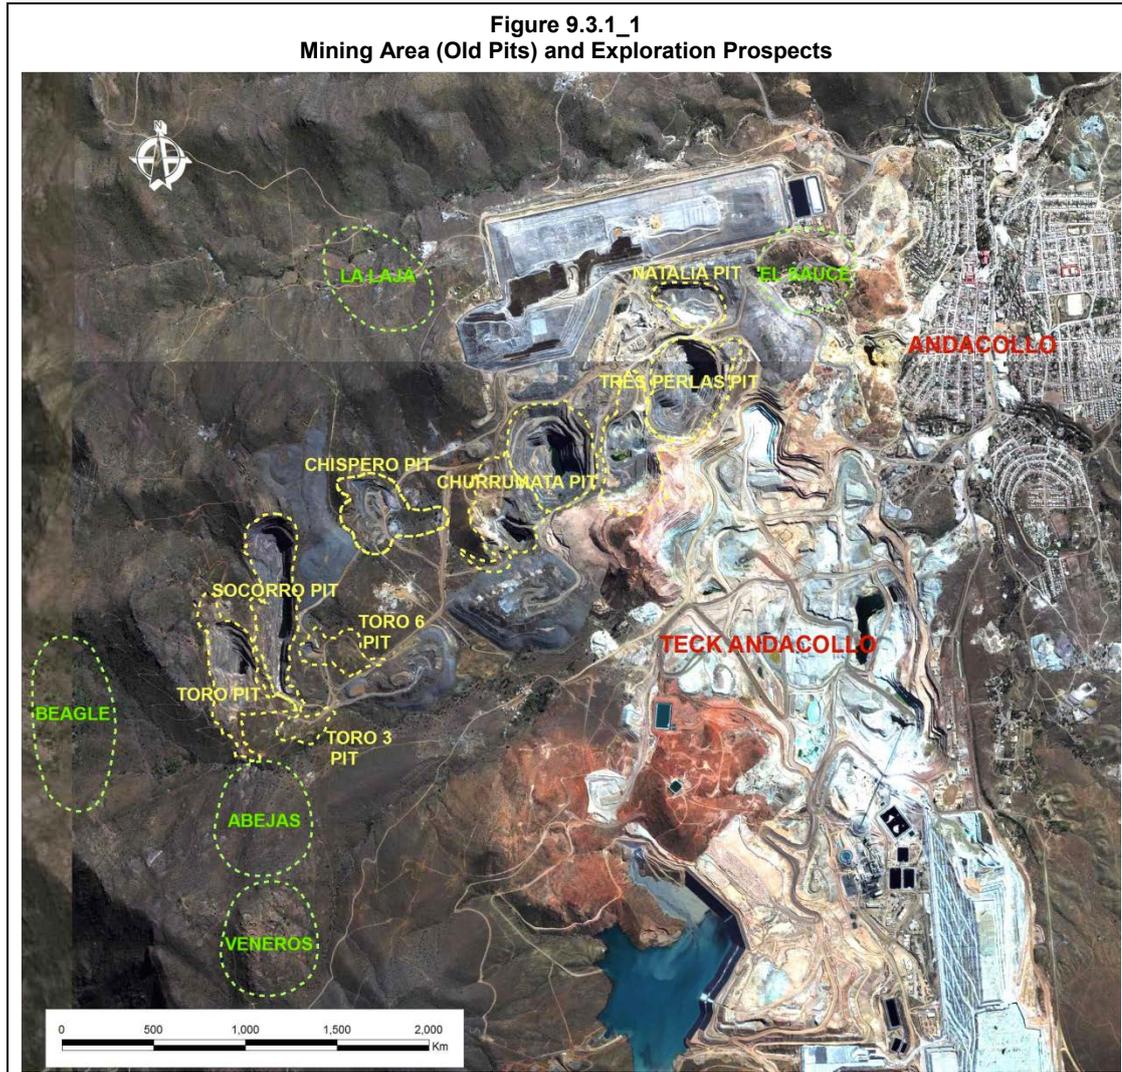
Figure 9.3.1\_1 shows the various mining areas exploiting the manto mineralisation (“Old Pits”) and the most important exploration prospects for reference purposes.

- The Veneros exploration project;
- Strike extension of the Las Loas Pit (not shown on Figure 9.3.1\_1);
- East of the Tres Perlas Pit;
- El Sauce.

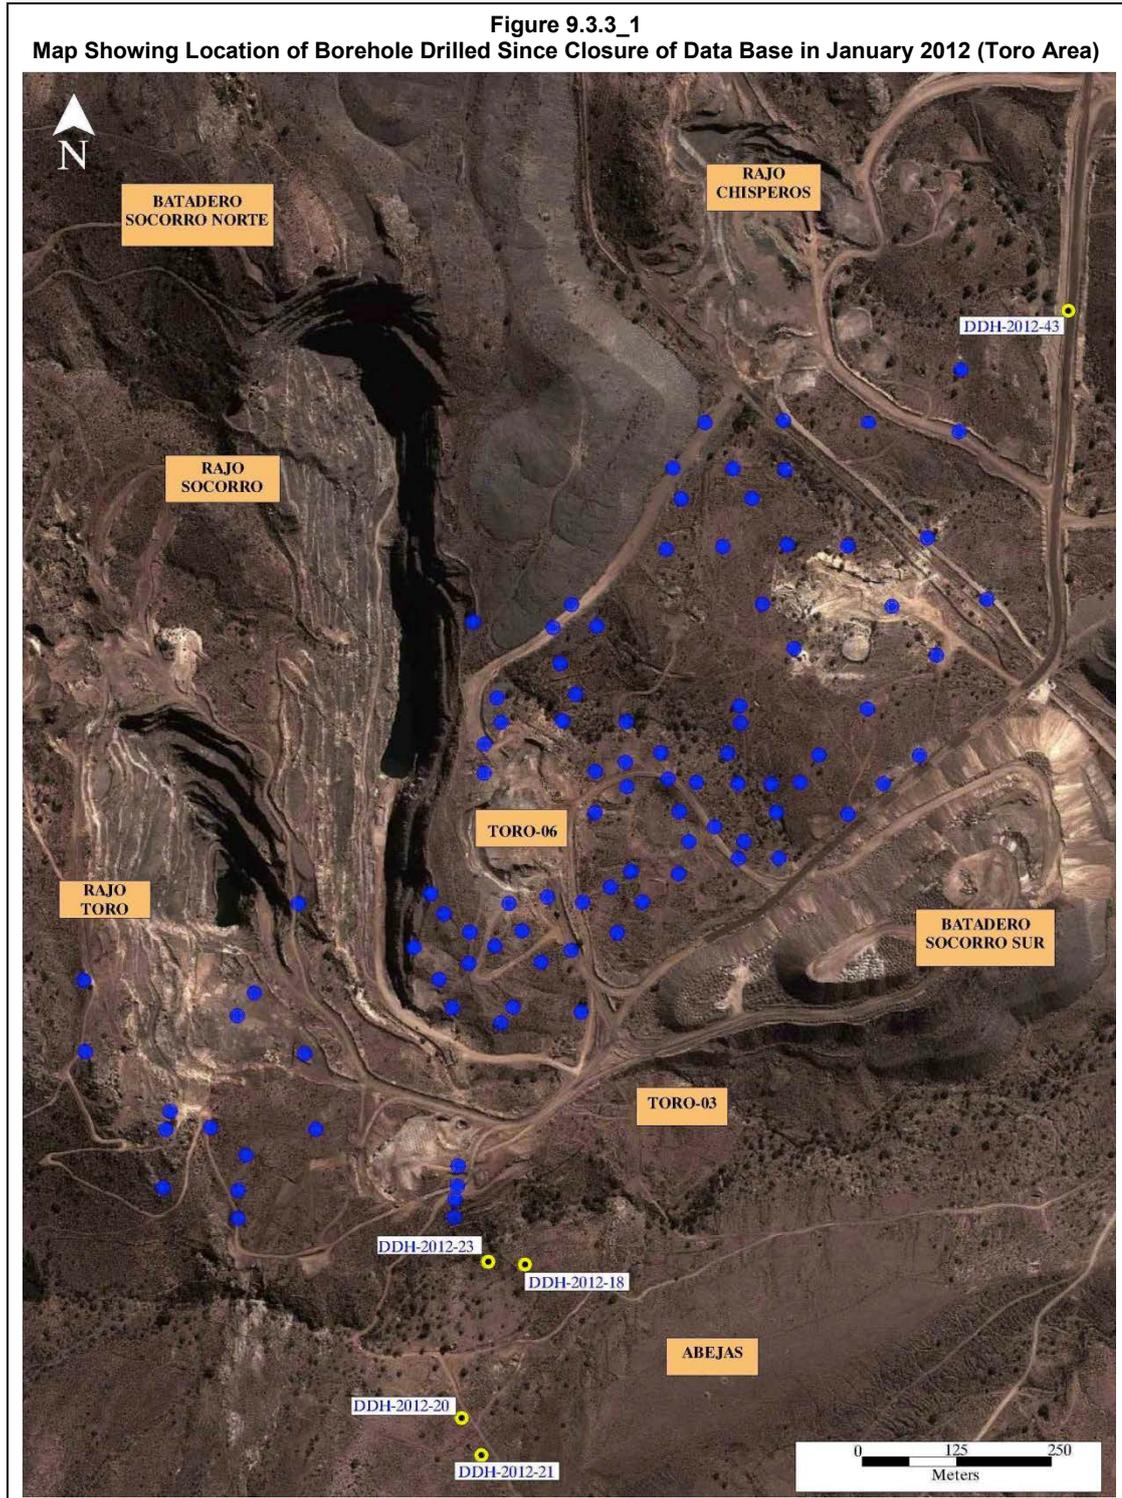
Figure 9.3.3\_1 shows the drillhole locations of the drilling carried out at the Toro Area since closing the database for the previous resources estimate.

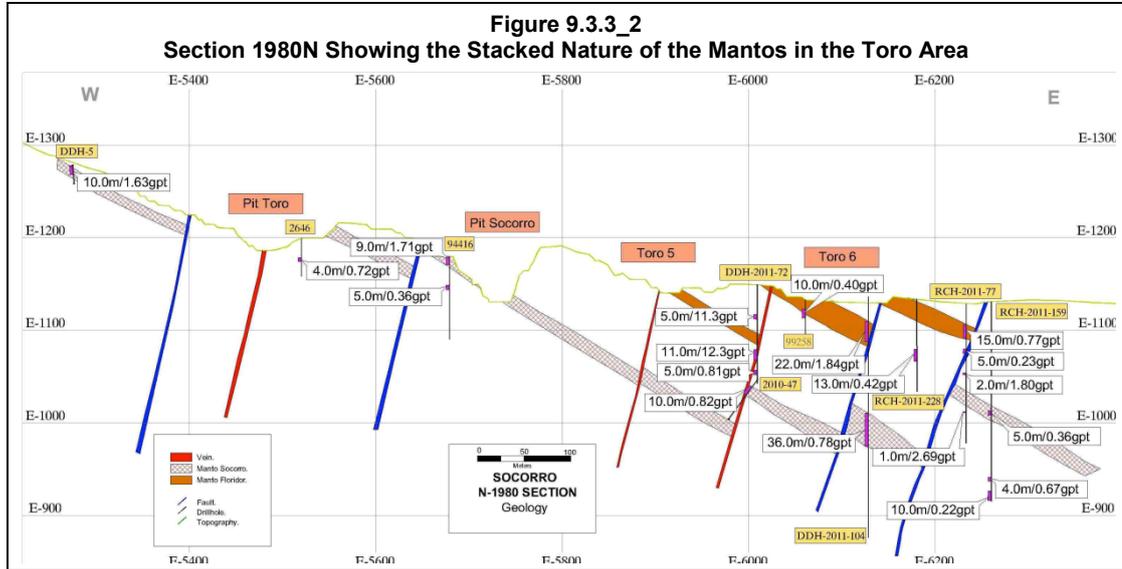
Figure 9.3.3\_2 gives cross section 1980N and shows the stacked nature of the mantos, here represented by the Floridor manto overlying the Socorro manto. The mantos are at regular intervals affected by normal faults with downthrows to the west. The drilling proved the repetition and downward extension of known mineralisation.

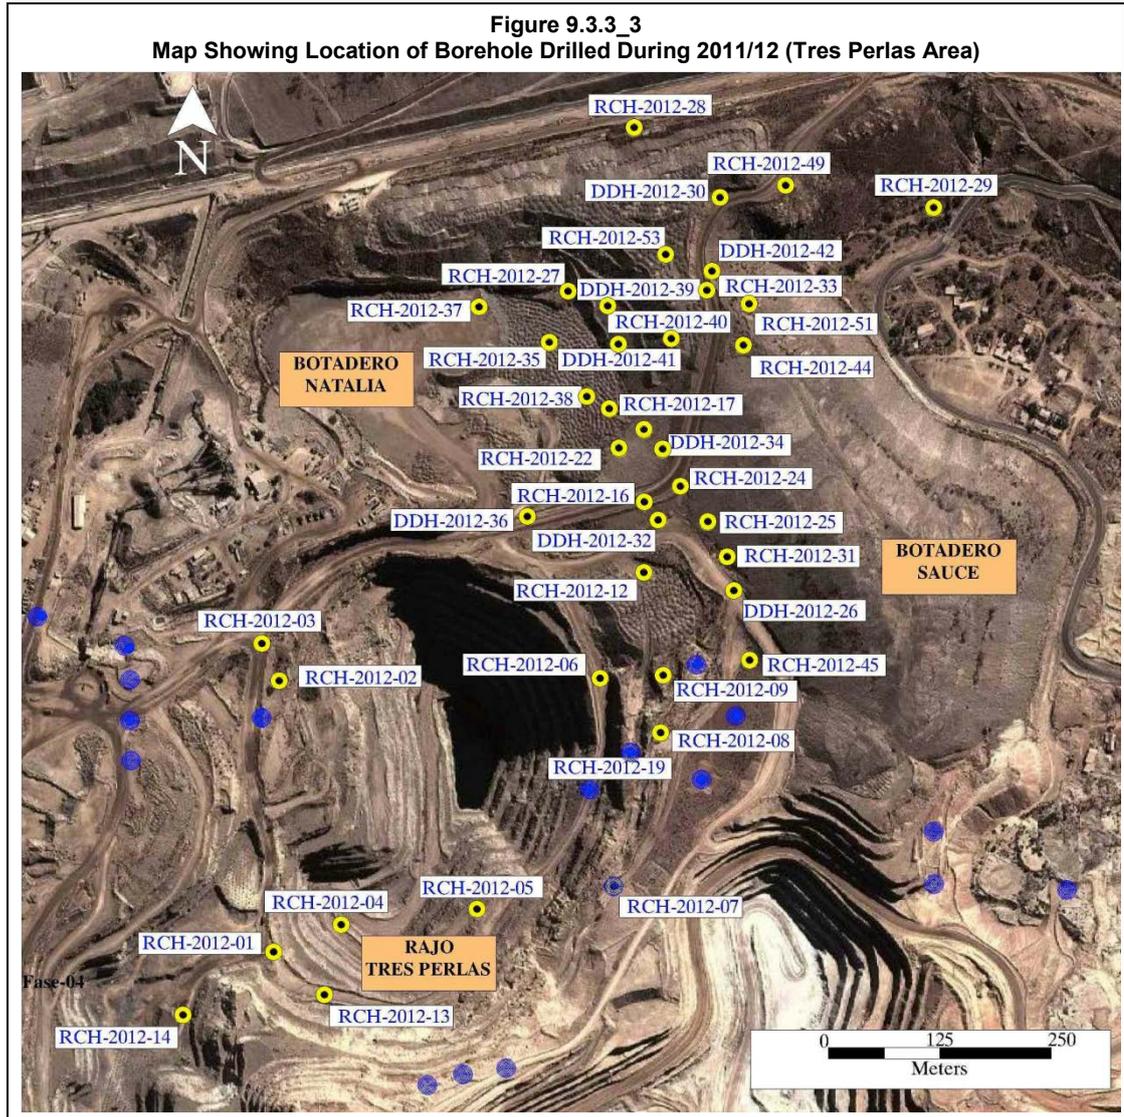
At the Tres Perlas Area it has long been recognised that considerable mineralization is present in the hanging wall, previously perceived as too low grade to be of interest. With the prospect of dump leaching and the prevailing gold price these resources are of economic interest and a large programme commenced to define the footwall mineralization, but in particular the hanging wall of the mineralization better. Figure 9.3.3\_3 gives the drillhole locations for drilling during 2011 (in blue) and during 2012 (in yellow) in the Tres Perlas Area.

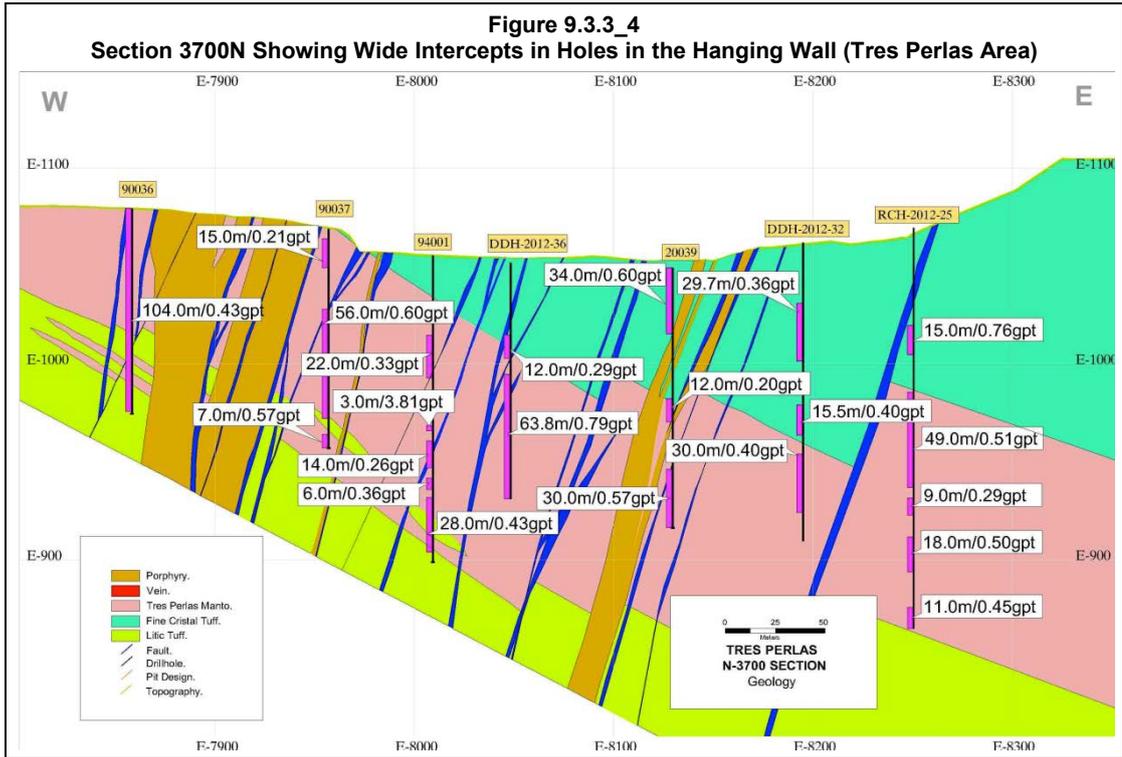
Figure 9.3.3\_4 shows cross section 3700N with the results of a number of holes in the hanging wall confirming the continuation of mineralisation over very wide intercepts.

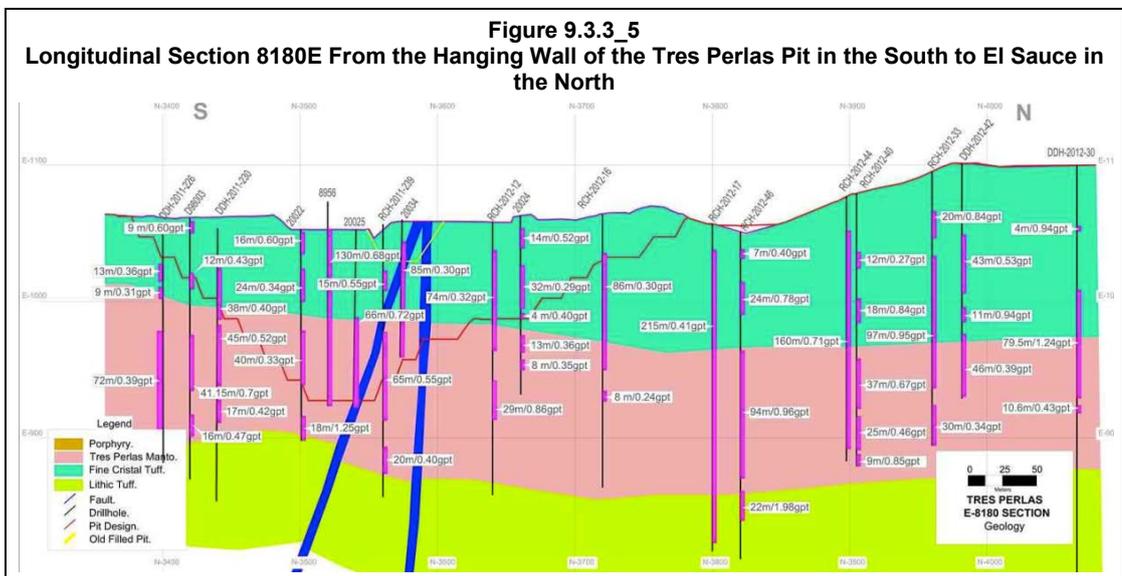
As part of the programme holes have also been drilled to the north-east to test the relationship between mineral resources at Tres Perlas- Natalia and at El Sauce, previously categorised as Inferred. Figure 9.3.3\_5 gives a longitudinal section along coordinate 8180E confirming that El Sauce is part of the same deposit, but with much better grades.

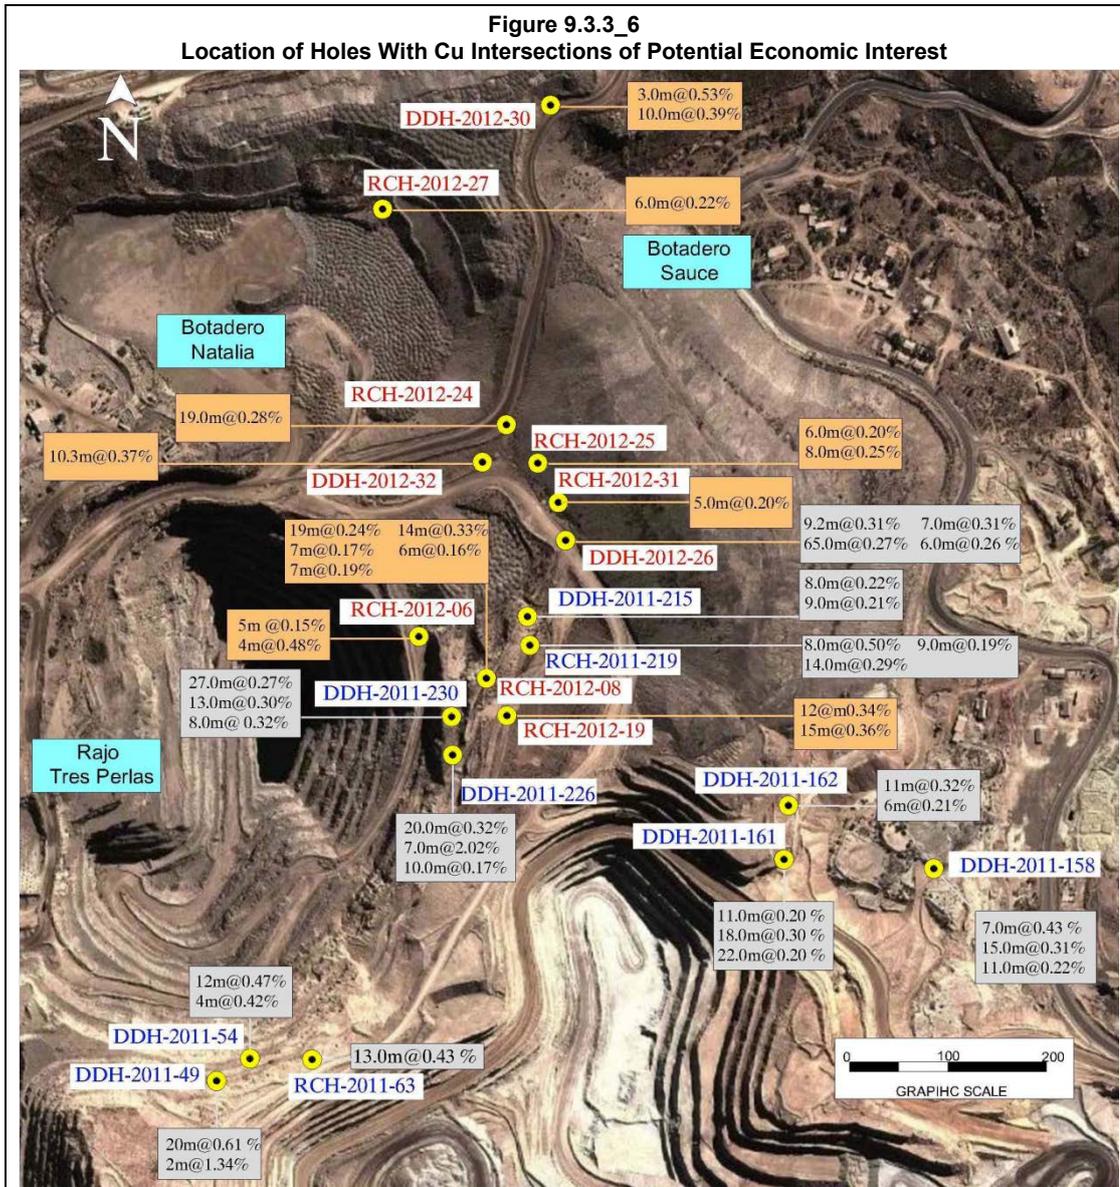
Figure 9.3.3\_6 shows the location of the holes with Cu intercepts of potential economic interest.

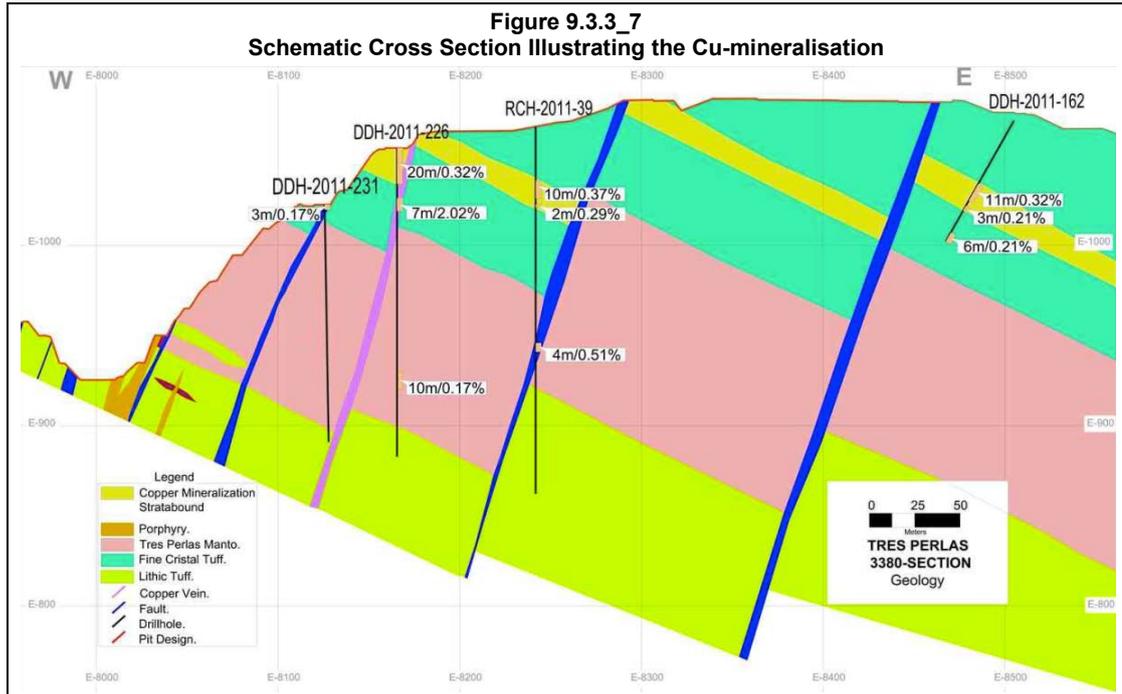
From the results received until now it appears that the copper mineralisation is stratabound, associated with a brittle contact zone within the Crystal Tuff at a short distance above the Tres Perlas manto, and in lenses in the Tres Perlas Manto, associated with subvertical structures. Figure 9.3.3\_7 gives a schematic cross section along 3380N illustrating the relationship of the copper mineralisation with the contact zone above the Tres Perlas Manto and associated with subvertical structures within the Tres Perlas Manto.

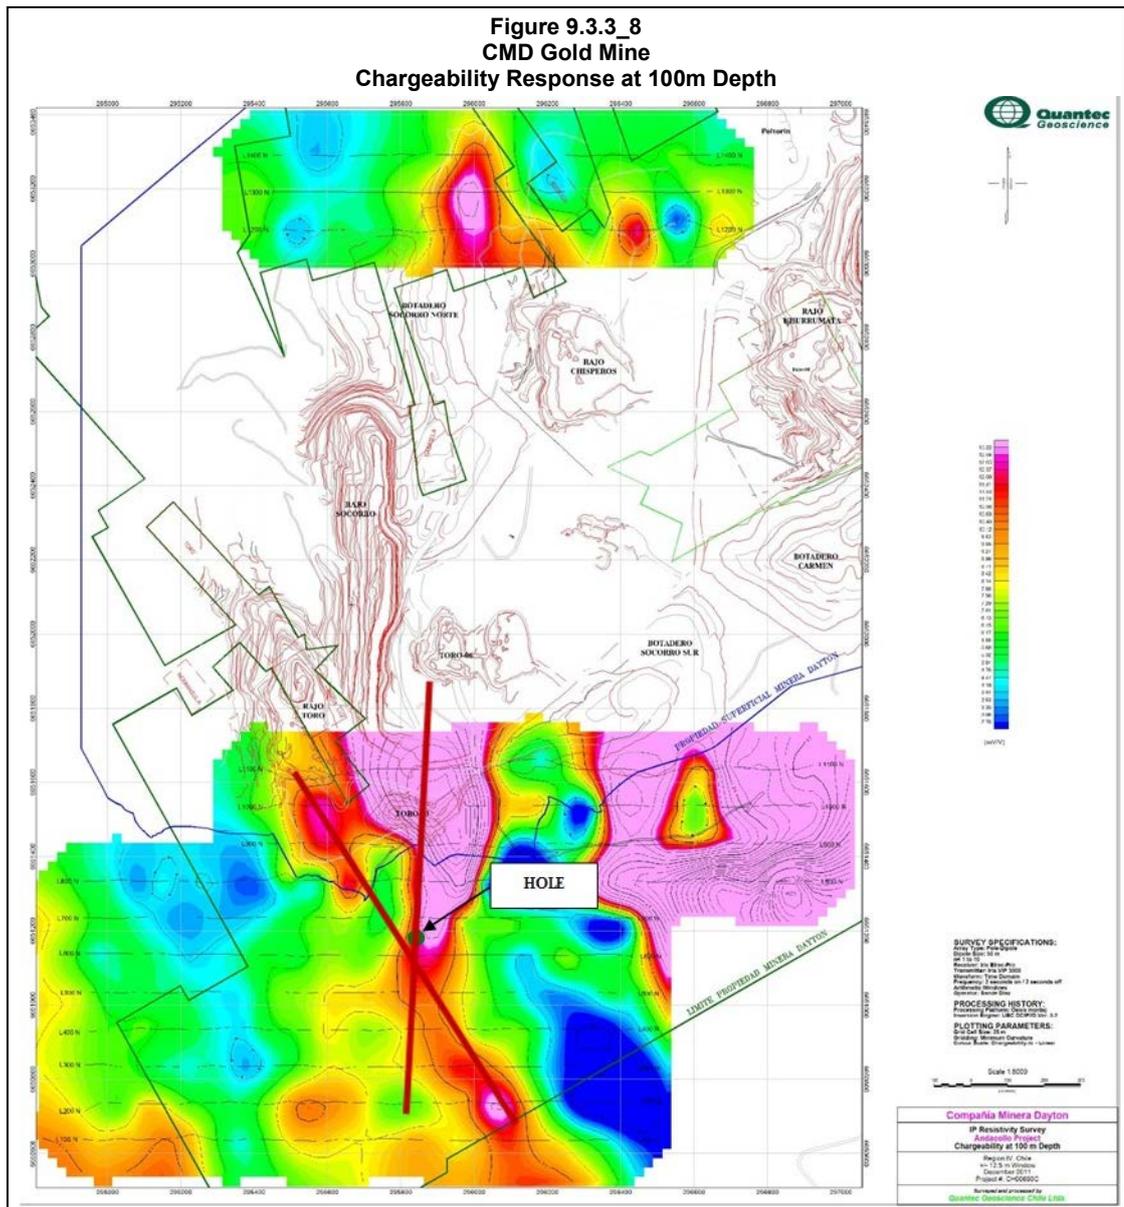
The area south of Toro and north of Veneros is referred to as the Abejas Area. During 2011 an IP Survey was commissioned over the area (and a number of lines in the La Laja Area north of the Socorro pit) to determine the response of the sulphide rich mantos and establish whether the Floridor, Socorro and Toro mantos continued southwards into this area. Figure 9.3.3\_8 shows the extent of the survey relative to the various pits and the chargeability response at a depth of 100m together with the site of a 400m deep exploration hole.

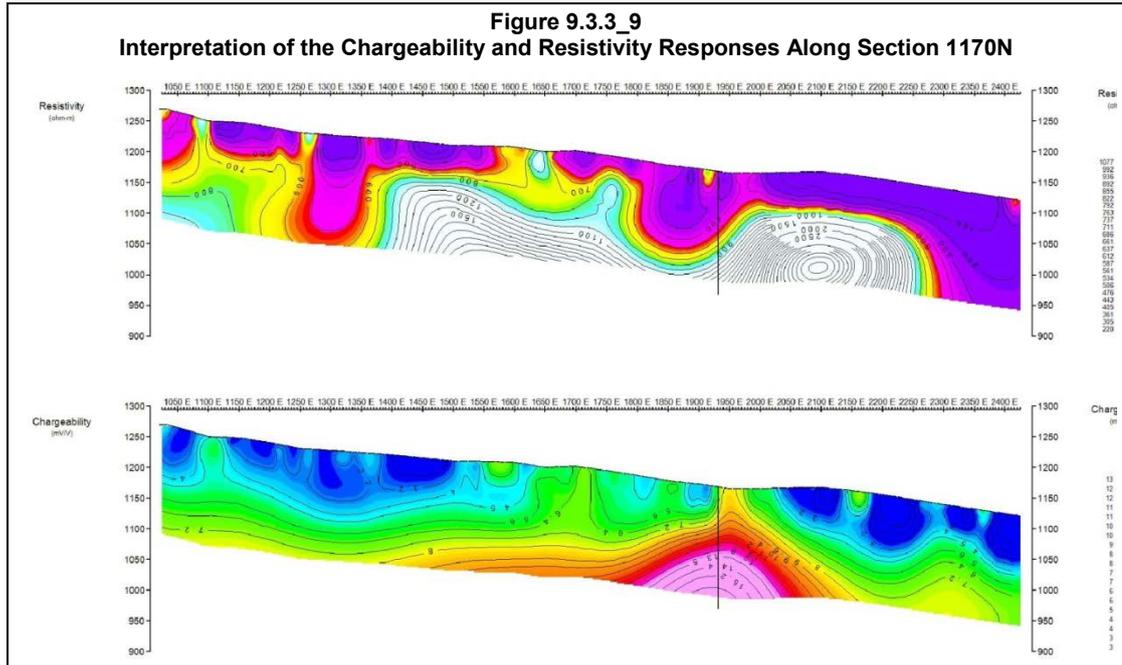
Figure 9.3.3\_9 shows the chargeability and resistivity responses along line 1170N. The section lacks any evidence of east dipping mantos, but with indications of a possible mineralised stock, which was tested by a 400m deep hole.

This particular hole only intersected frequent and strong pyrite mineralisation, partially contained in hydrothermal breccias, but without or with little gold content, which ceases altogether below 180m. Another deep hole drilled 200m further north has stronger gold mineralisation with the best intersection 6m at 1.98 g/t Au from 90m down the holes, but again totally devoid of gold below 195m. The absence of gold, normally associated with the same euhedral pyrite as found further north, could possibly be the result of zonation with precipitation of gold only at greater distance from its source.

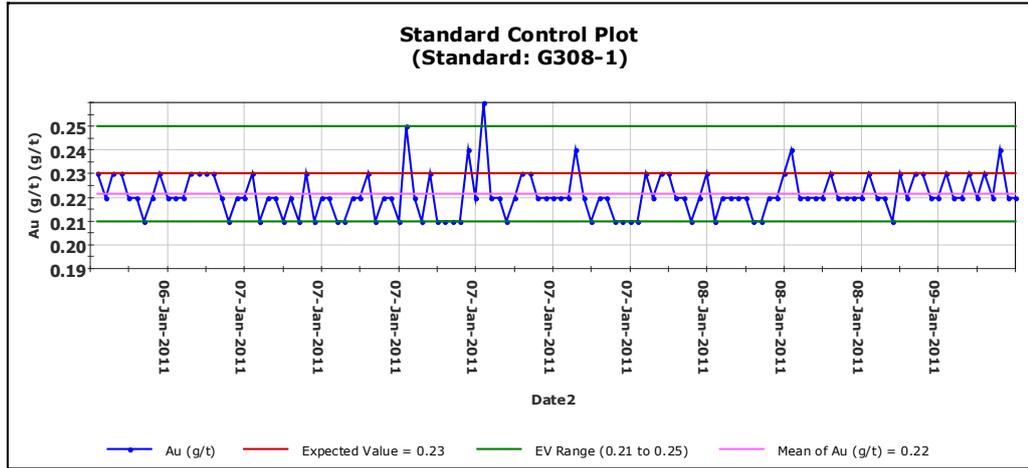
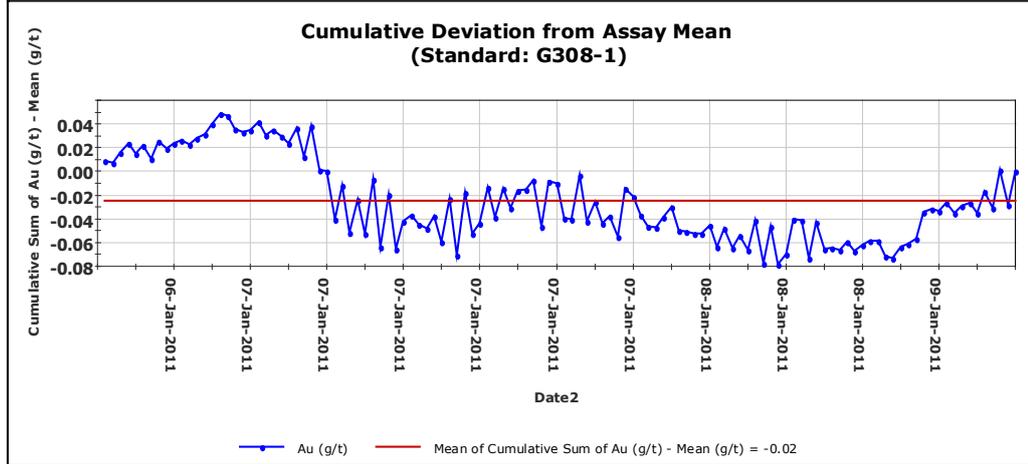
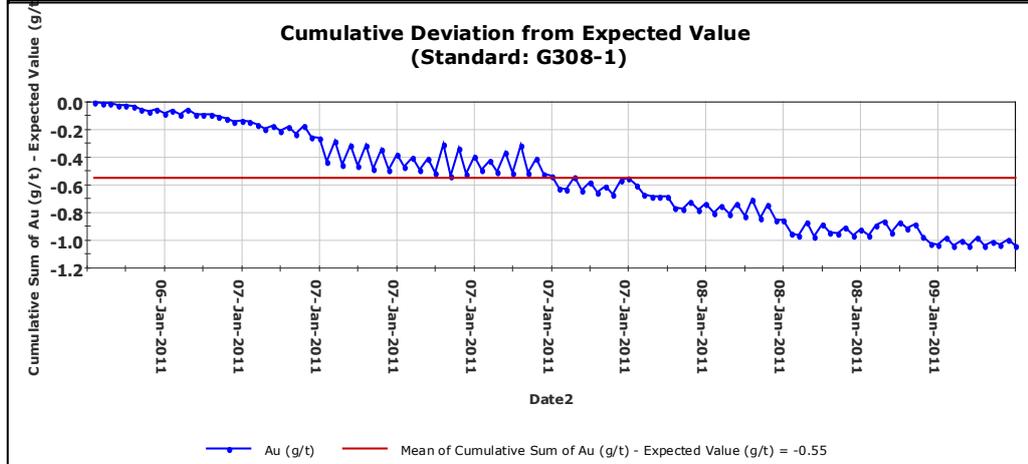
**Figure 12.1.1\_1  
CMD - Standard G308-1**

Standard:	G308-1	No of Analyses:	120
Element:	Au (g/t)	Minimum:	0.21
Units:		Maximum:	0.26
Detection Limit:		Mean:	0.22
Expected Value (EV):	0.23	Std Deviation:	0.01
E.V. Range:	0.21 to 0.25	% in Tolerance	99.17 %
		% Bias	-3.77 %
		% RSD	3.95 %

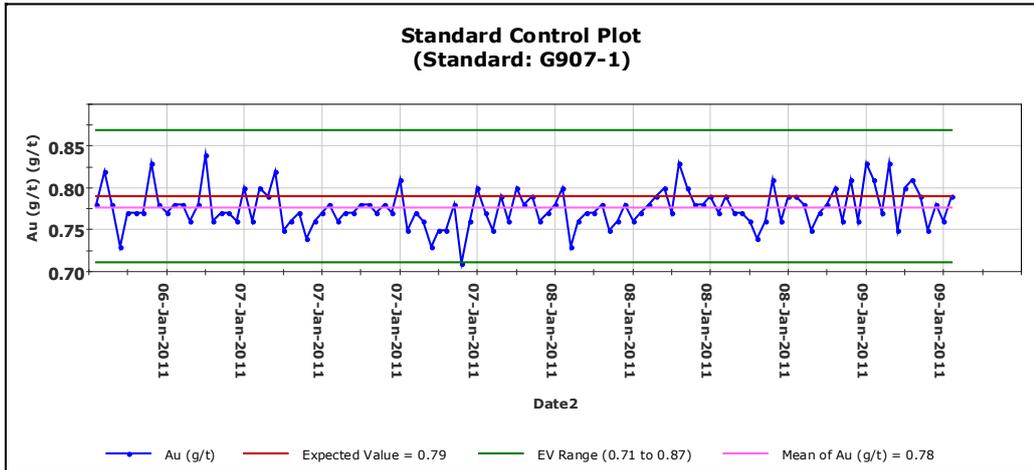
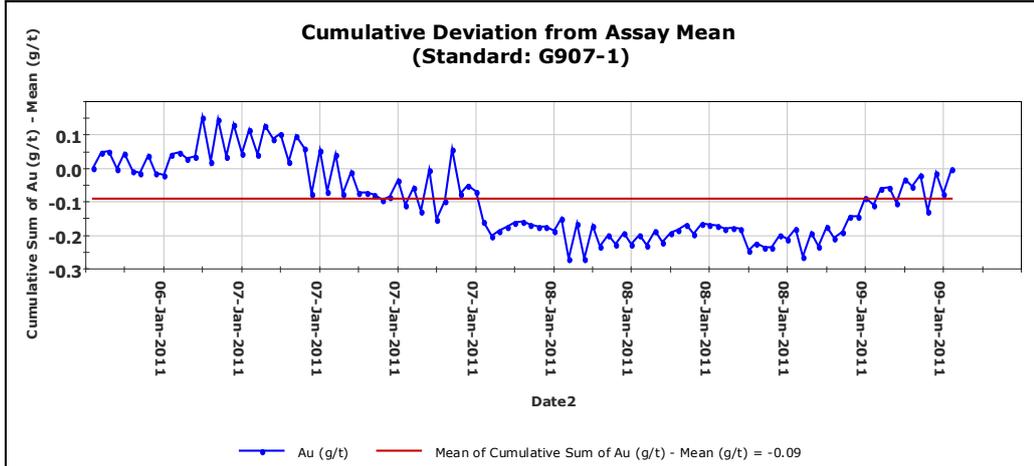
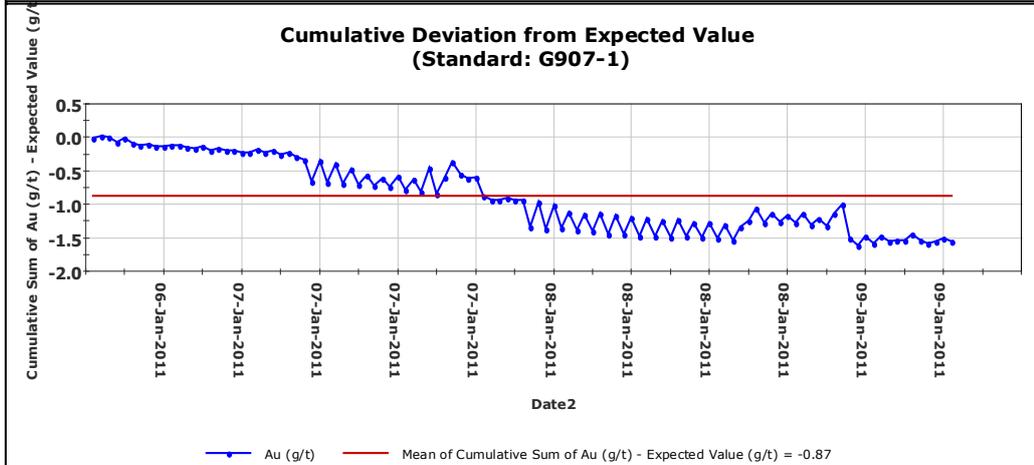
**Figure 12.1.1\_2**  
**CMD - Standard G907-1**

Standard:	G907-1	No of Analyses:	111
Element:	Au (g/t)	Minimum:	0.71
Units:		Maximum:	0.84
Detection Limit:		Mean:	0.78
Expected Value (EV):	0.79	Std Deviation:	0.02
E.V. Range:	0.71 to 0.87	% in Tolerance	99.10 %
		% Bias	-1.77 %
		% RSD	2.95 %

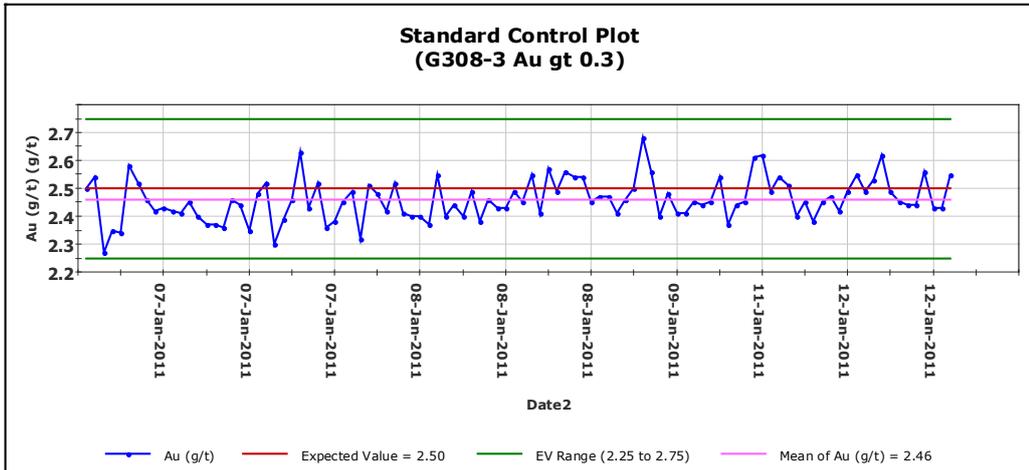
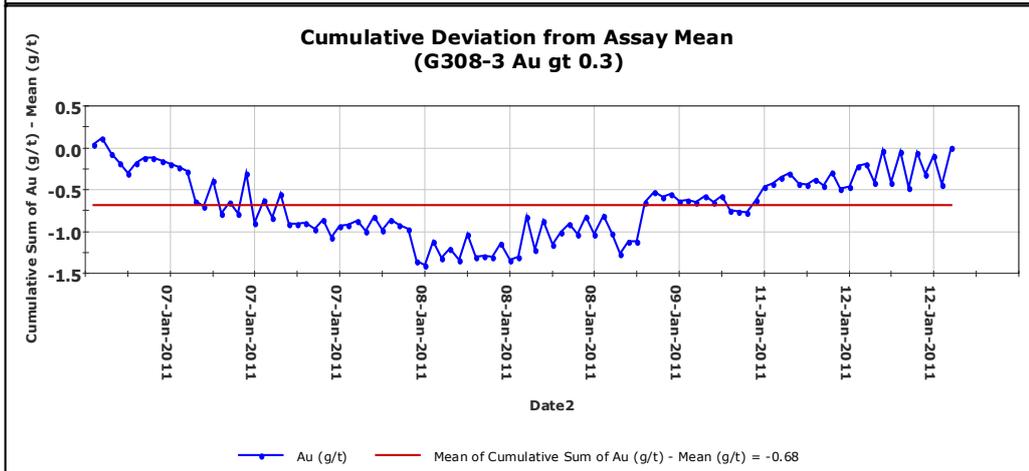
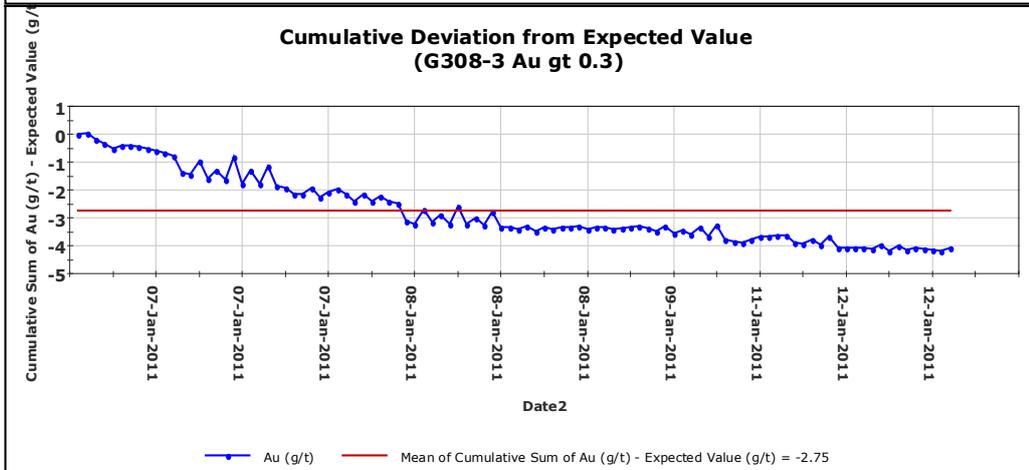
**Figure 12.1.1\_3  
CMD - Standard 308-3**

Standard:	G308-3	No of Analyses:	102
Element:	Au (g/t)	Minimum:	2.27
Units:		Maximum:	2.68
Detection Limit:		Mean:	2.46
Expected Value (EV):	2.50	Std Deviation:	0.07
E.V. Range:	2.25 to 2.75	% in Tolerance	100.00 %
		% Bias	-1.60 %
		% RSD	3.01 %

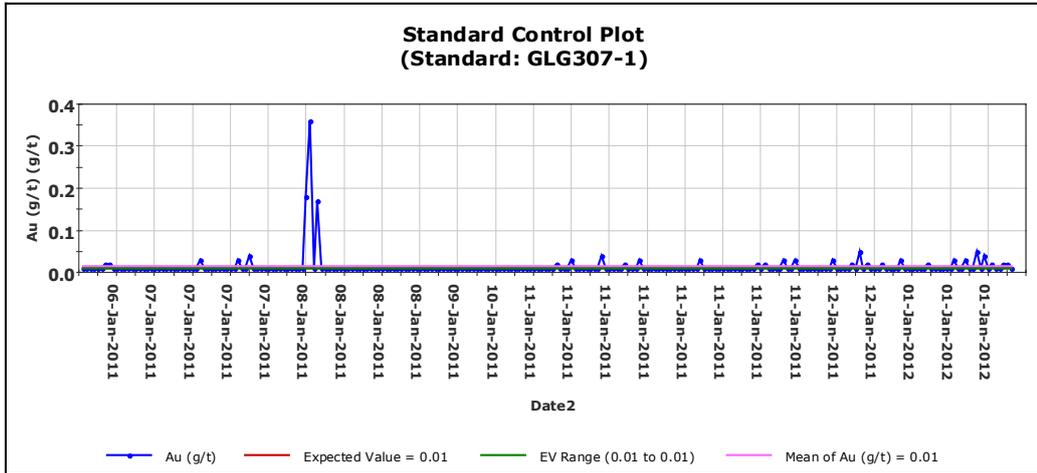
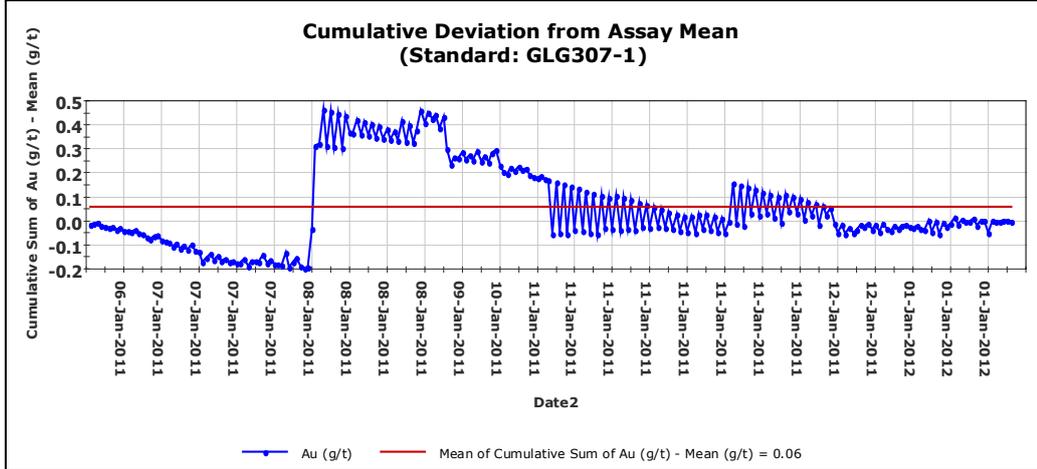
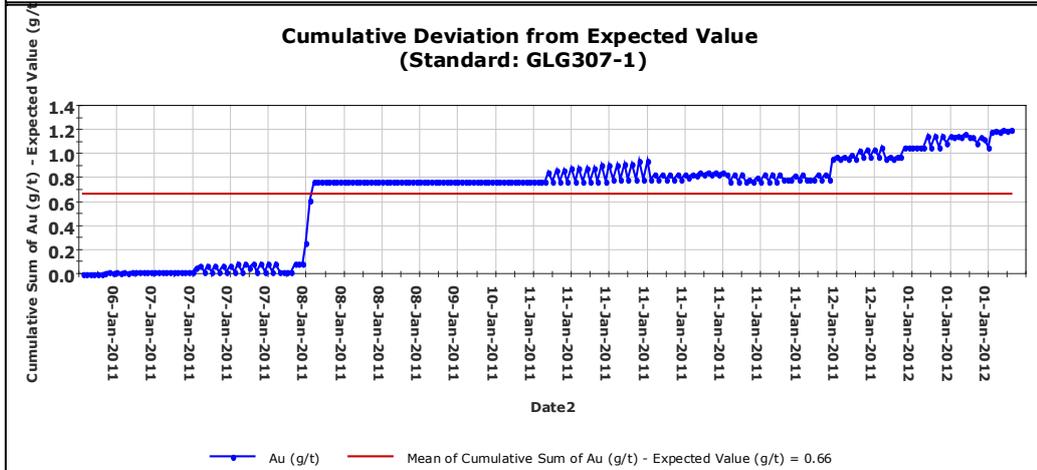
**Figure 12.1.1\_4**  
**CMD – Standard: GLG307-1**

Standard:	GLG307-1	No of Analyses:	246
Element:	Au (g/t)	Minimum:	0.01
Units:		Maximum:	0.36
Detection Limit:		Mean:	0.01
Expected Value (EV):	0.01	Std Deviation:	0.03
E.V. Range:	0.01 to 0.01	% in Tolerance	86.99 %
		% Bias	48.78 %
		% RSD	183.19 %

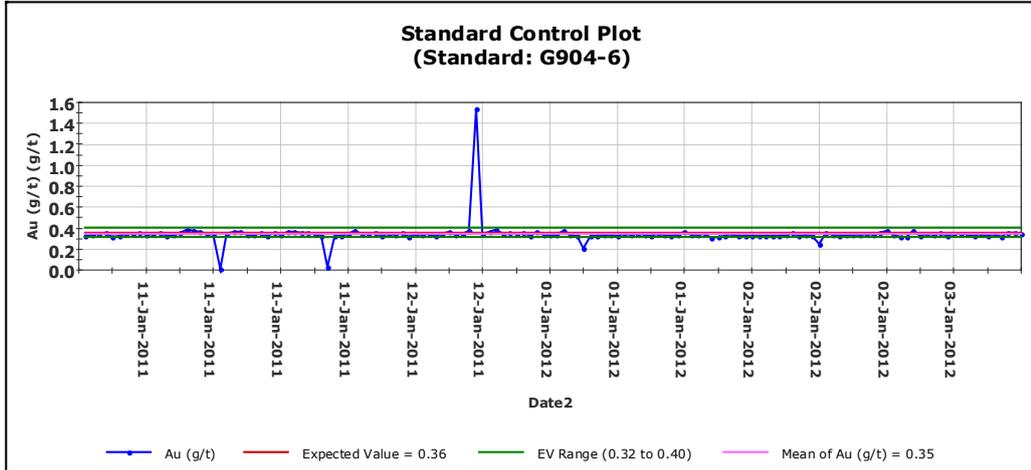
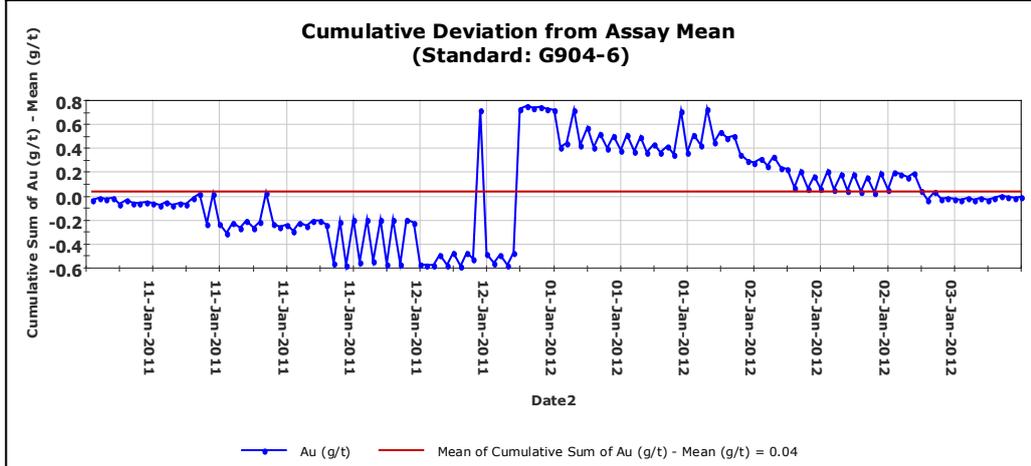
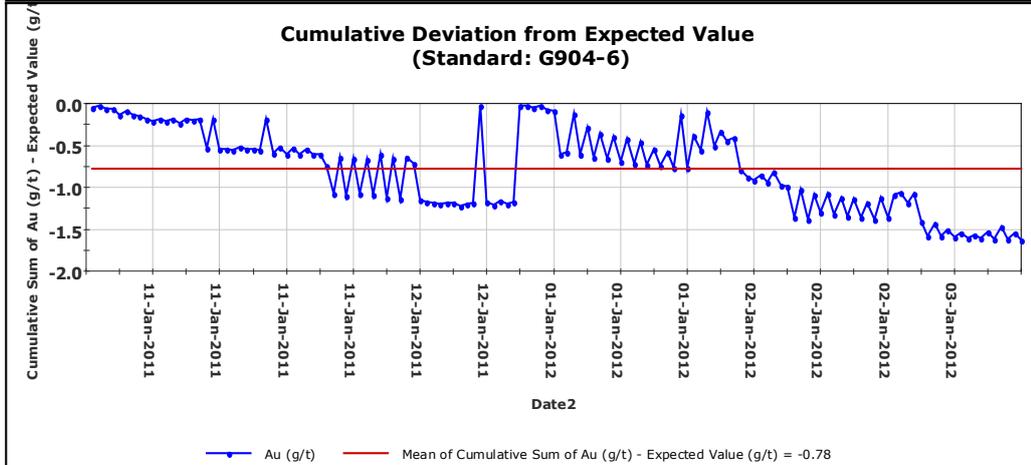
**Figure 12.1.1\_5**  
**CMD - Standard G904-6**

Standard:	G904-6	No of Analyses:	140
Element:	Au (g/t)	Minimum:	0.01
Units:		Maximum:	1.54
Detection Limit:		Mean:	0.35
Expected Value (EV):	0.36	Std Deviation:	0.11
E.V. Range:	0.32 to 0.40	% in Tolerance	95.71 %
		% Bias	-3.23 %
		% RSD	31.63 %
