**CMD Gold Mine, Andacollo, Chile**  
**Independent Technical Report**

**Lachlan Star Resources**

Effective Date: 1<sup>st</sup> April 2012

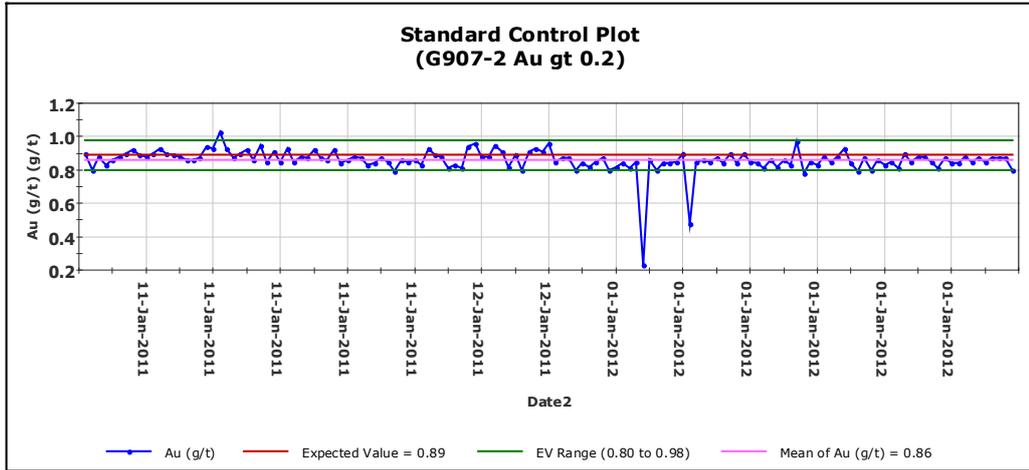
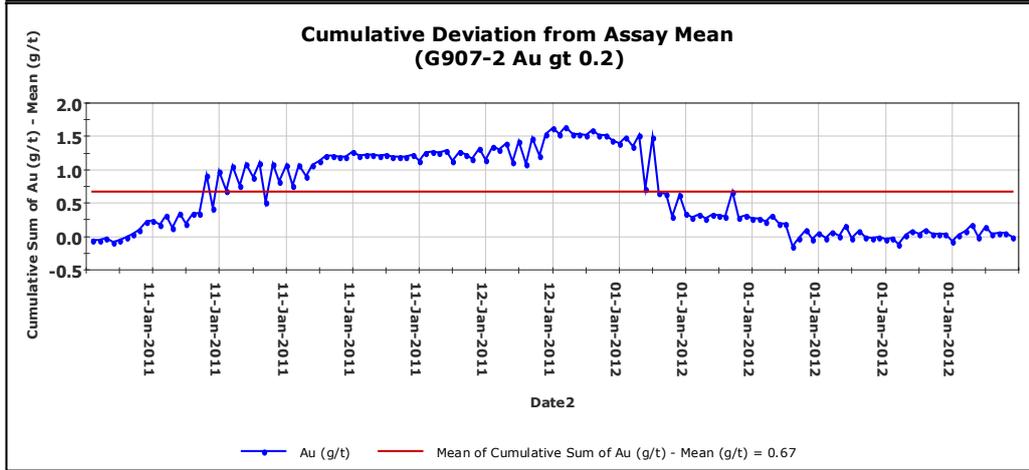
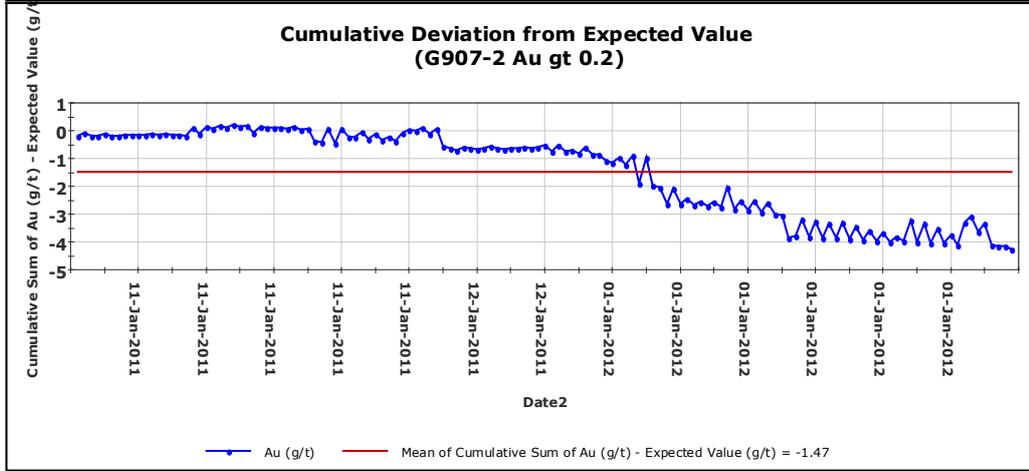
**Figure 12.1.1\_6  
CMD - Standard G907-2**

Standard:	G907-2	No of Analyses:	139
Element:	Au (g/t)	Minimum:	0.23
Units:		Maximum:	1.03
Detection Limit:		Mean:	0.86
Expected Value (EV):	0.89	Std Deviation:	0.08
E.V. Range:	0.80 to 0.98	% in Tolerance	90.65 %
		% Bias	-3.44 %
		% RSD	8.78 %

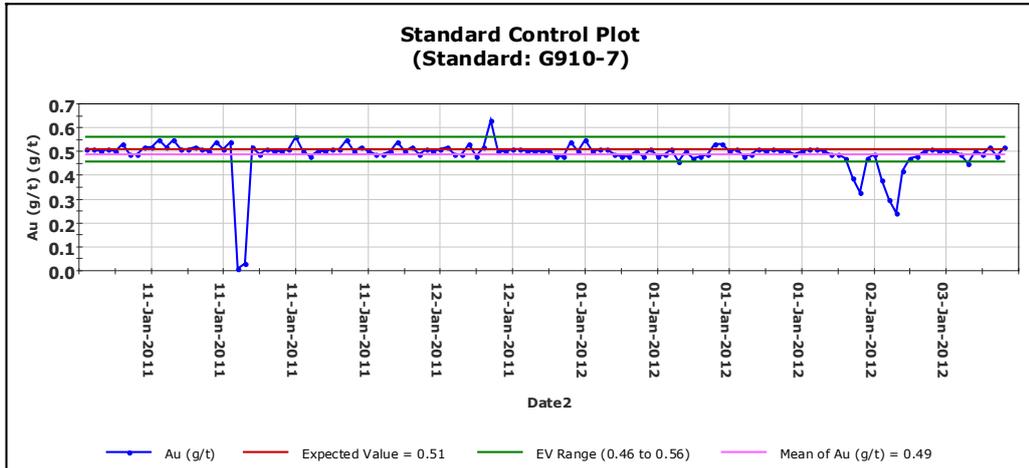
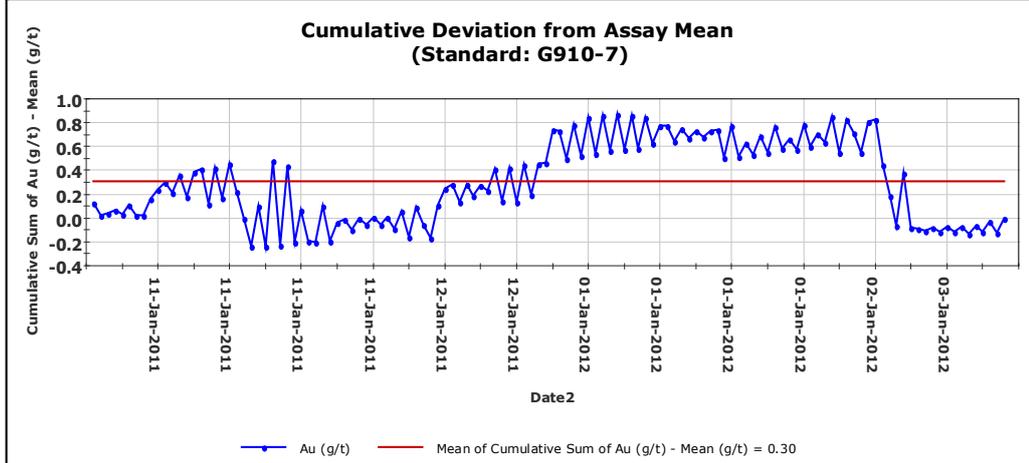
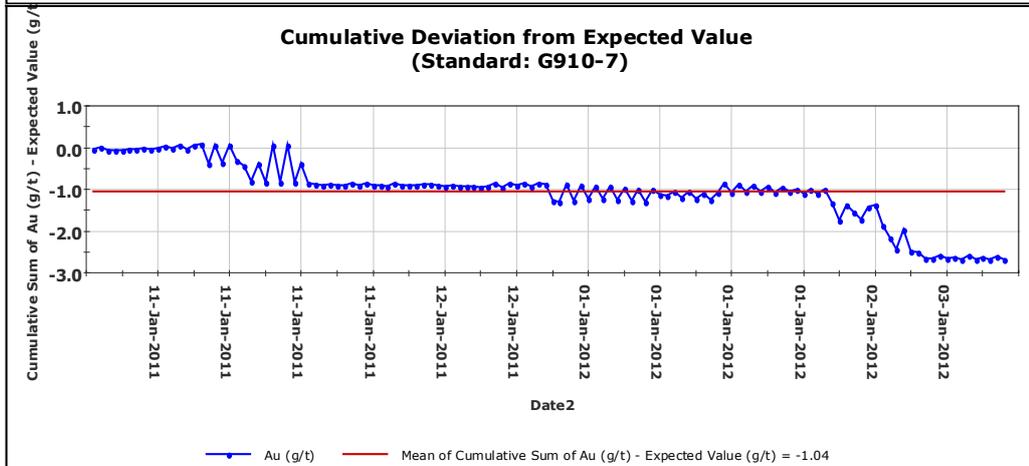
**Figure 12.1.1\_7  
CMD - Standard G910-7**

Standard:	G910-7	No of Analyses:	128
Element:	Au (g/t)	Minimum:	0.01
Units:		Maximum:	0.63
Detection Limit:		Mean:	0.49
Expected Value (EV):	0.51	Std Deviation:	0.07
E.V. Range:	0.46 to 0.56	% in Tolerance	92.19 %
		% Bias	-4.09 %
		% RSD	14.87 %

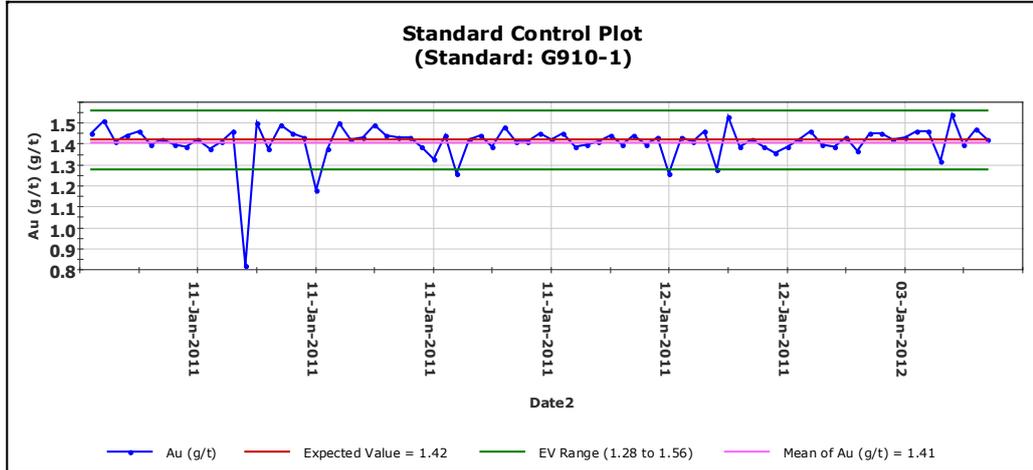
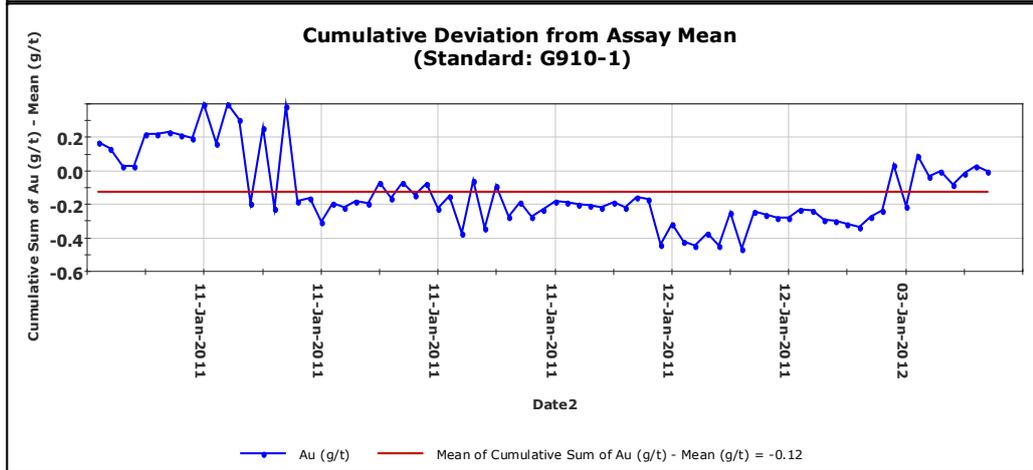
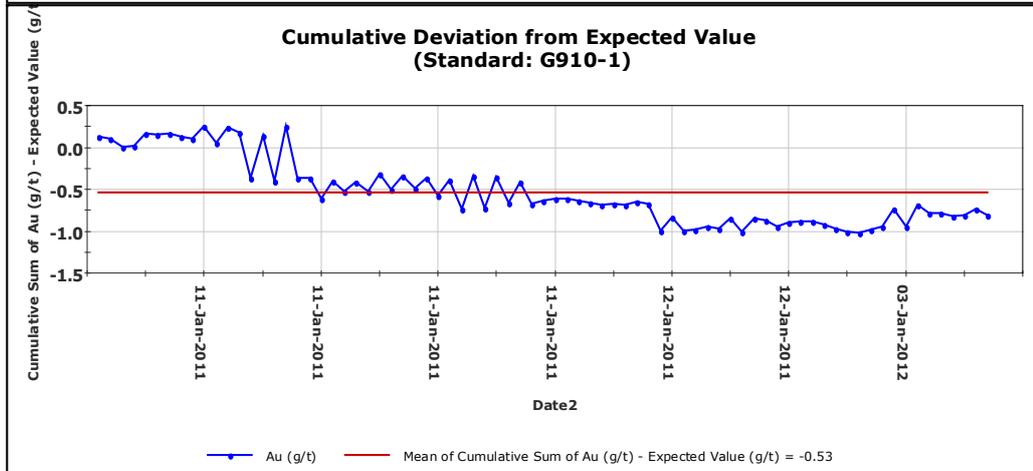
**Figure 12.1.1\_8  
CMD - Standard G910-1**

Standard:	G910-1	No of Analyses:	77
Element:	Au (g/t)	Minimum:	0.82
Units:		Maximum:	1.54
Detection Limit:		Mean:	1.41
Expected Value (EV):	1.42	Std Deviation:	0.09
E.V. Range:	1.28 to 1.56	% in Tolerance	94.81 %
		% Bias	-0.74 %
		% RSD	6.27 %

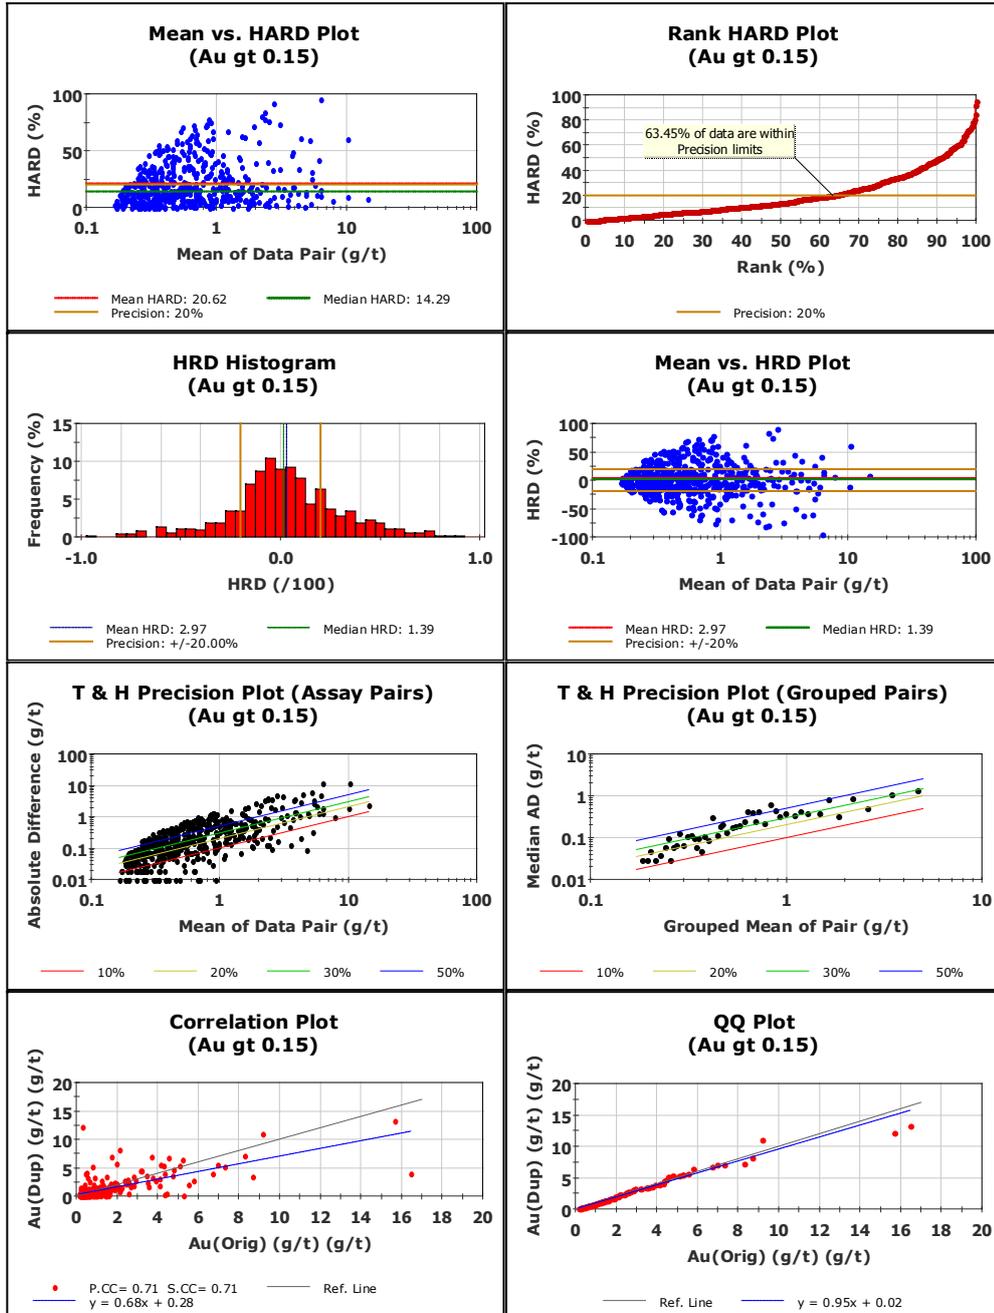
Figure 12.1.2\_1  
 CMD – Field Duplicates  
 (Au gt 0.15)

Au(Orig) (g/t)	Au(Dup) (g/t)	Units		Result
No. Pairs:	550	550		Pearson CC:	0.71
Minimum:	0.16	0.16	g/t	Spearman CC:	0.71
Maximum:	16.47	13.35	g/t	Mean HARD:	20.62
Mean:	0.94	0.92	g/t	Median HARD:	14.29
Median:	0.47	0.42	g/t	Mean HRD:	2.97
Std. Deviation:	1.49	1.43	g/t	Median HRD:	1.39
Coefficient of Variation:	1.58	1.56

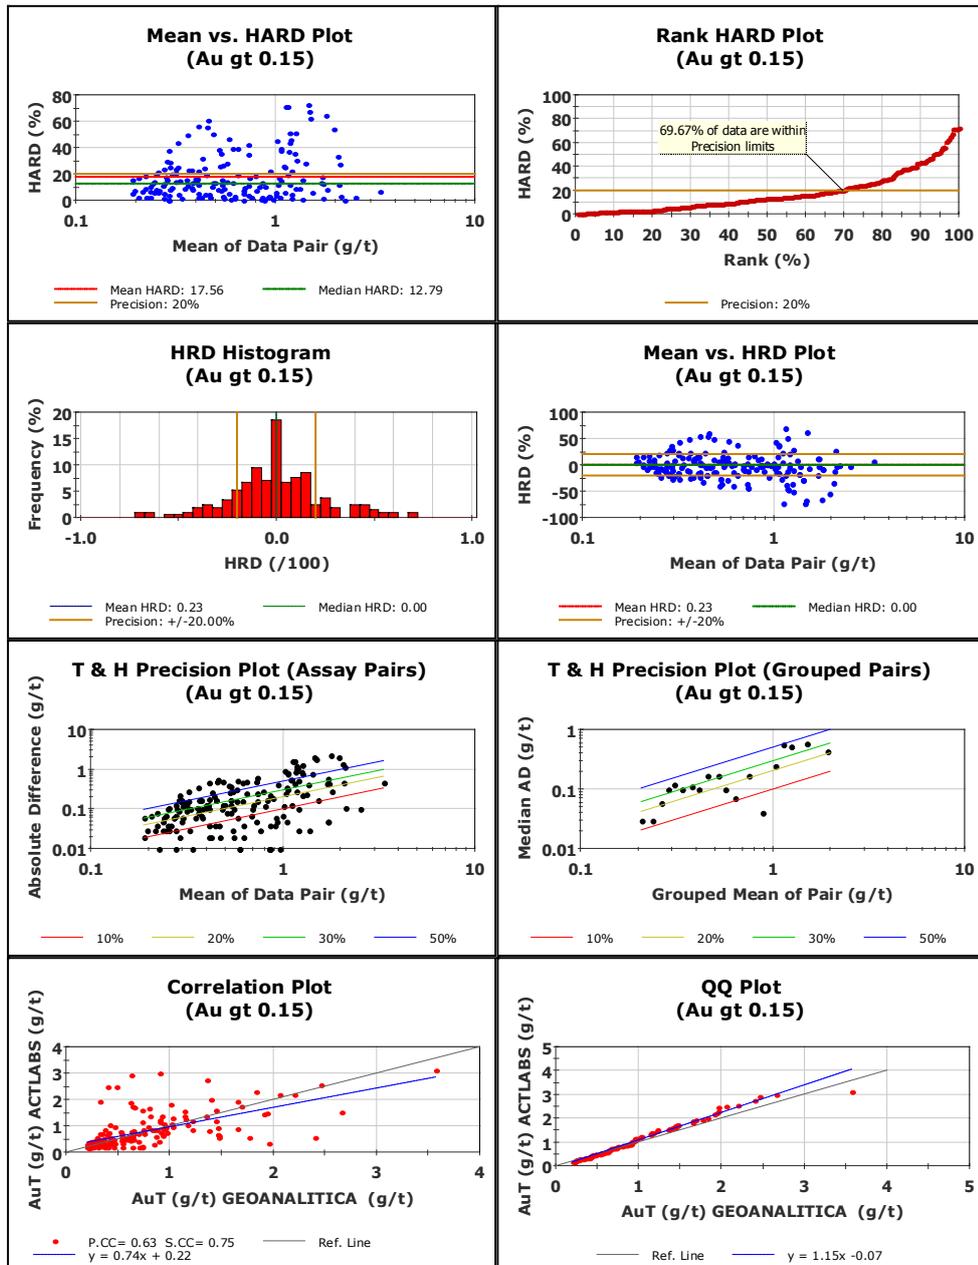
Figure 12.1.3\_1  
CMD – Field Duplicates

### Umpire Geoanalytica vs Actilabs (Au gt 0.15)

AuT (g/t) GEOANALI TICA	AuT (g/t) ACTLABS	Units		Result
No. Pairs:	211	211		Pearson CC:	0.63
Minimum:	0.20	0.16	g/t	Spearman CC:	0.75
Maximum:	3.57	3.11	g/t	Mean HARD:	17.56
Mean:	0.69	0.73	g/t	Median HARD:	12.79
Median:	0.52	0.49	g/t	Mean HRD:	0.23
Std. Deviation:	0.53	0.62	g/t	Median HRD:	0.00
Coefficient of Variation:	0.77	0.85

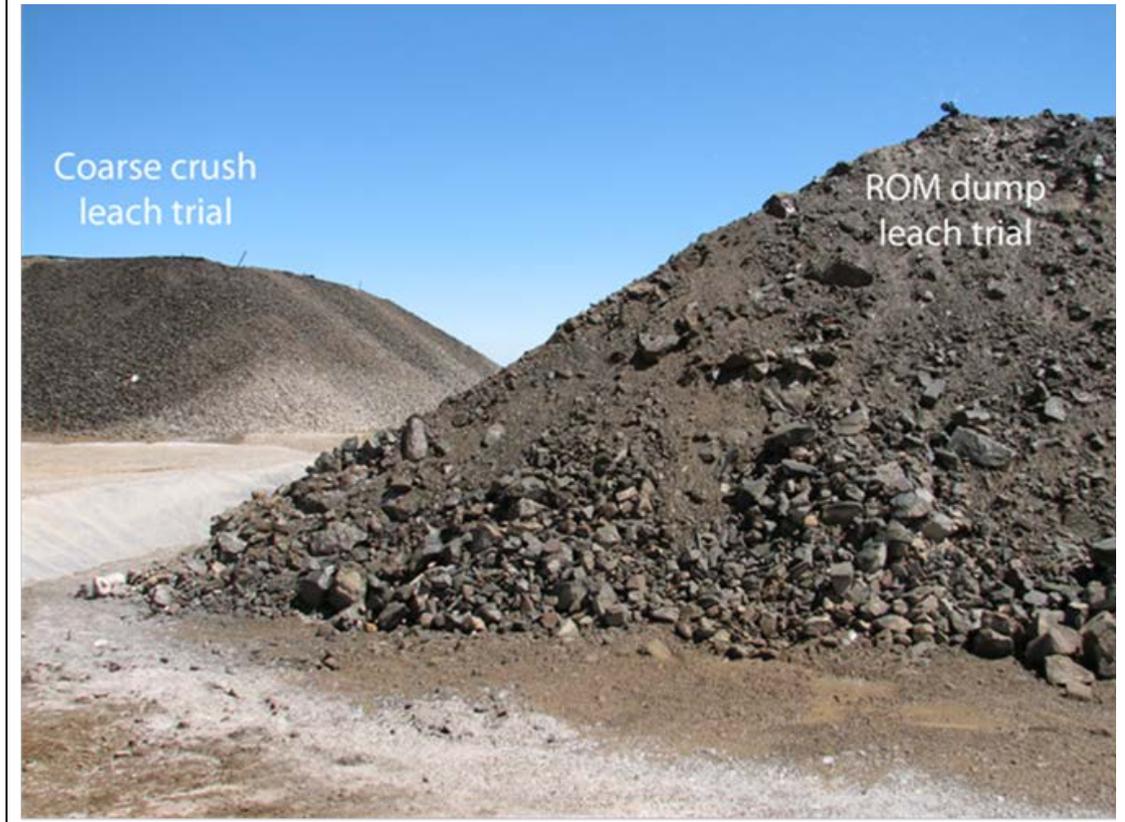
Figure 13.2.1\_1  
First ROM and Coarse Crush Leaching Trial

In October 2011, Lachlan Star commenced two trials of leaching ore sourced directly from the pit, having been blasted but not crushed, and a second trial with coarse crushed ore from two stage crushing (approximately 35mm). The initial trial material was sourced from the Toro Pit area. Figure 13.2.1\_1 shows the nature of the material used for the first ROM and coarse crush leaching trials.

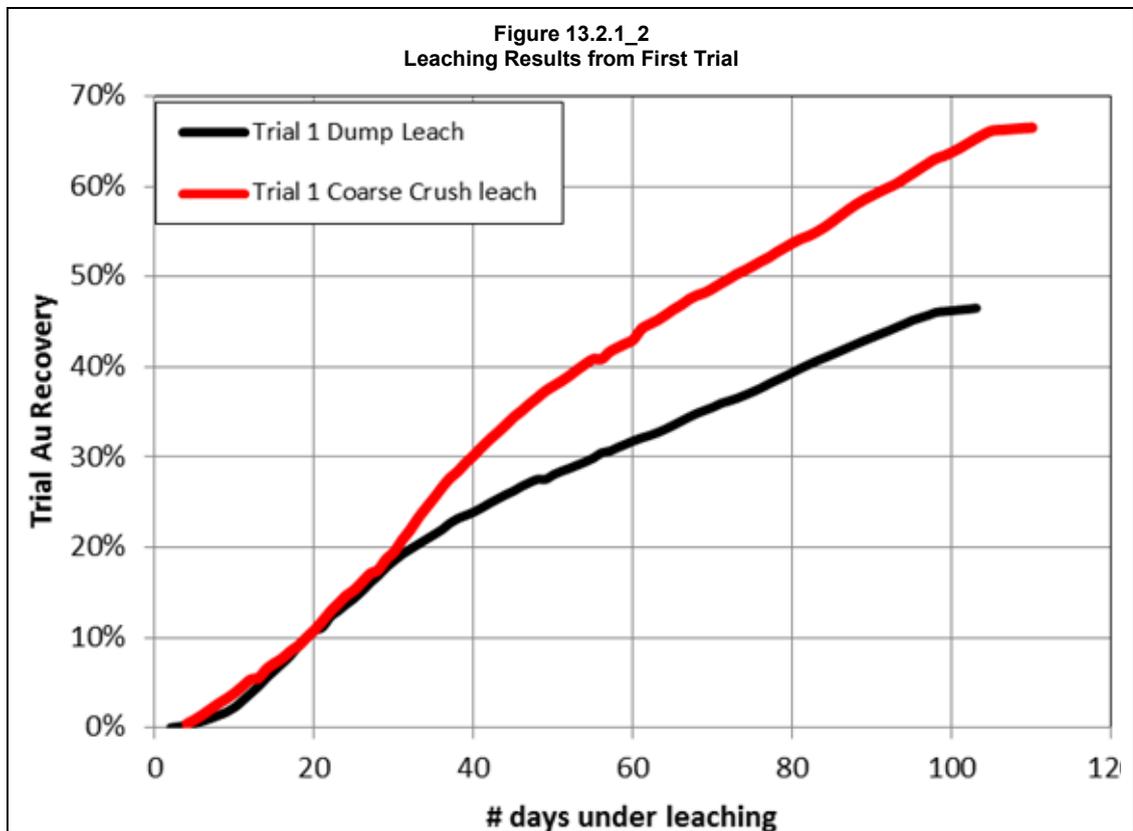
The results of the first trial are summarised in Figure 13.2\_2, showing the recovery curve for dump leaching and 2-stage crushed leaching.

Over 103 days of constant leaching, the estimated recovery of the dump leach trial was 46.5% of the gold contained in the ore. For the material that was 2-stage crushed, the estimated recovery was 66.5%, achieved over a total leach time of 110 days.

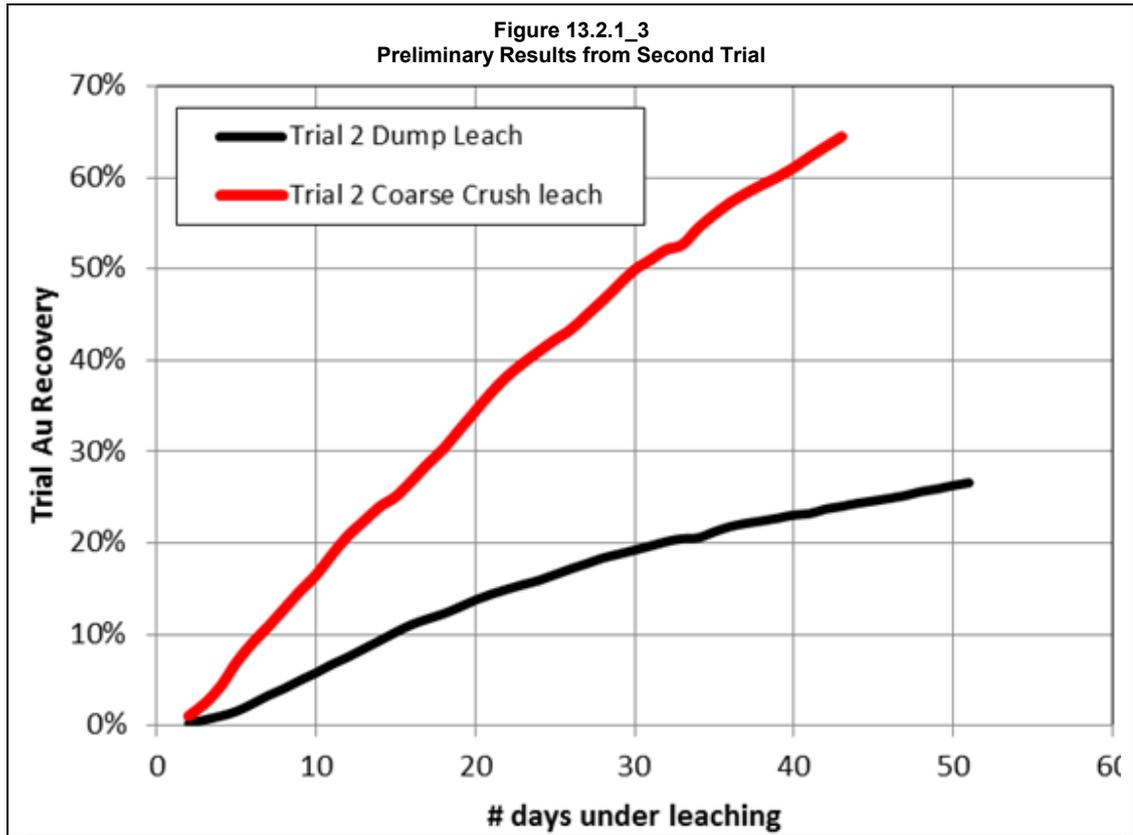
Figure 13.2.1\_3 illustrates the preliminary results for the second leaching trial. The trial was not complete at the time of preparation of this Technical Report, with approximately another 55 days of leaching remaining. Also, the crushing of the remnant material after the end of the trial is required in order to determine the grade of the residue, which in turn allows the original head grade to be back calculated. Until this has been completed the results can only be considered preliminary in nature.

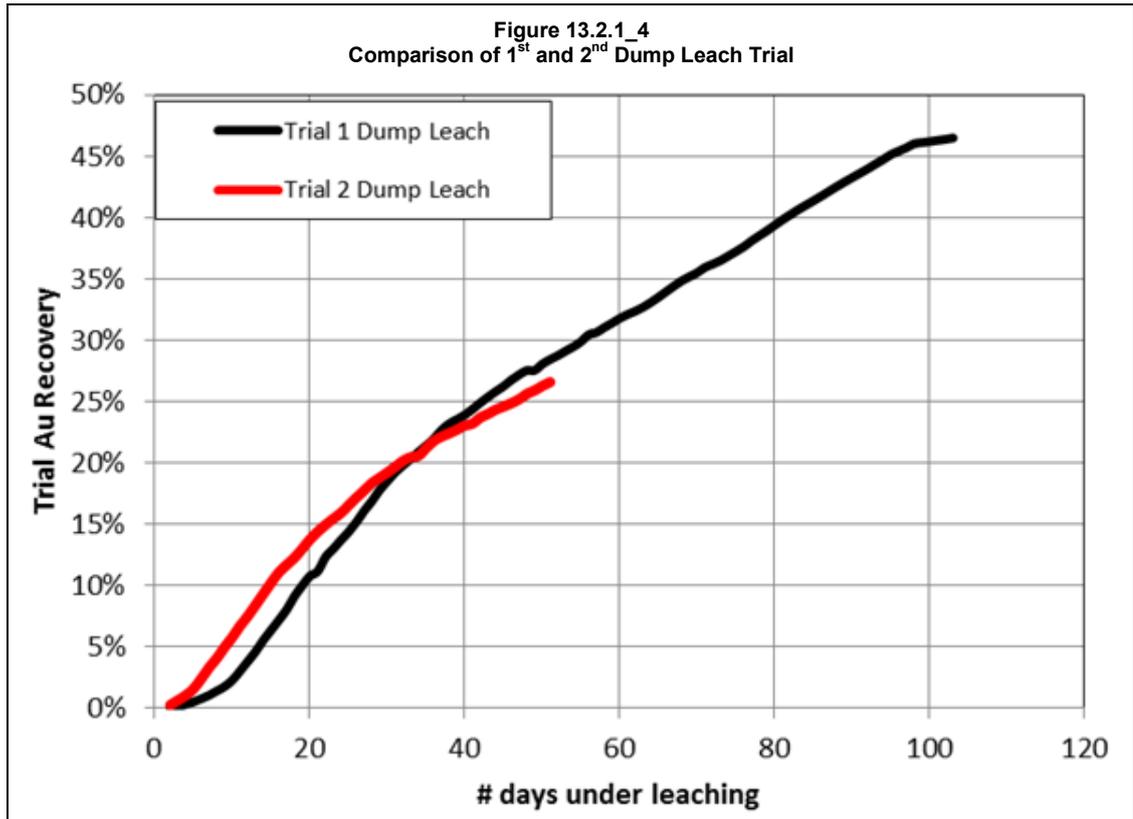
Figure 13.2.1\_4 shows the comparison of the results of the first trial with the preliminary results for the second dump leach trials. This indicated that the leach kinetics for both dump leach trials was similar at 52 days of leaching.

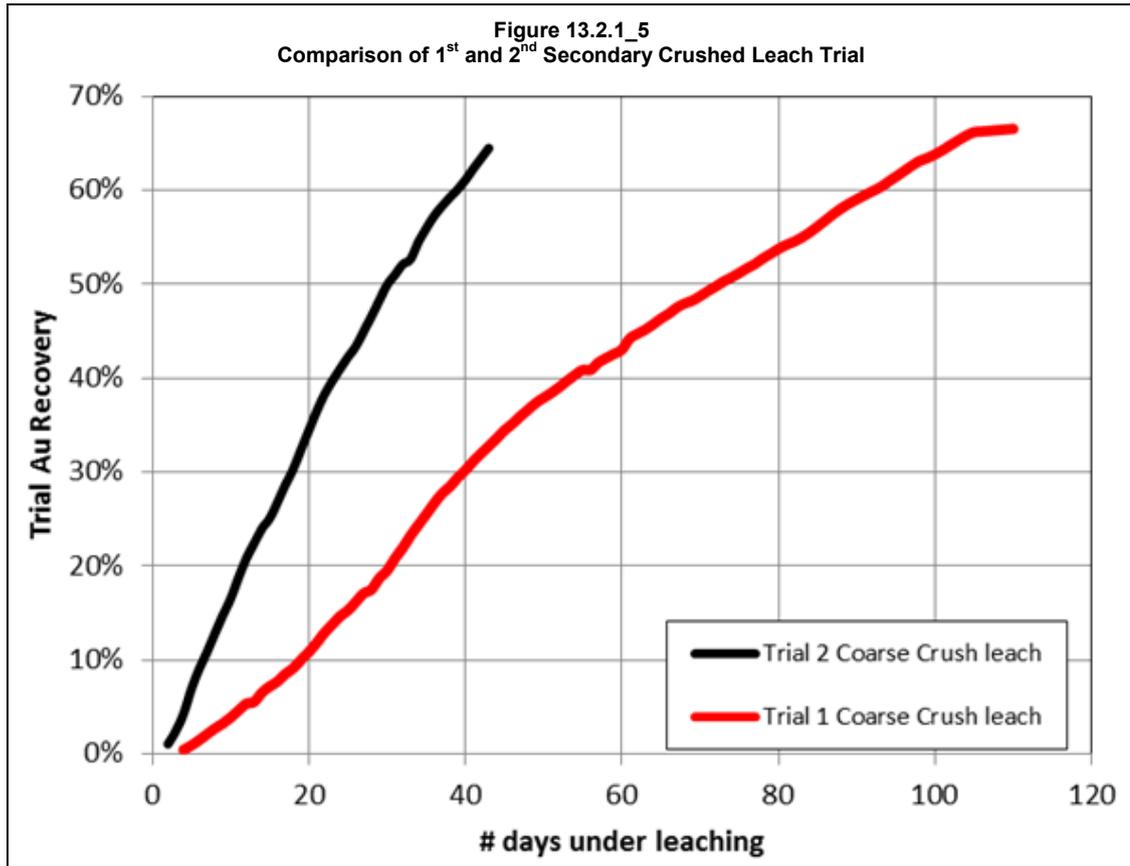
Figure 13.2.1\_5 illustrates the comparison of the secondary crushed leaching trial, with the results for the first trial on material from Toro, and the preliminary results for the second trial using material from Tres Perlas.

The difference between the results shown in Figure 13.2.1\_5 are likely a result of the fact that head grade was estimated by blast hole sampling, which may be underestimating the average grade of the trial material. The head grade will be confirmed once the residue of the trial is crushed and sampled allowing the head grade to be back calculated. The slope for the Toro test (red line) was also steeper than that shown in the graph above prior to the measurement of the grade of the ripios and determining the calculated head grade. This head grade correction is an important step in ascertaining the true process recovery

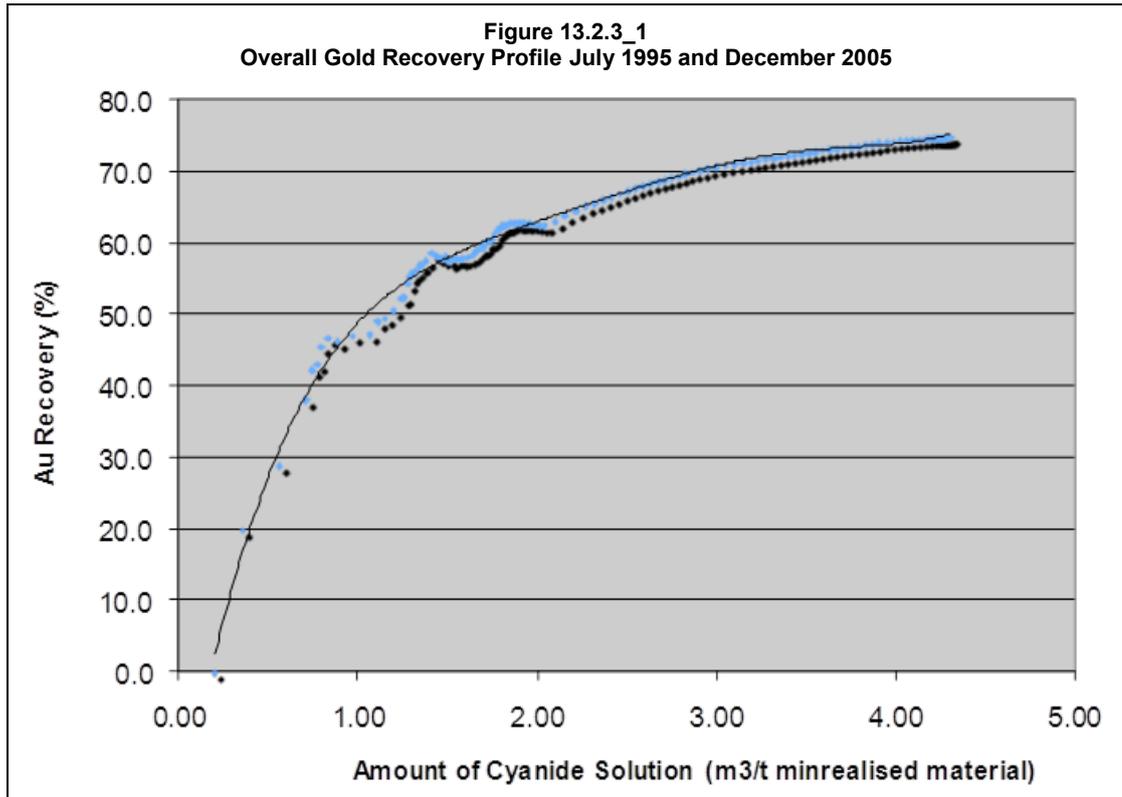
Figure 13.2.3\_1 gives the overall recovery as a function of cumulative cyanide addition for the first production cycle between July 1995 and December 2005.

When stacking of ore stopped in December 2000, the cumulative amount of cyanide solution per tonne of ore was 2.27m<sup>3</sup>/t ore for a total recovery of 65.3%. The graph in Figure 13.2.3\_1 illustrates that an additional recovery of approximately 10% was achieved in the subsequent five years of leaching.

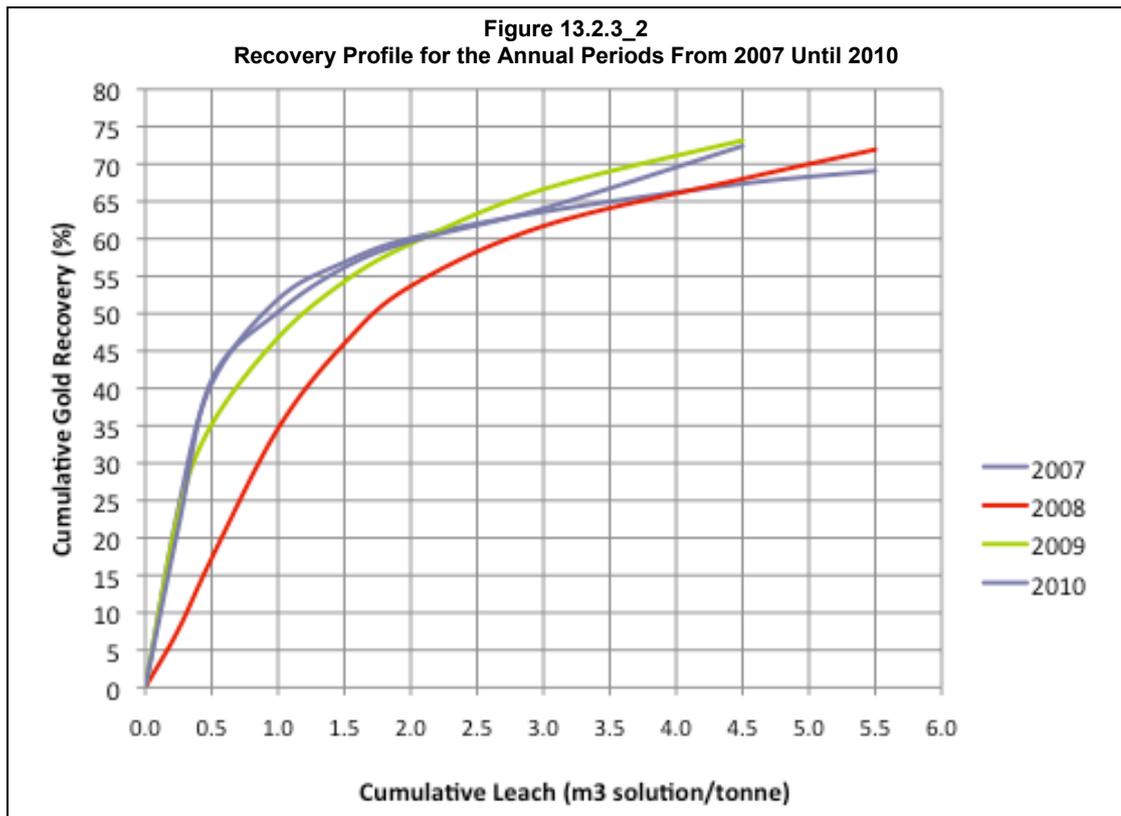
The kinetics of recovery is a function of many parameters, such as type of material, amount of ounces added to the stack, stacking height, number of lifts, permeability, etc. The overall profile is a composite of a number of profiles such as illustrated in Figure 13.2.3\_2 with the recovery profiles for the material stacked in the years 2007 until 2010 as per column leach tests on composites for those years.

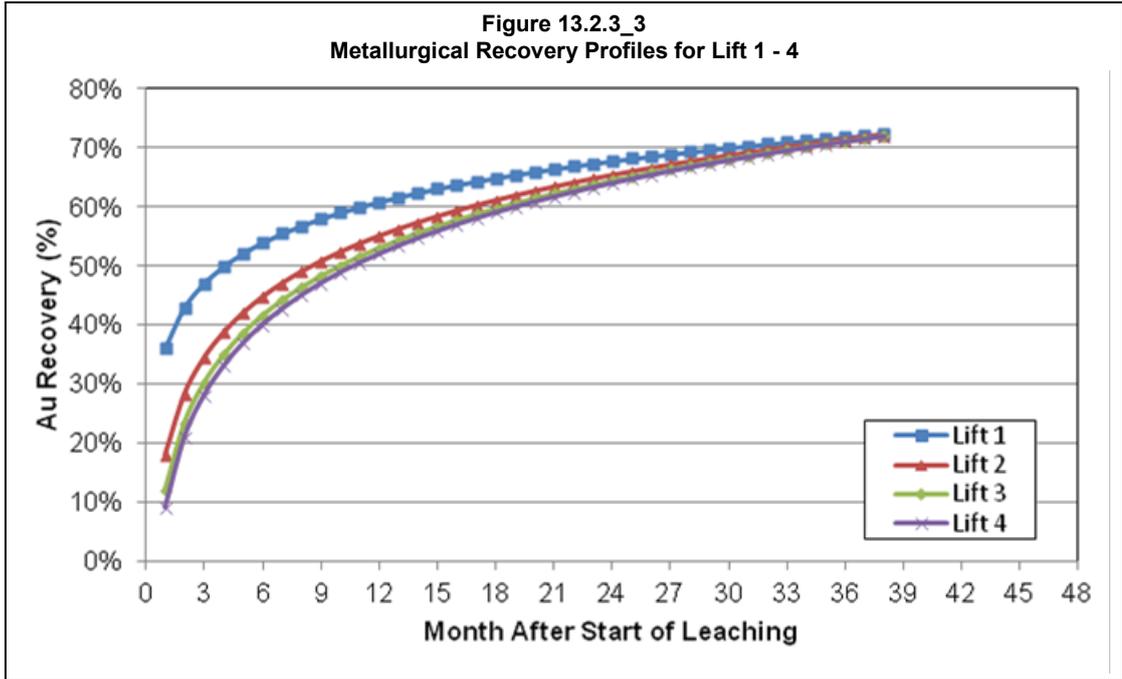
The metallurgical department of CMD has over the years build up a database on the kinetics of the process and Figure 13.2.3\_3 gives the relationships for average recovery over time for the various lifts.

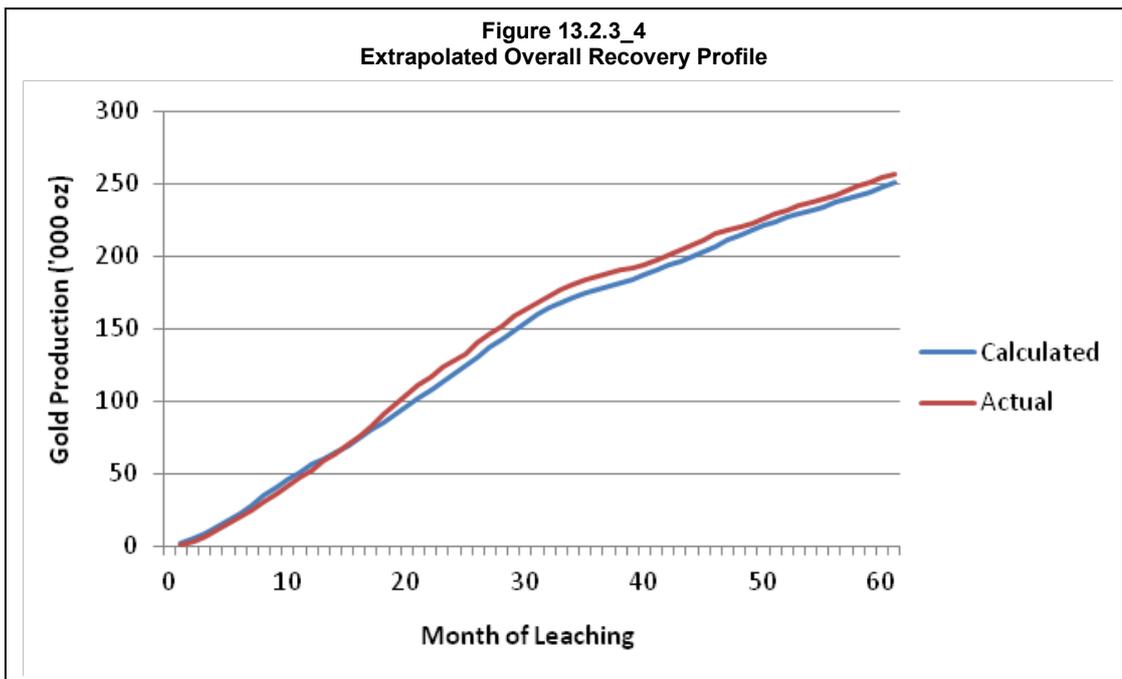
The overall accuracy of these relationships has been verified against historical production performance from April 2006 until March 2011. Figure 13.2.3\_4 shows the actual gold recovered in ounces compared to calculated based on the recovery curves in the preceding diagram.

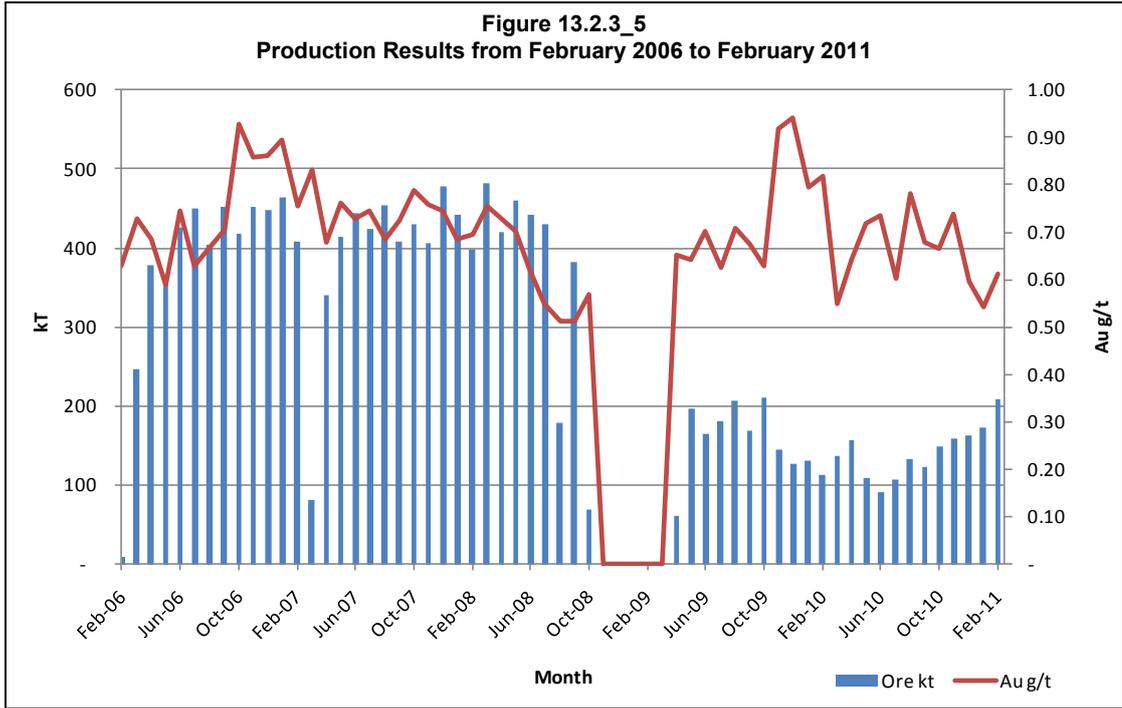
Production for the period February 2006 through February 2011 is shown below in Figure 13.2.3\_5. The decrease in monthly production since the shutdown in March 2009 is due to the smaller scale mining equipment utilized in the Las Loas deposit. Plant throughput for the period was approximately 5,000tpd (currently 7,000tpd as more ore is sourced from the Old Pits). The average gold grade is similar before and after the shutdown period.

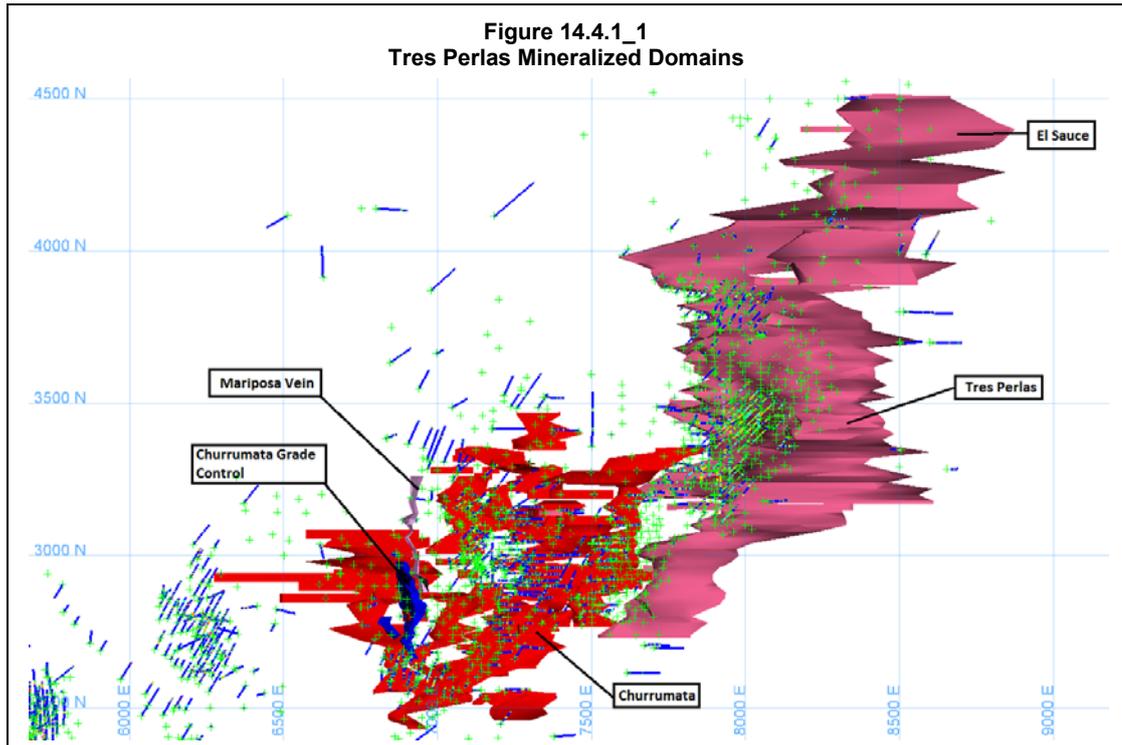
East West oriented drillhole sections showing rock types and drillhole sample grades were interpreted resulting in 69 mineralized domains being constructed in the Churrumata area mineralisation and 13 major domains in the Tres Perlas/El Sauce area mineralisation, as shown in Figure 14.4.1\_1. Two domains at Churrumata were developed from grade control data. Domain continuity varies from north to south. Of the domains interpreted in the Churrumata area mineralisation, 8 domains are significant and capture the vast majority of mineralisation and of the domains interpreted at Tres Perlas/El Sauce area mineralisation 5 domains are significant and capture the vast majority of mineralisation.

The base of oxidation surface was constructed from logged depths in the drillholes however the majority of the mineralisation lies in the transitional/sulphide portion of the oxidation profile. The digital terrain model is the general topography covering the entire CMD Gold Mine area, termed mina\_231110 based in the November 2011 site survey. Backfill at the Natalia pit was also separately wireframed.

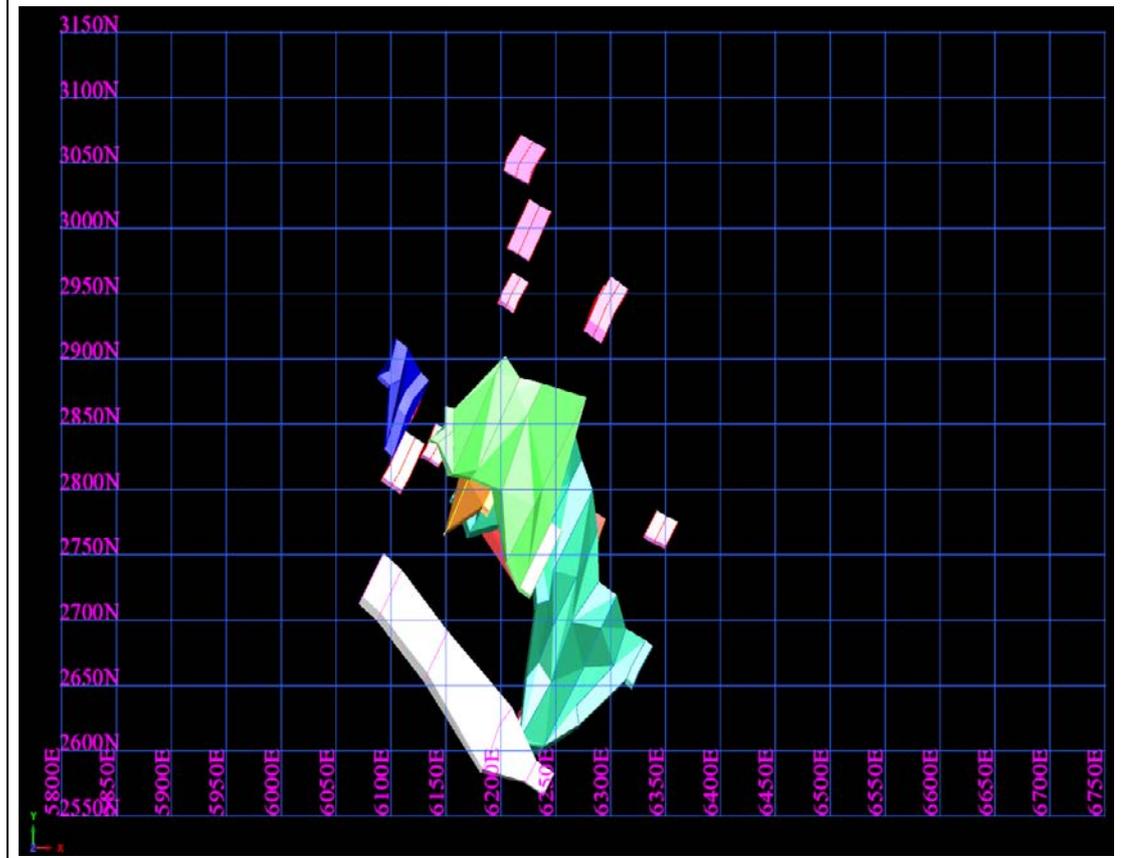
Figure 14.2.1\_1  
Chisperos Mineralized Domains

The wireframe at a nominal 0.3g/t Au cutoff grade was constructed from outlines interpreted by Coffey Mining on north-northeast (030°) oriented drillhole sections showing rock types and sample grades. Interpretation of the mineralized zones resulted in 4 larger domains, 2 intermediate domains and 16 small domains based on single intercepts. Domain continuity varies from northwest to north-south. (See Figure 14.2.1\_1)

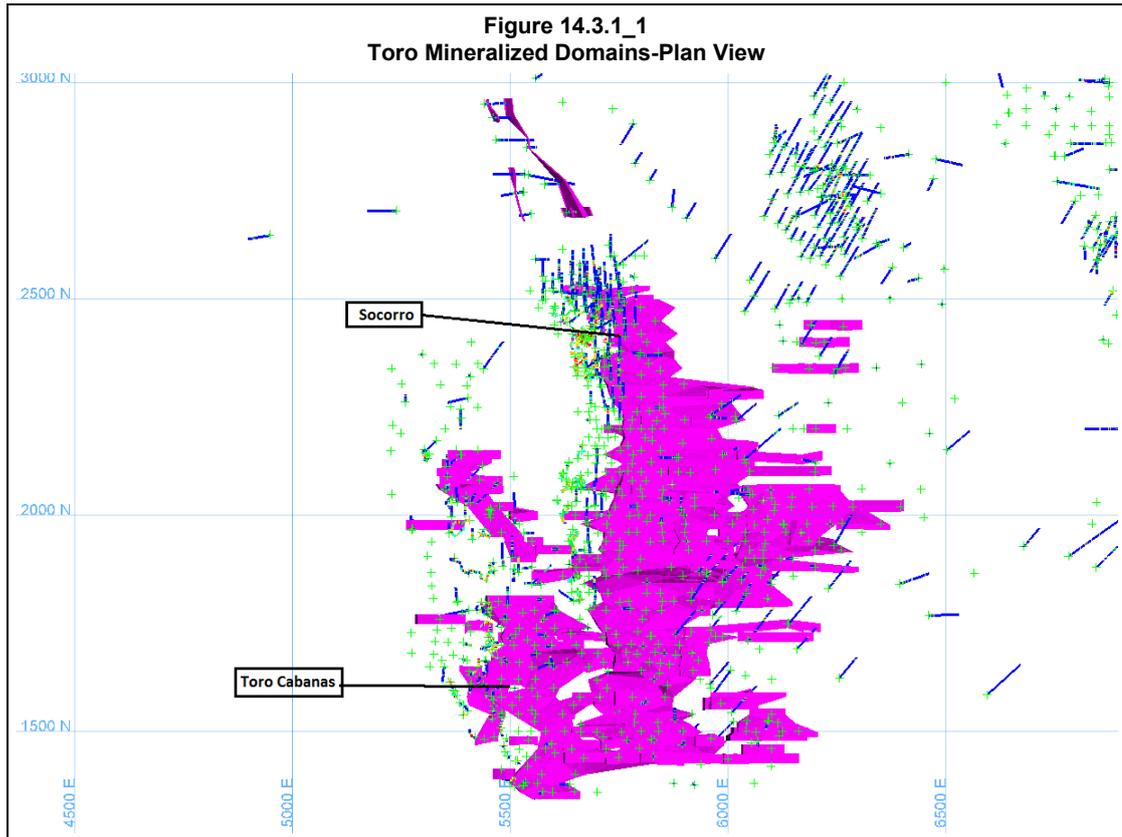
The Toro mineral resource contains the Toro Cabanas mineralization area and the Socorro mineralization area. The wireframe at a nominal 0.15 g/t Au cutoff grade was constructed from outlines interpreted by Coffey Mining based on a geological interpretation supplied by Lachlan Star. Interpretation was based on east west oriented drillhole sections showing rock types and sample grades. Interpretation of the mineralized zones resulted in 142 domains being constructed (Figure 14.3.1\_1) comprising 6 larger domains. Domain continuity varies from north to south.

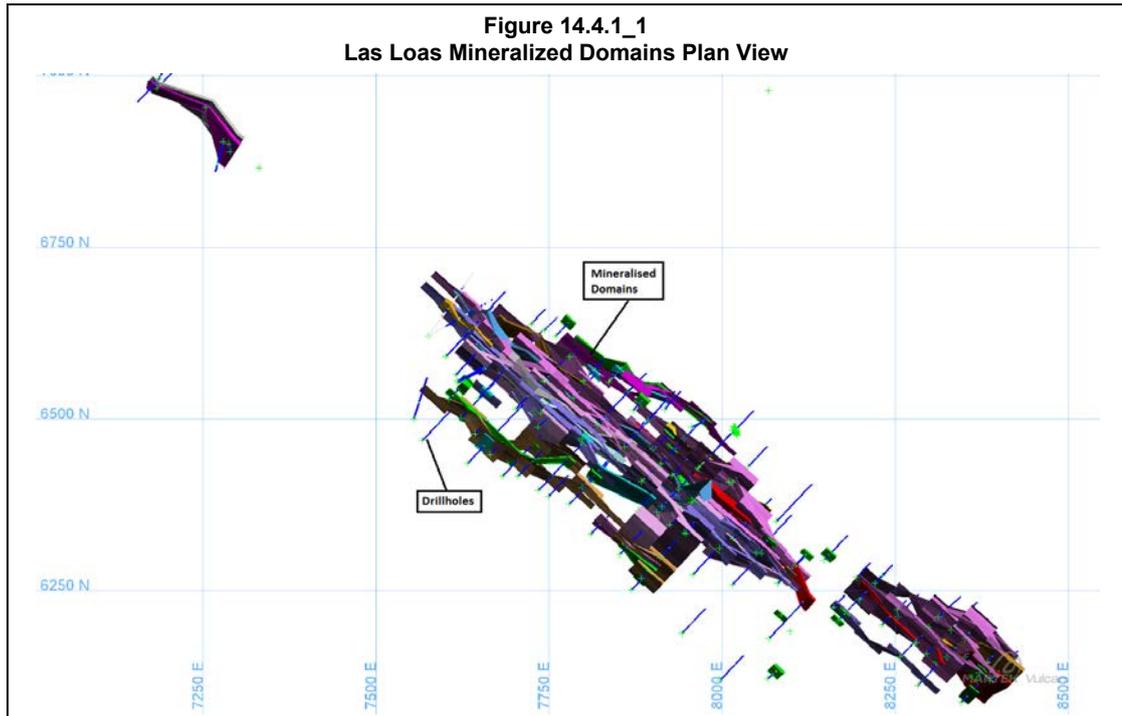
The wireframe representing mineralisation were generated by Coffey Mining at a nominal 0.2-0.3g/t Au cutoff grade. These mineralisation domains have been based on a geological interpretation supplied by Lachlan Star. The interpretation was based on east west oriented drillhole sections showing rock types and drillhole sample grades. The interpretation resulted in a total of 62 domains being constructed, as shown in Figure 14.4.1\_1. 10 larger domains, which contained the majority of sample data and were volumetrically the most significant of the zones, were interpreted.
