**CMD Gold Mine, Andacollo, Chile**  
**Independent Technical Report**

**Lachlan Star Resources**

Effective Date: 1<sup>st</sup> April 2012

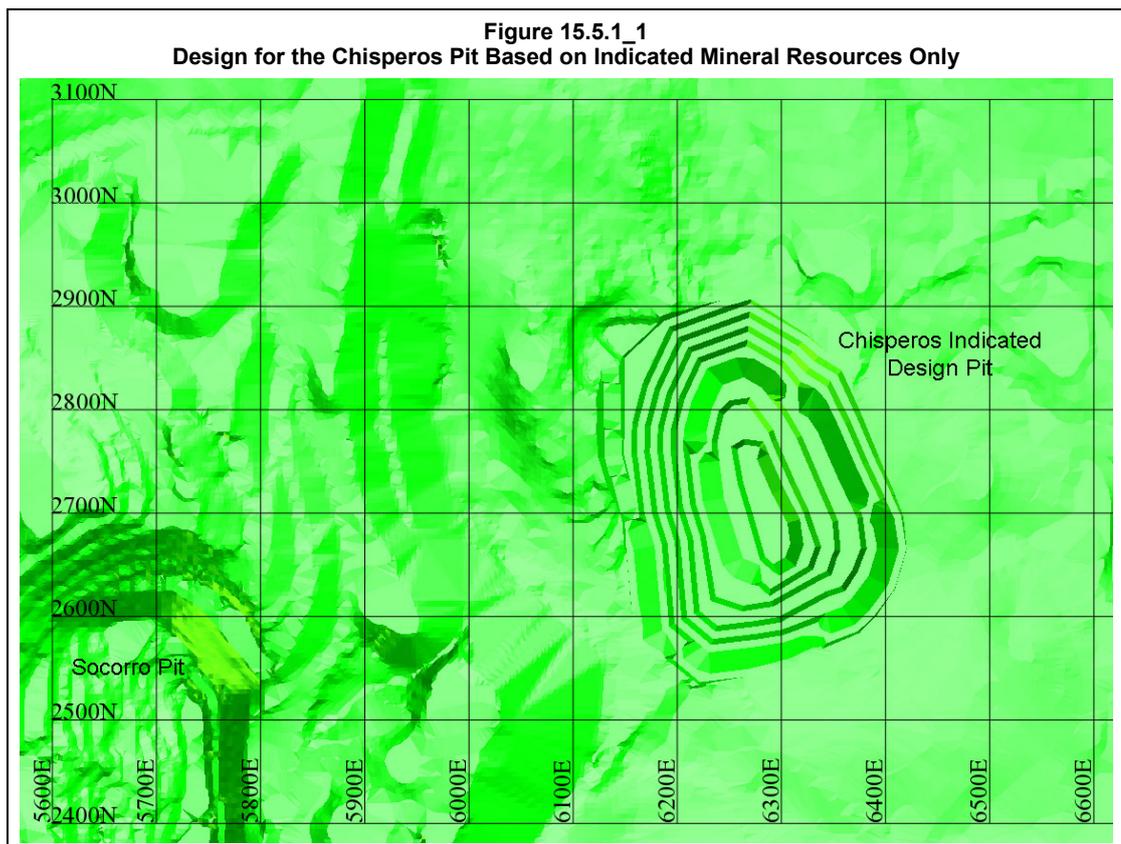
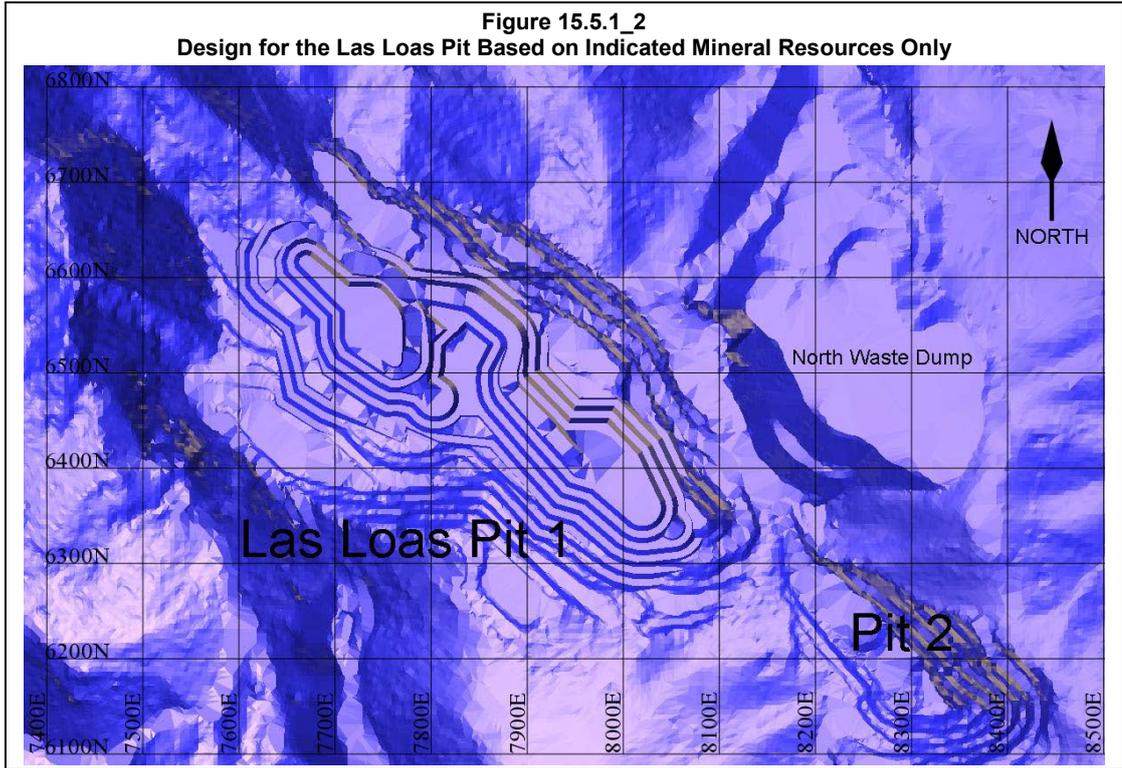
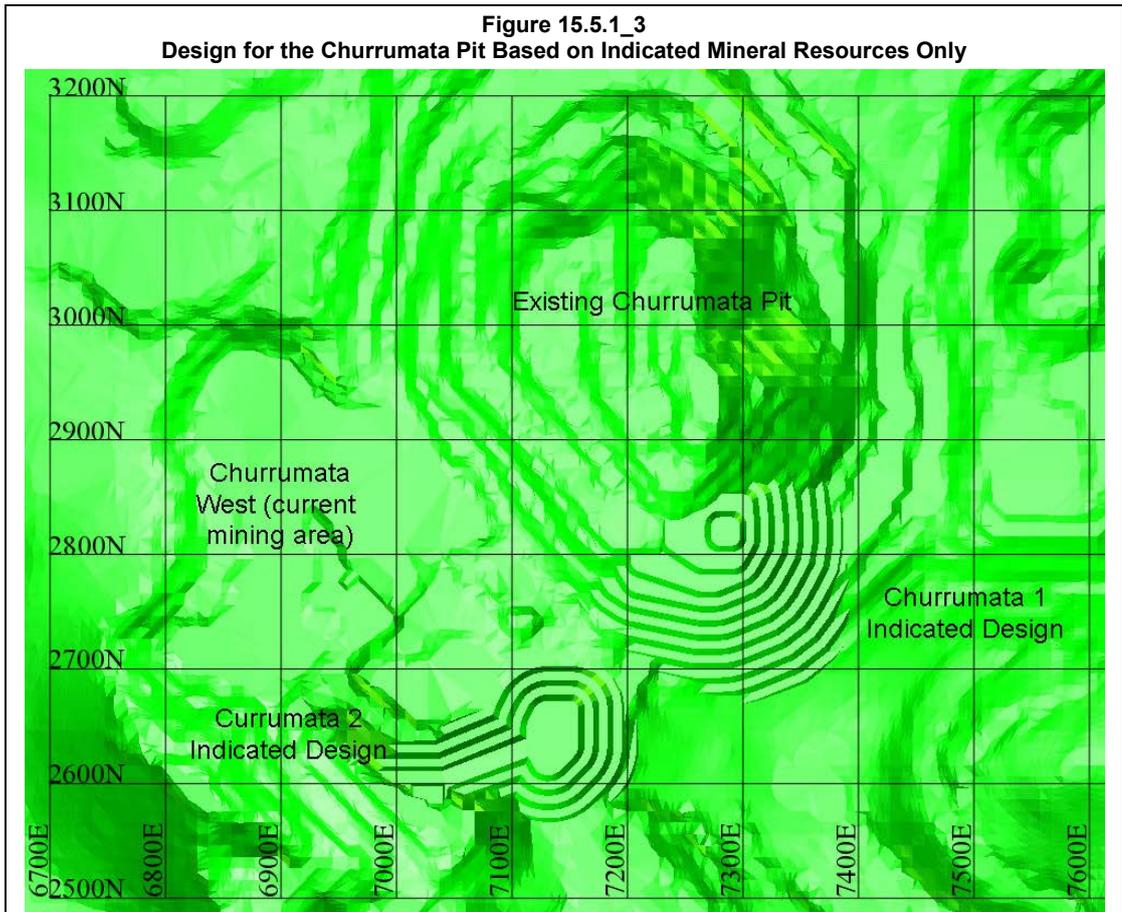
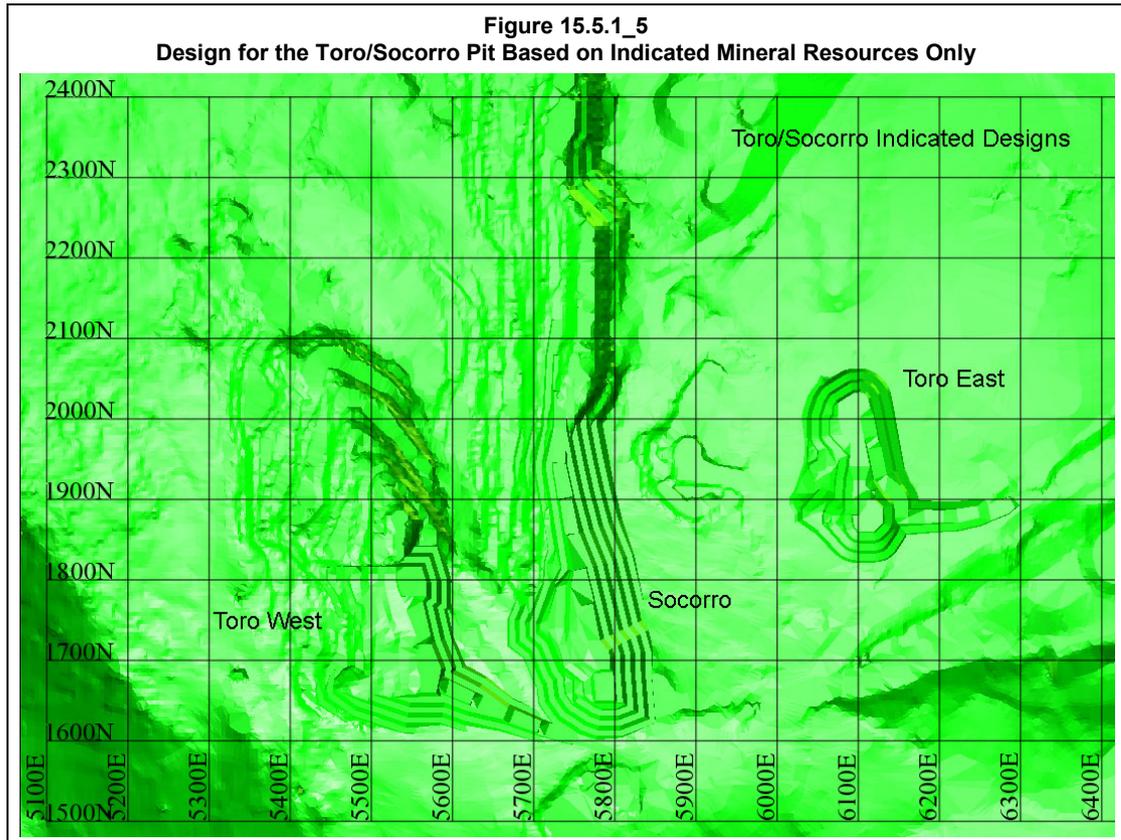
- Bench height 15m
- Batter angle 70°
- Berm width 7.1m
- Ramp gradient 1 in 9
- Ramp width 15m.

The designs for the pits for the Indicated Mineral Resources only and for the generation of Mineral Reserves are shown in Figure 15.5.1\_1 through to Figure 15.5.1\_5 for the Chisperos, Las Loas, Churumata, Tres Perlas and Toro/Socorro Pits respectively.

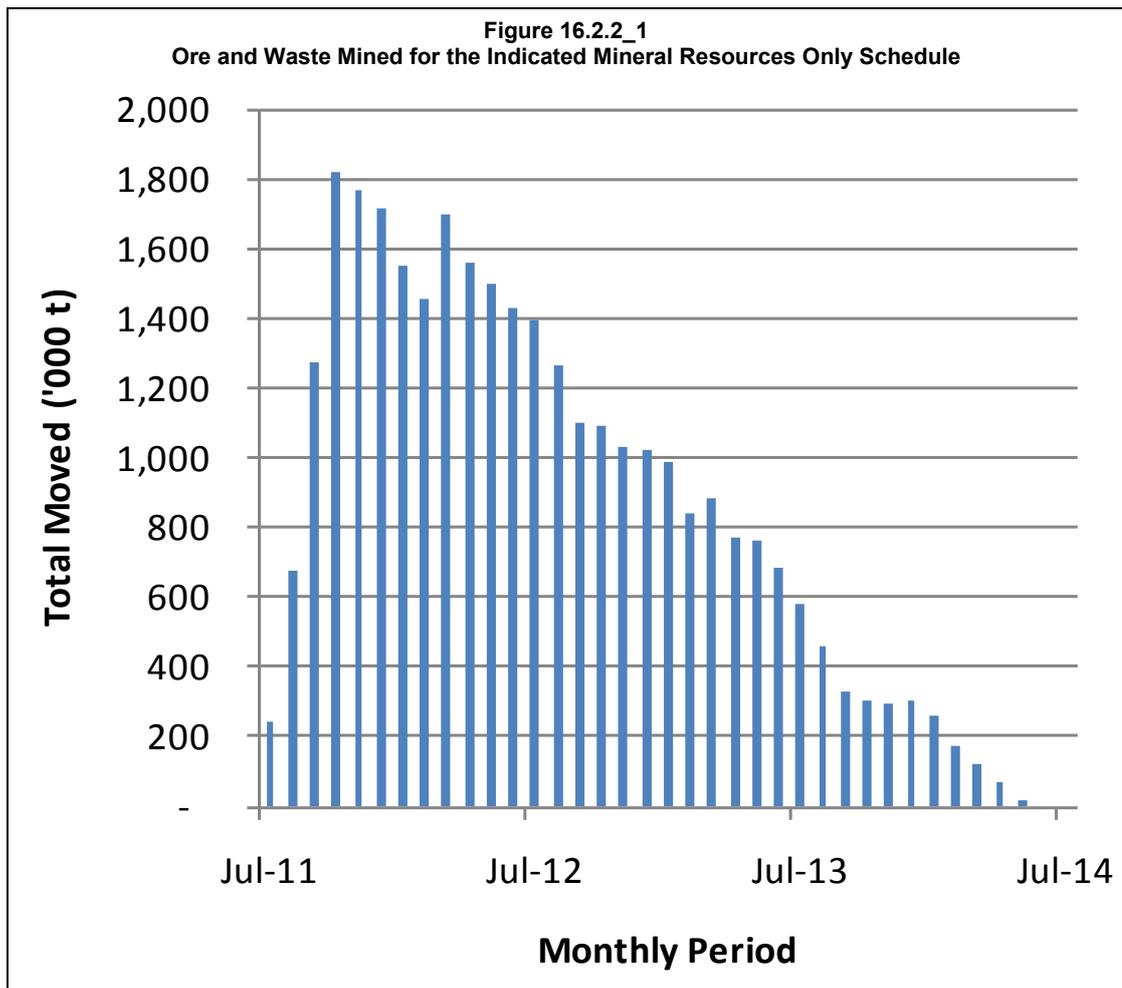
Figure 16.2.2\_1 shows the total material moved from all the pits combined.

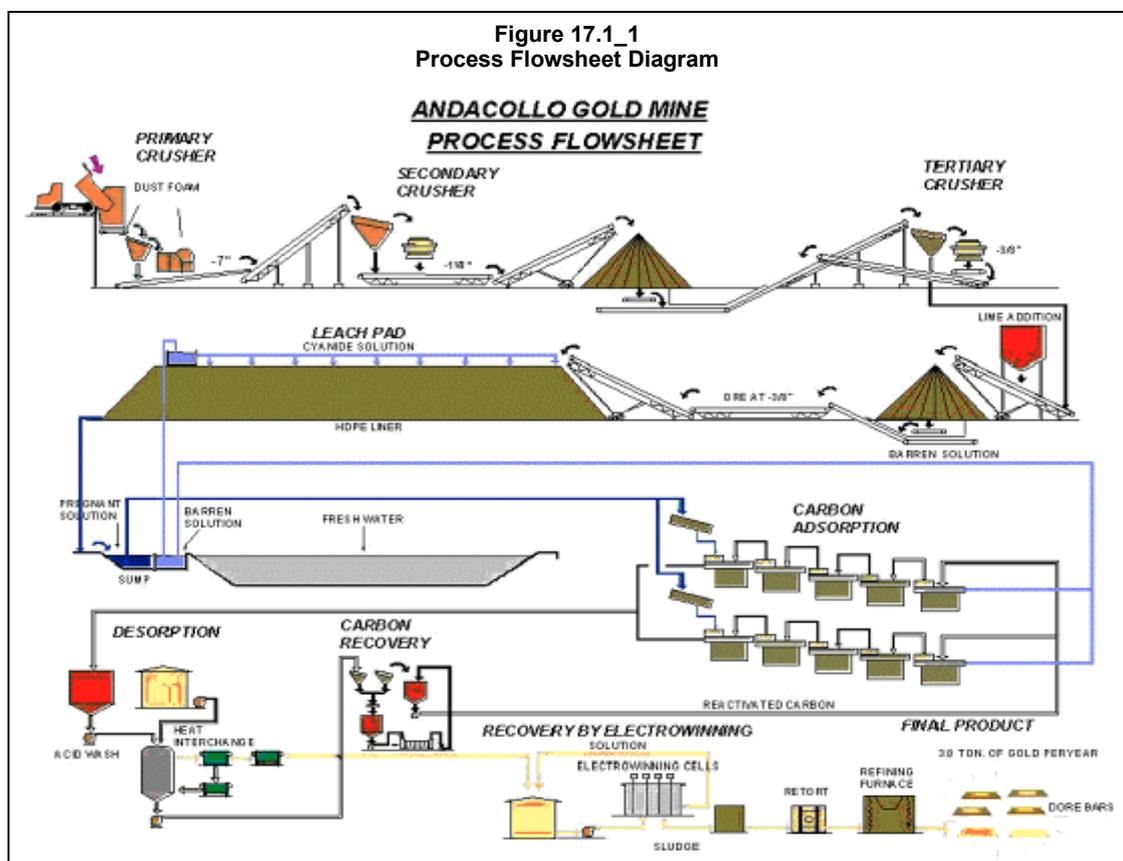
A simplified flowsheet is presented in Figure 17.1\_1 below.

The primary crusher is a jaw crusher that reduces the run of mine (ROM) ore from a size less than approximately 50cm to 10cm-15cm, followed by a standard 7-foot cone crusher, which reduces the product to 3.5cm. Three shorthead 7foot cone crushers that are operating in parallel reduce the material further to 9mm in a closed circuit with a classification section. To monitor the crushed head grade belt cuts are taken automatically every 30 seconds from which is immediately taken another cut to reduce the amount to a few hundred grams.

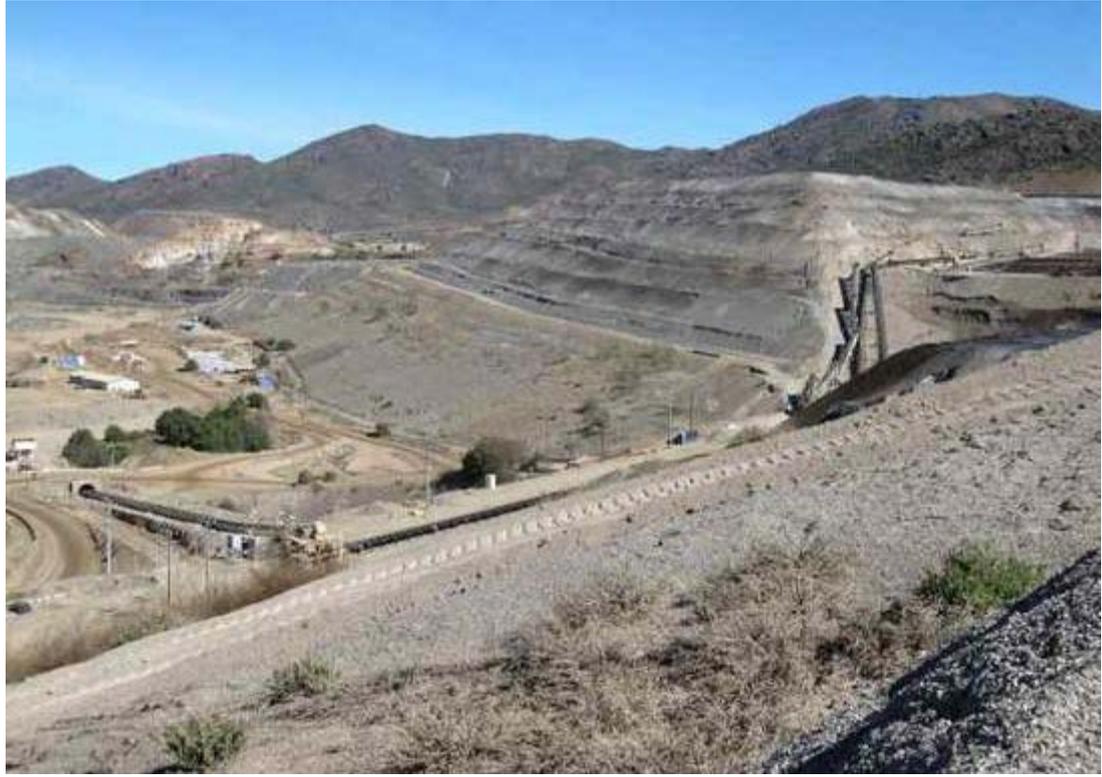
Figure 17.1\_2  
 Conveyor System at CMD Gold Mine (August 2010)

The final crushed product is reclaimed from the fine ore stockpile and conveyed to the heap loading system. A hopper/feeder arrangement fed by a FEL is installed on the overland conveyor as a back-up to the fine ore stockpile reclaim system. The tripper, grasshopper conveyors, crawler and radial stacker all appeared visually to be in good condition.

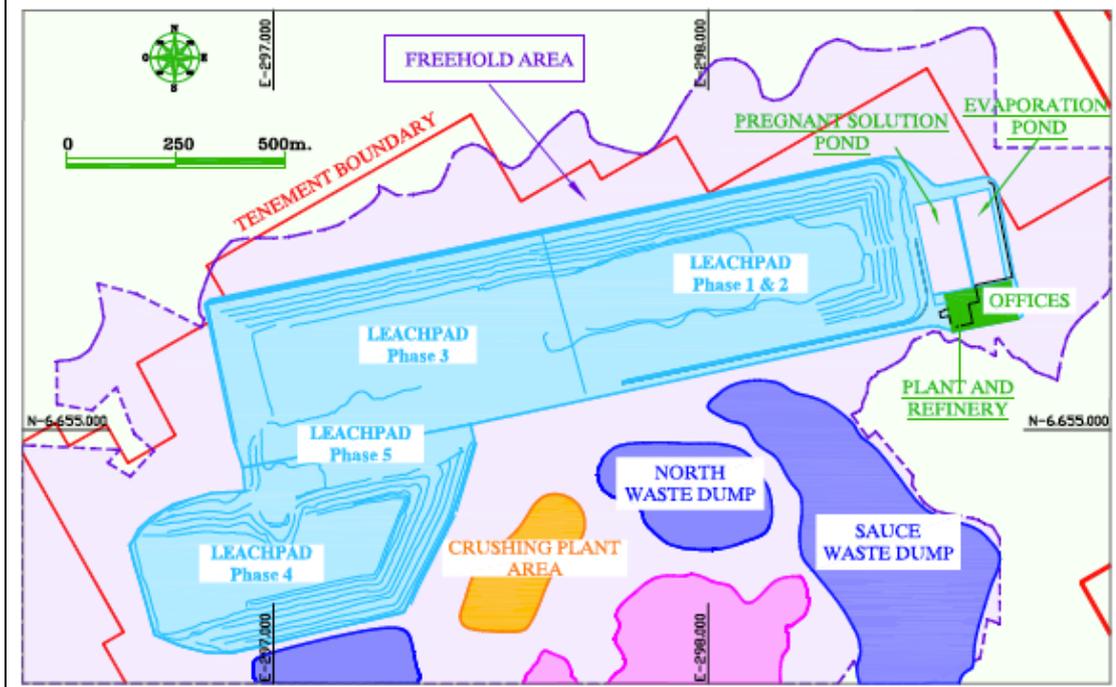
Figure 17.1\_3  
 Heap Leach Phases

Historically the ore was stacked first on Phase I, which is a pad 400m long by 400m wide. Each phase was prepared by a 2mm HDPE liner to provide an impermeable layer on which a base of 2m ore is laid to protect the liner from damage during the stacking process. Each heap is subdivided in cells with a length of 80m along the strike of the heap and extending over the full width of the heap. Along the sides of the cells perforated HDPE pipes are positioned to collect the leachate which drains to the main collector pipes along the sides of the heaps.

Ore is stacked in 6 lifts of 8m height for a maximum elevation of 50m (for stability purposes). Phase I was followed by Phase II again 400m by 400m placed such that it extended the pad towards the west. Phase III was 800m long by 400m wide resulting in a pad with a total length of 1,600m. Phase IV was placed separate from Phases I – III. Currently the area between Phases I - III and Phase IV is being filled (see Figure 17.1\_4) as Phase V and is now at Lift 4. The maximum slope has been set at 1V:2H for stability reasons.

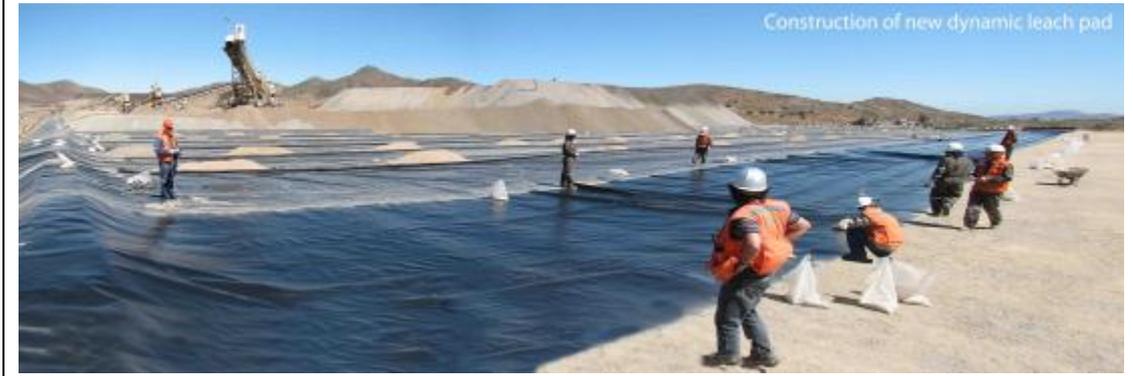
**Figure 17.1\_5**  
**Construction of Pad3B (November 2011)**

During January 2011, an operational refinement was implemented with the inclusion of an inter-lift liner on top of the Phase 3 pad. The aim of this installation was to improve leach kinetics, increasing the speed of recovery, whilst reducing cyanide consumption. Figure 17.1\_5 shows the construction of a new cell on what is now called Leach Pad 3B.

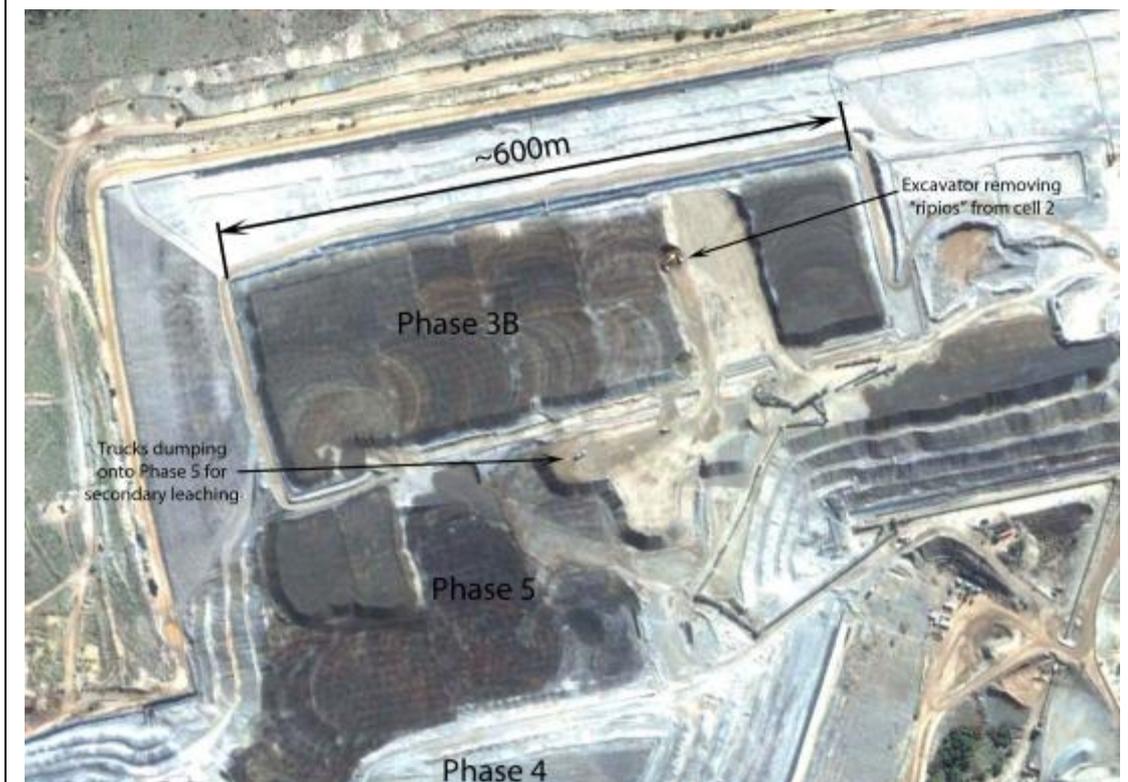
**Figure 17.1\_6**  
**Operation of Dynamic Pad (April 2011)**

The concept was to leach ore on one 8m high pad for around 4 months, known as the “Primary Leach”. The aim of the primary leach was to rapidly leach a large amount of gold. The “ripios” (or leached ore) is then moved to a secondary leach pad at Phase 5 where the ultimate gold recovery is achieved at a slower rate. This is illustrated in Figure 17.1\_6. The system is known as dynamic pad leaching.

In the dynamic pad system the crushed ore is stacked on the primary pad by the same system of conveyors, grasshopper conveyors and the radial stacker traditionally used at the CMD Gold Mine. Ore is leached for around 4 months to recover around 65% of the contained gold.

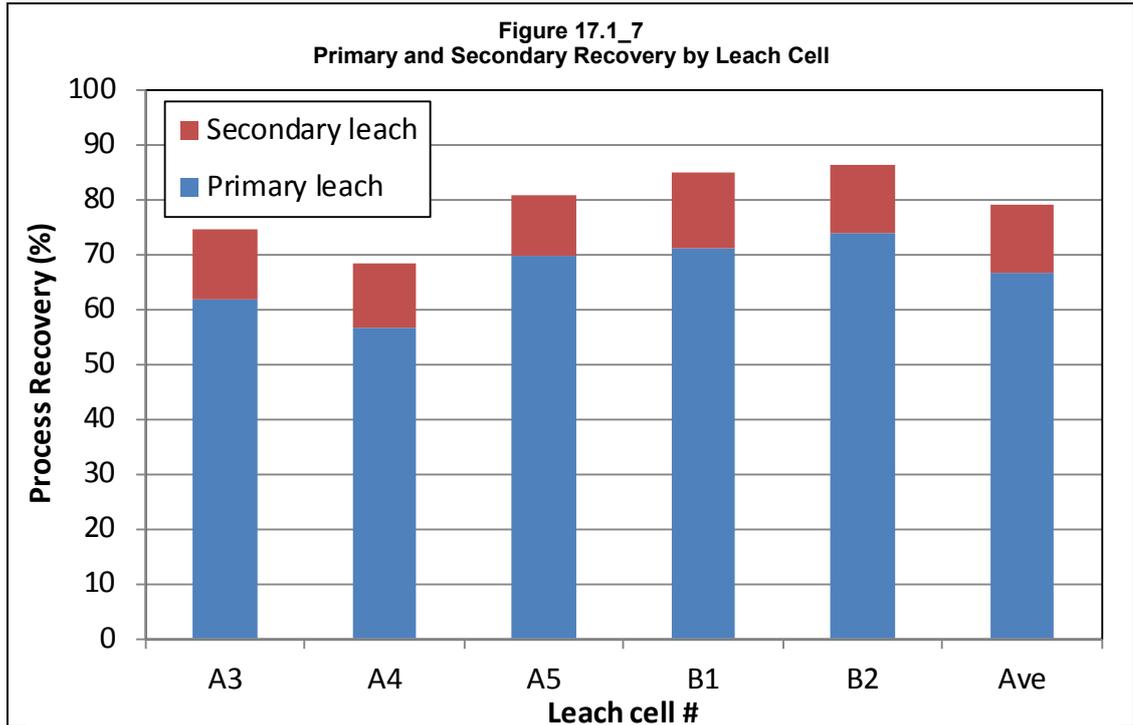
CMD Gold Mine personnel have carried out estimates of recovery from the first dynamic pad cells and the ripios areas; and these are shown in the Figure 17.1\_7.

Typically, gold recovery on the primary pad is in the order of 65%, with an additional 10% recovery expected during the secondary leaching process. These recoveries are largely based on assays of ripios samples taken from the secondary leach pads at the end of irrigation. It is anticipated that a small increase in recovery over the historic average will be achieved due to the transportation of the ripios from the primary to secondary pads. This movement results in the addition of oxygen to the secondary pad and improved solution flow through the breakup of solution flow paths in the primary pad.

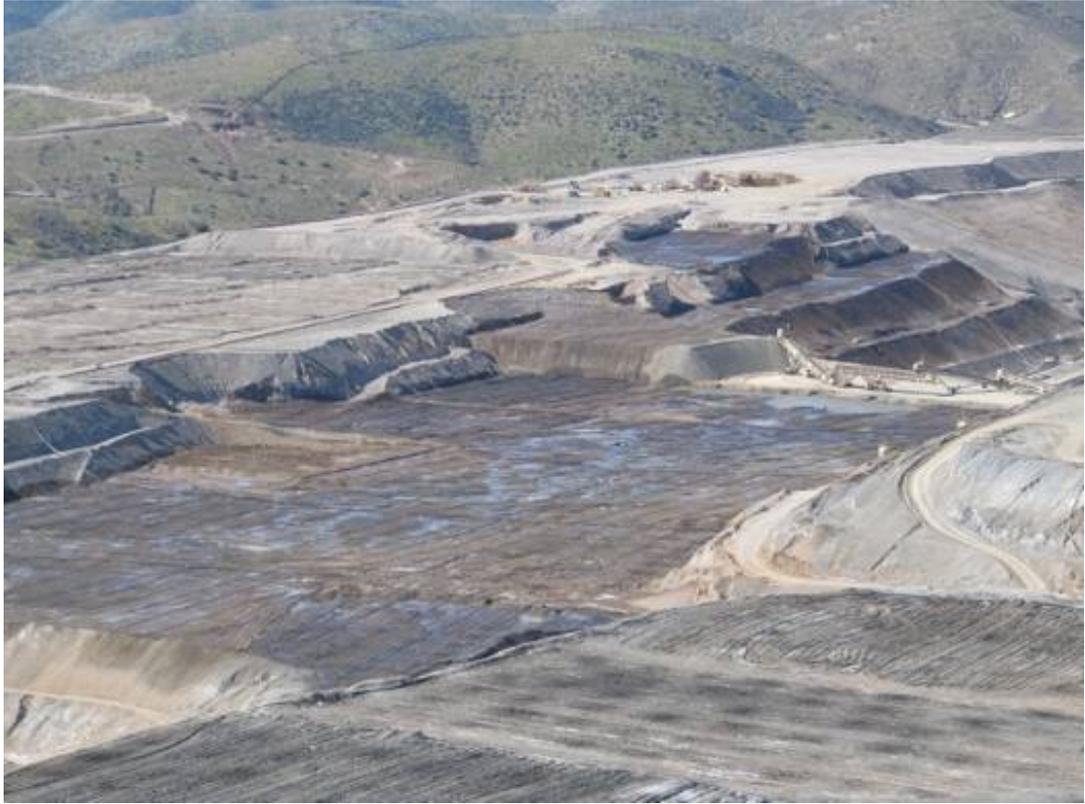
**Figure 17.1\_8**  
**Overview of Phase V (August 2010)**

Figure 17.1\_8 is a picture taken from the eastern extremity of Phase I presenting an overview from the plant where the gold is captured by carbon in column in five tanks using counter flow, stripped and poured (see process flow diagram in Figure 17.1\_1). The carbon is regenerated and a section of the plant treats 10% of the solution to remove the copper and recover and recycle free cyanide.

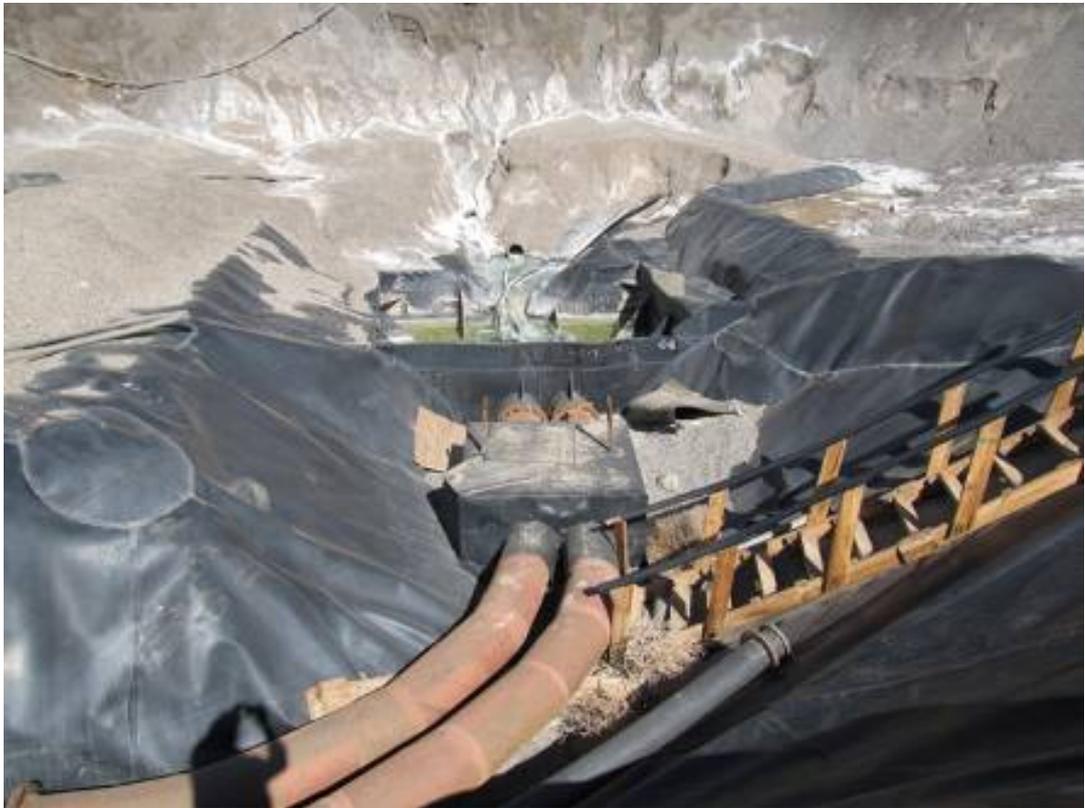
**Figure 17.1\_9**  
**Collection Point at Bottom of Phase V (August 2010)**

Figure 17.1\_5 provides an overview picture of Phase V and Figure 17.1\_6 provides an overview of a collection point at the bottom of Phase IV. Phase V covers two pregnant solution pipes along its borders, which are used to transfer the captured solution from the older phases. Samples at the various collection points show that Phase IV still yield 3oz per day.

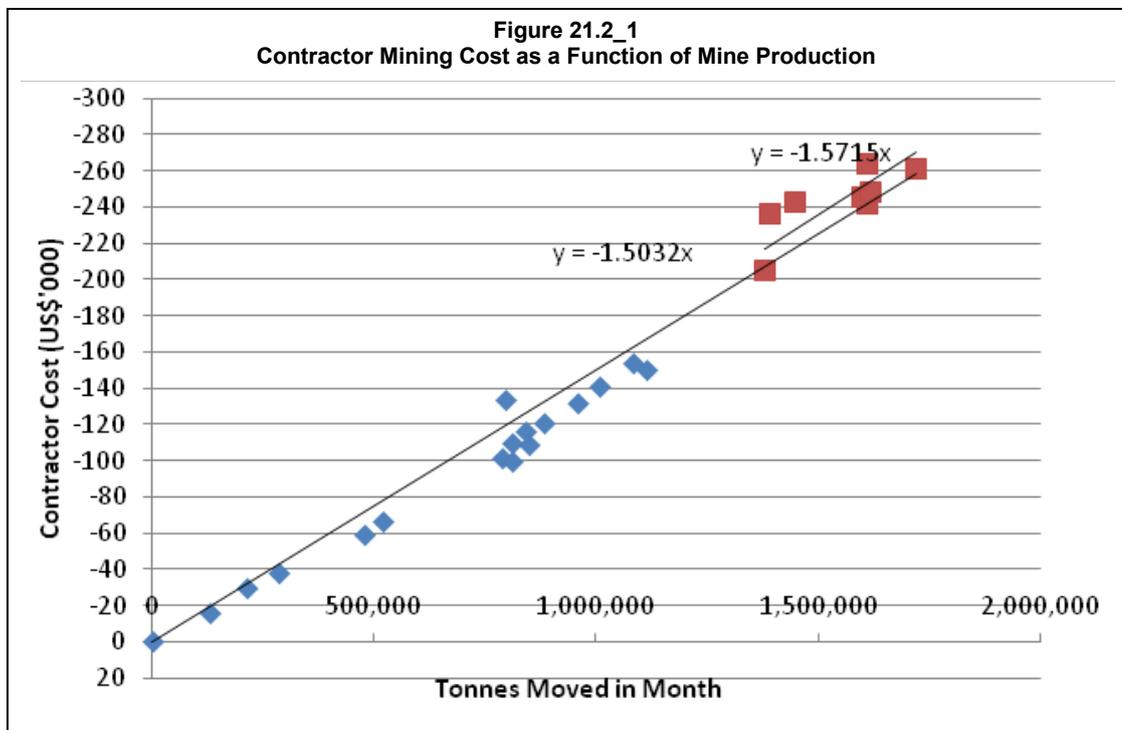
Figure 21.2\_1 shows the degree by which contractor's mining cost vary with production together with the regression equation for the best fit. To avoid an inflationary bias and because of start of mining at the older Pits since August 2010, the relationship for the period since August 2010 is shown separately in red. It shows that the implied unit cost is \$1.57/t.

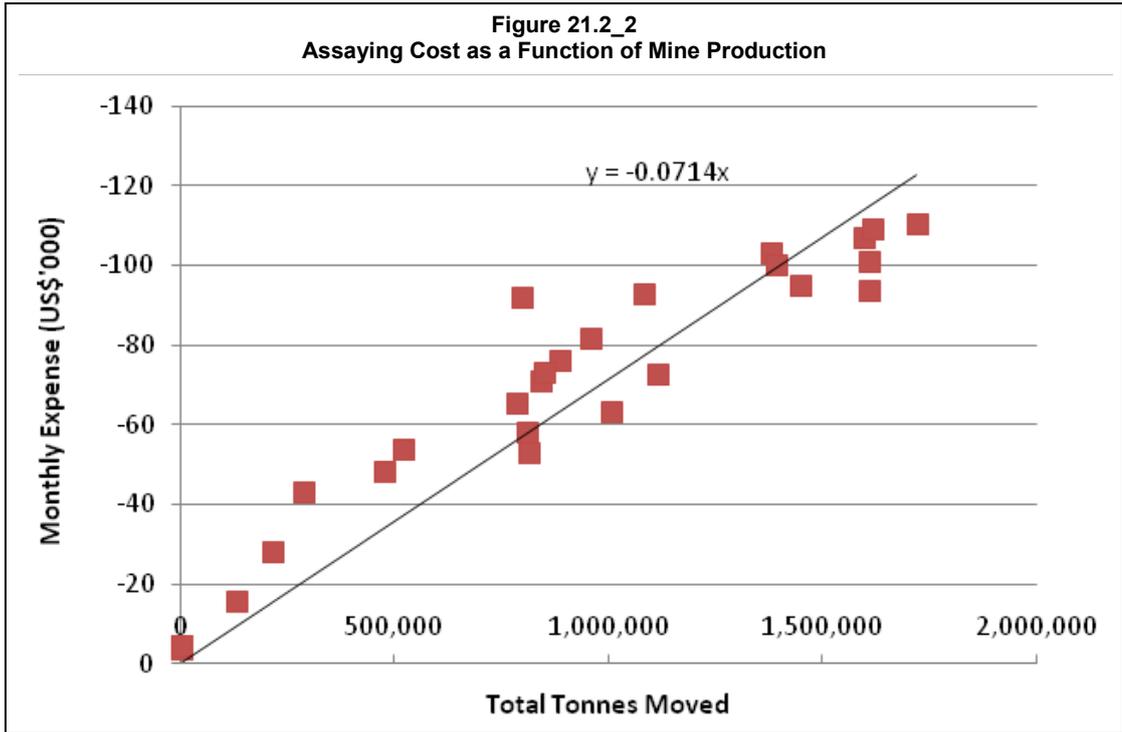
Other mining related costs such as General and Engineering & Geology, are mostly fixed. Laboratory costs, which relate to assays of production samples, are dominantly variable as shown in Figure 21.2\_2.

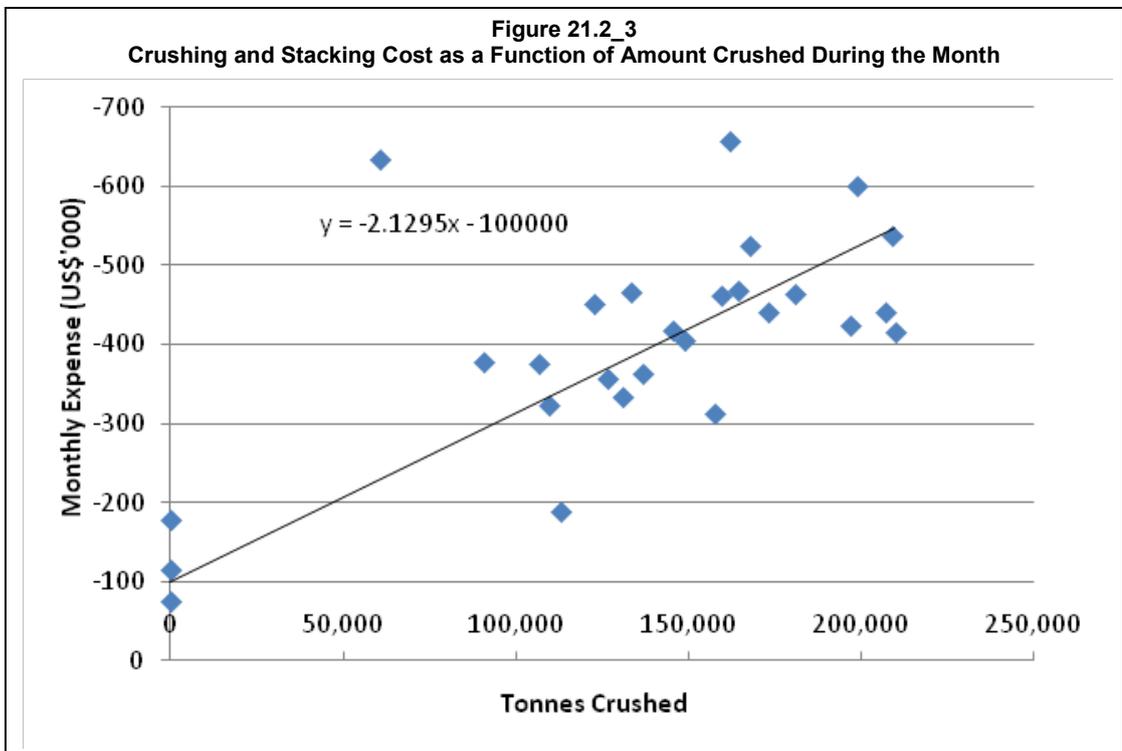
Figure 21.2\_3 shows the degree by which total crushing and stacking cost varies with the amount of material crushed. A fixed cost of US\$100,000 per month is used in the cost model, which is the approximate average cost for the four months when there was no production. The unit crushing cost implied by the regression line is US\$2.13/t treated.

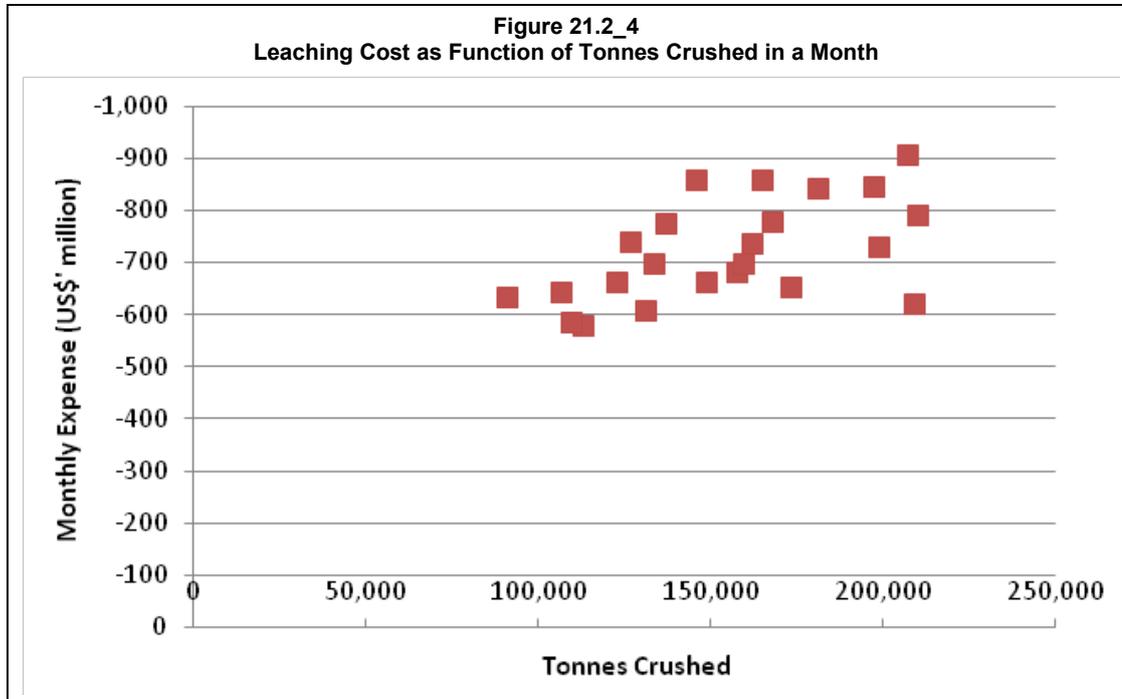
Figure 21.2\_4 shows the degree by which the leaching expenses vary with tonnes crushed in a month. However, because cyanide consumption is a function of both ounces of gold produced and tonnes of ore stacked, no simple relationship can be used and a more fundamental approach to estimating its cost was made.

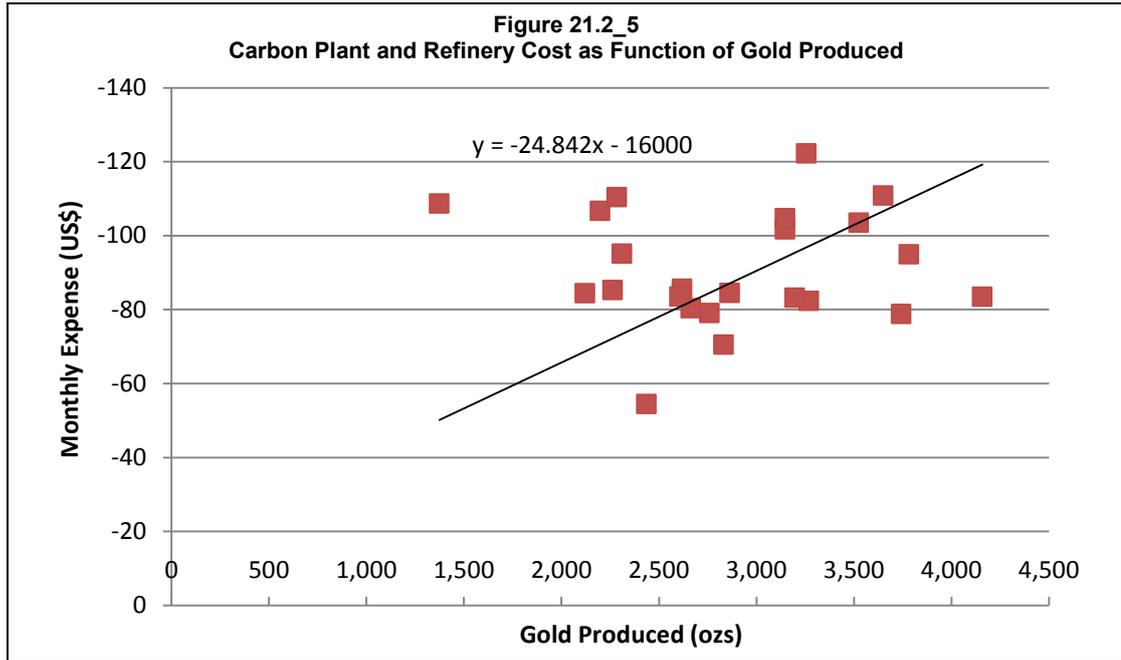
Cost for the carbon plant and refinery are determined by the amount of gold produced with Figure 21.2\_5 presenting the relationship. The intercept of the regression line has been set to US\$16,000 as this is the known monthly staffing cost.

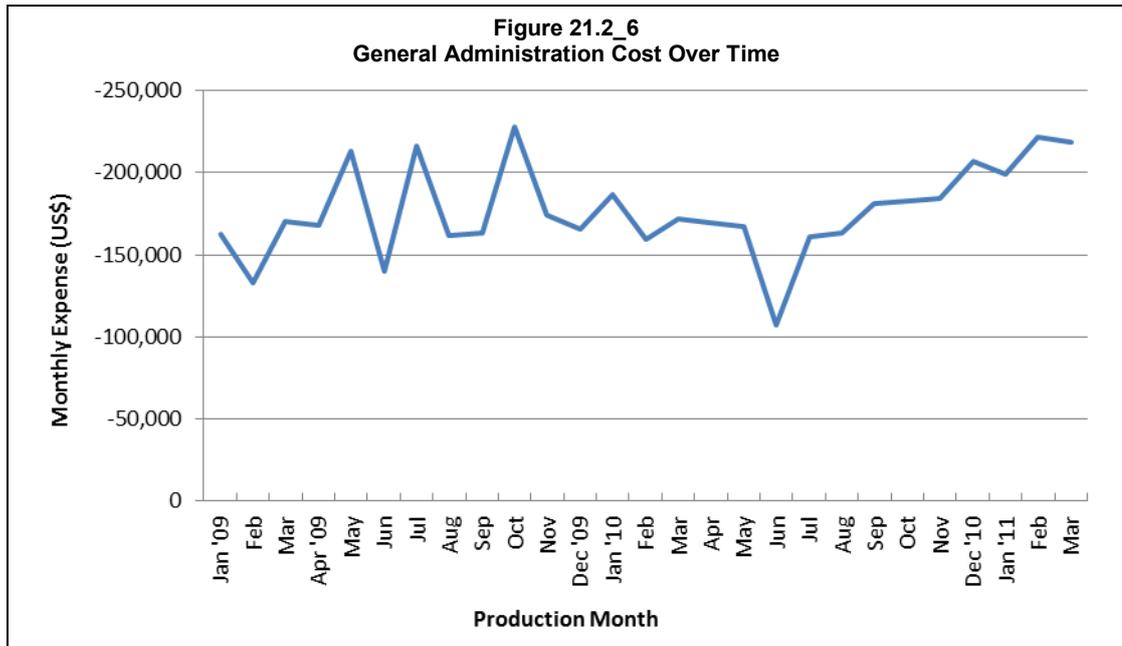
General and Administration costs are generally fixed in nature, but when plotted over time (see Figure 21.2\_6), it is evident that the latest nine months shows a clear upward trend in US Dollar terms, which is a combination of small inflationary increases, but more importantly a weakening of the US Dollar versus the Chilean Peso. The March cost of US\$220,000 is therefore a reasonable reflection of General and Administration Cost going forward, assuming no further change in the exchange rate. As from the cessation of mining and crushing/stacking activities, this cost item has been estimated to drop by 40%.

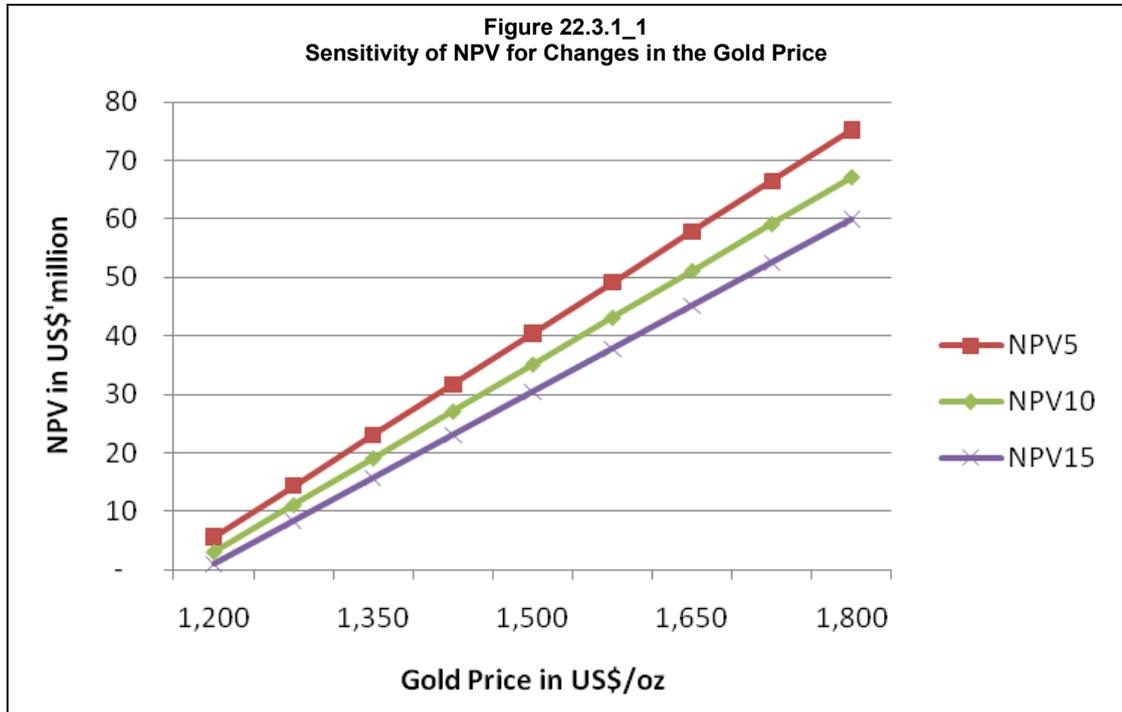
The sensitivity of the financial return and payback periods have been tested for changes in long term gold price, plant feed grade, cash operating cost and capital expenditure plus closure cost. Figure 22.3.1\_1 shows the change of the Net Present Value at discount rates of 5% (“NPV<sub>5</sub>”), 10% (“NPV<sub>10</sub>”) and 15% (“NPV<sub>15</sub>”) for changes in the gold price.

The diagram shows that the gold price has to drop to less than US\$1,200/oz for the NPV to turn negative.

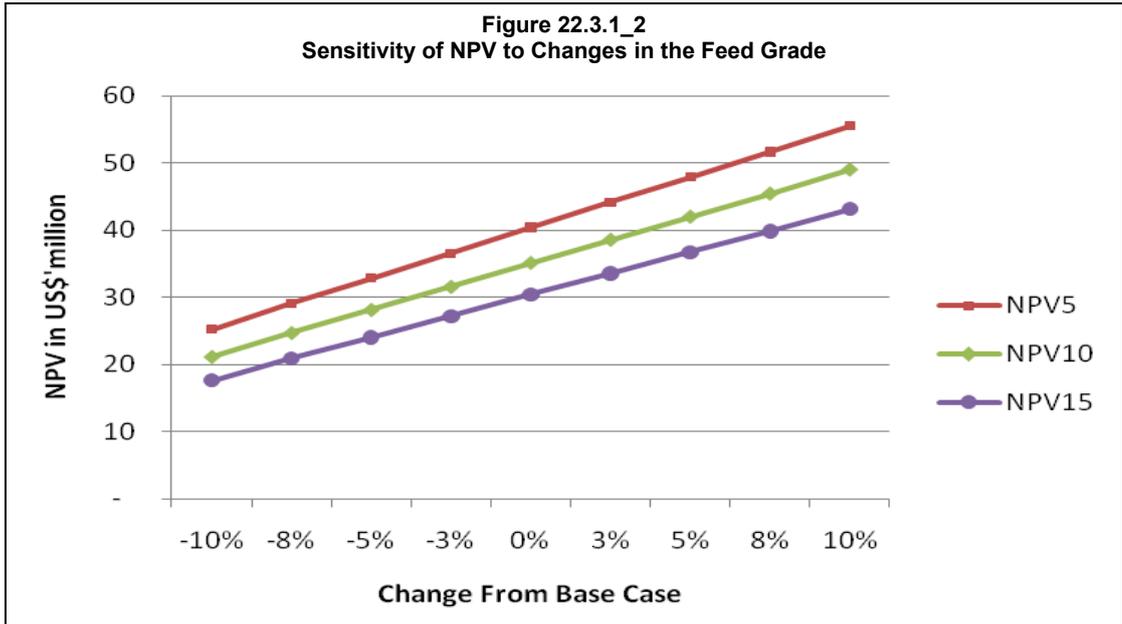
Figure 22.3.1\_2 gives the sensitivity of the NPV as a function of the feed grade, showing that for a drop of 10% in the contained gold in the plant feed the NPV<sub>10</sub> drops to approximately US\$15 million to US\$25 million.

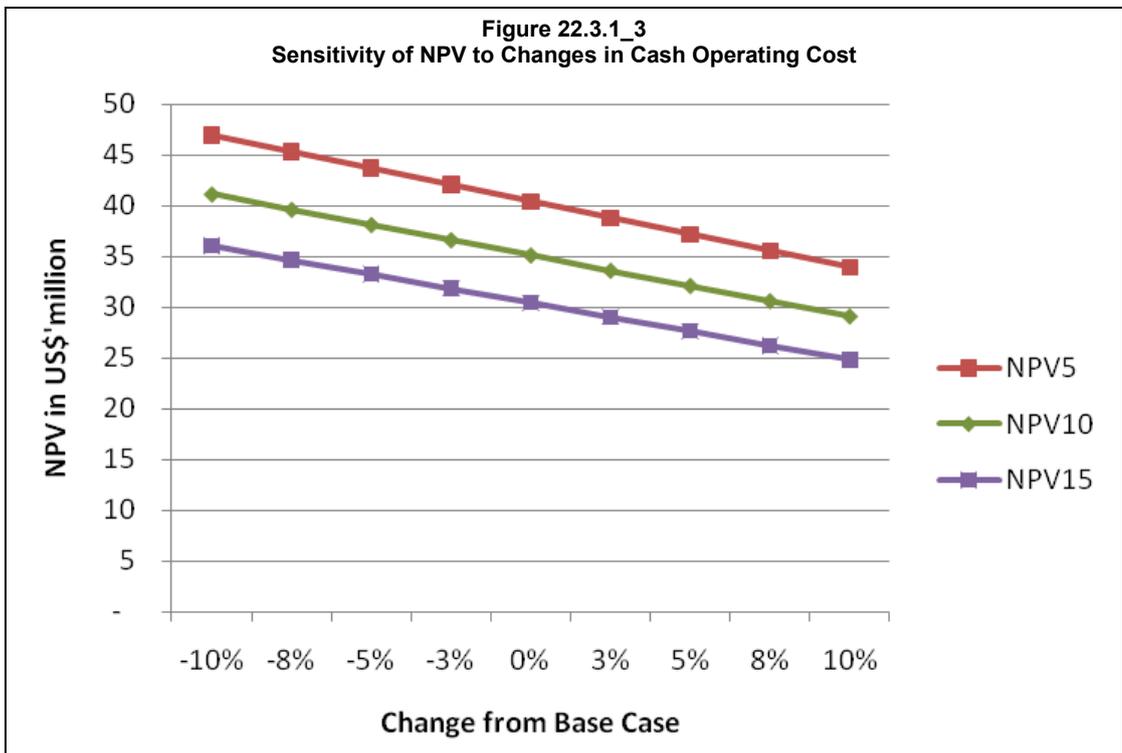
Figure 22.3.1\_3 gives the sensitivity of the NPV as a function of the cash operating cost.

The diagram illustrates that for a change of 10% from the base cash operating cost, the NPV<sub>10</sub> remains strongly positive at US\$29 million. Coffey Mining considers that any increase in cyanide price would be less than the overall cash cost increase of 10% and is therefore accounted for in the sensitivity analysis.

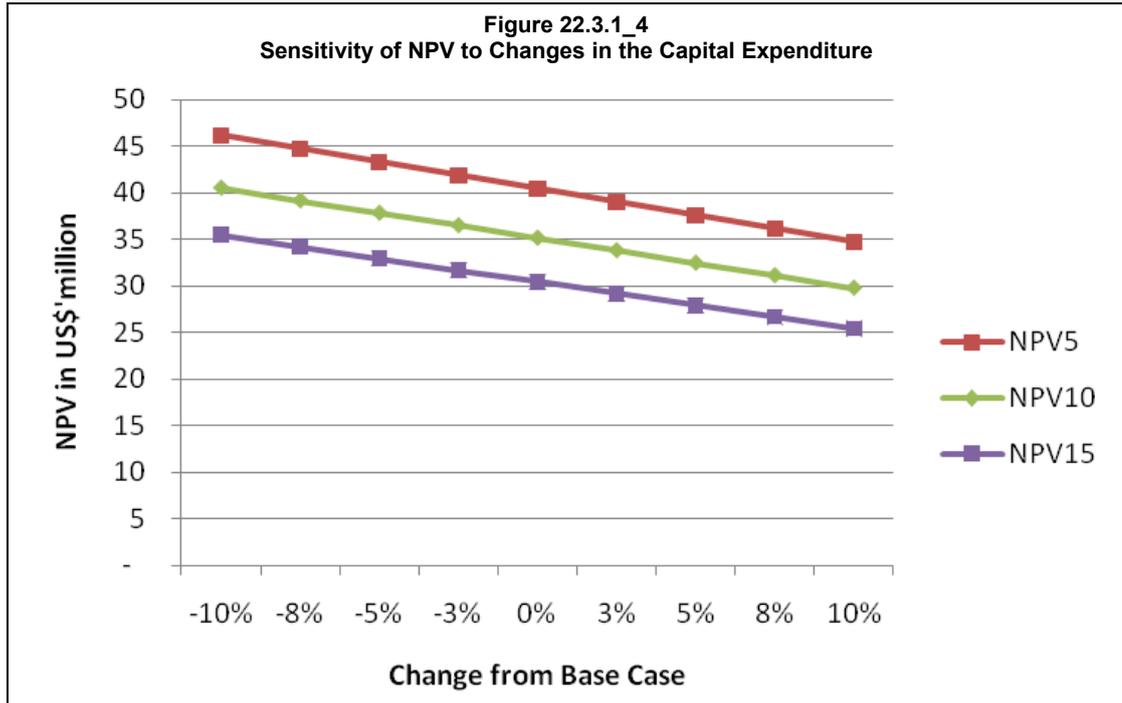
Figure 22.3.1\_4, which shows the sensitivity of the NPV for changes in the capital expenditure and closure cost, illustrates that the project is relatively insensitive to capital outlays. This is because the project requires relatively low capital expenditure over the remaining life of mine.

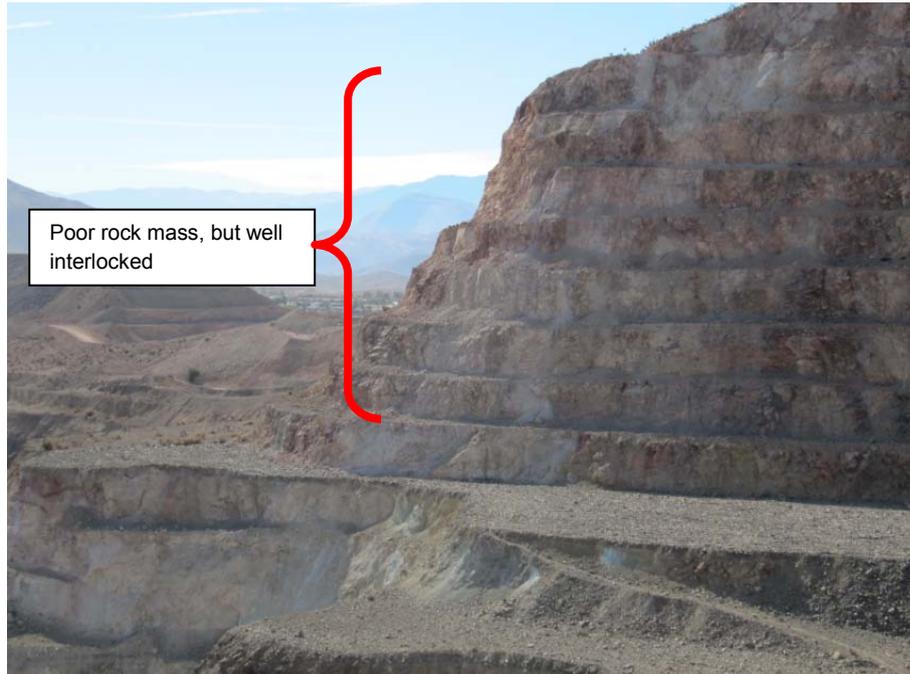
- **Churrumata:**
  - i. Surface to 70m GSI ~ 40 (poor to fair rock mass), though the rock mass appears to be of poor quality, it should be noted that on the overall slope scale it appears to be mechanically well interlocked, i.e. no large scale stability issues;

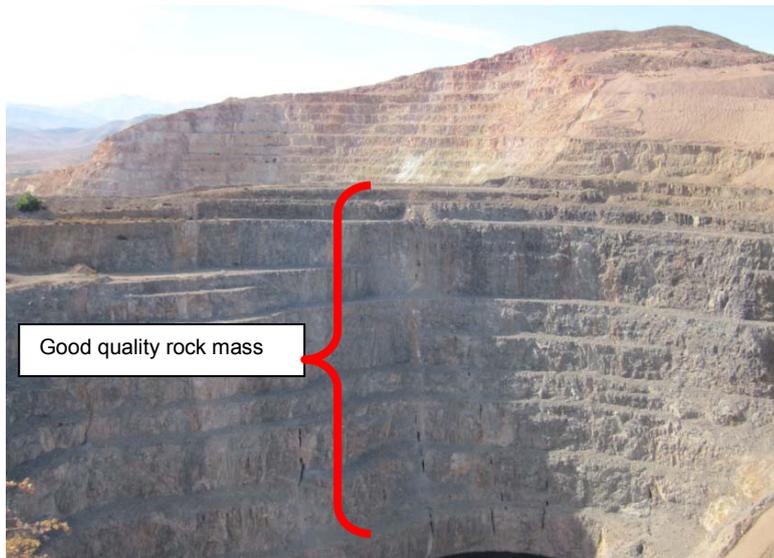
- ii. 70m to pit bottom GSI ~ 50 (fair to good rock mass), the rock mass here was able to sustain a number of small workings created by illegal miners. No sloughing or degradation proximate to these workings were visually noted.
