**CMD Gold Mine, Andacollo, Chile**  
**Independent Technical Report**

**Lachlan Star Resources**

Effective Date: 1<sup>st</sup> April 2012

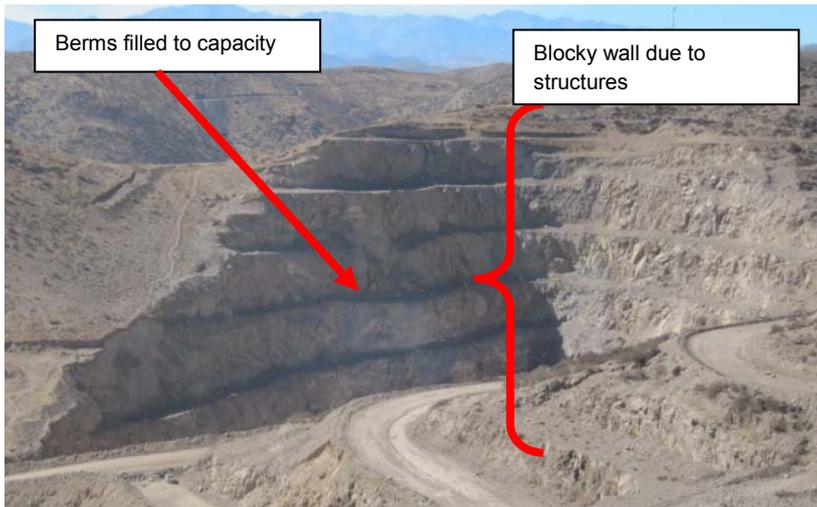
- **Chisperos** – Currently a starter pit has not been developed to the extent where noteworthy observations could be made.
- **Las Loas** - GSI ~ 40 (poor to fair rock mass). The poor quality of the rock mass is poor primarily due to the presence of closely spaced sub vertical structures and some intense jointing. The rock mass here is not well interlocked and is susceptible to ongoing sloughing type instabilities. A number of berms have been filled to capacity.

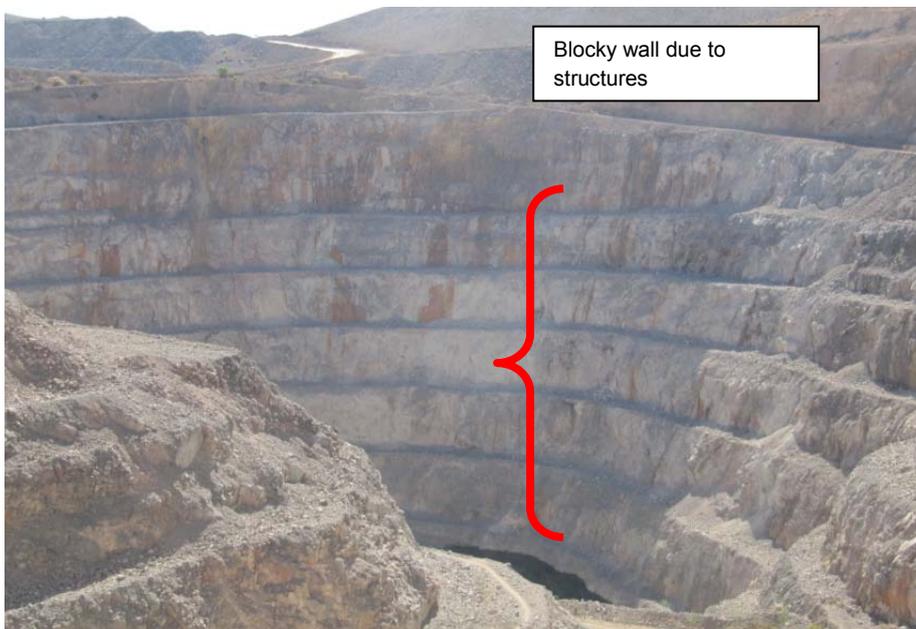
- **Socorro** - Currently a starter pit has not been developed to the extent where noteworthy observations could be made.
- **Toro** – Currently a starter pit has not been developed to the extent where noteworthy observations could be made.
- **Tres Perlas** – The GSI values appear to be fairly constant throughout the pit confines and ranges from about 40 to 45, indicative of a poor to fair rock mass. The poor quality of the rock mass is primarily due to the presence of closely spaced sub vertical structures and some intense jointing.

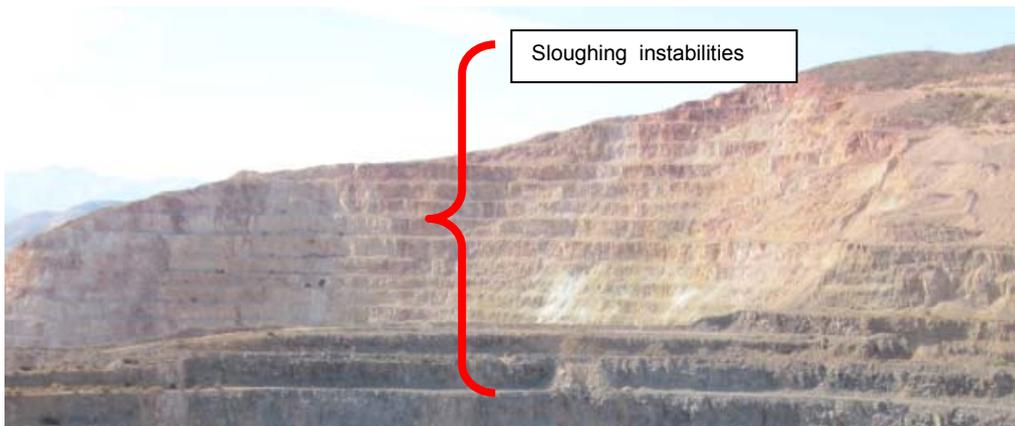
The weathered zone, approximately 70m below surface, has been subject to a number of sloughing failures, this indicates that the material may be somewhat slake sensitive. The fresh zone appears to be competent, apart from some minor rock mass exfoliation, caused by blasting there does not appear to be any noteworthy stability issues.

In some areas within the fresh zone, due to the presence of intense but low persistence jointing, small blocks have been geometrically formed and have become unstable due to blasting & exfoliation; these blocks have however been contained by the berms. There is a possibility that during periods of intense rain, wind or seismicity, these blocks may become a rock fall hazard.

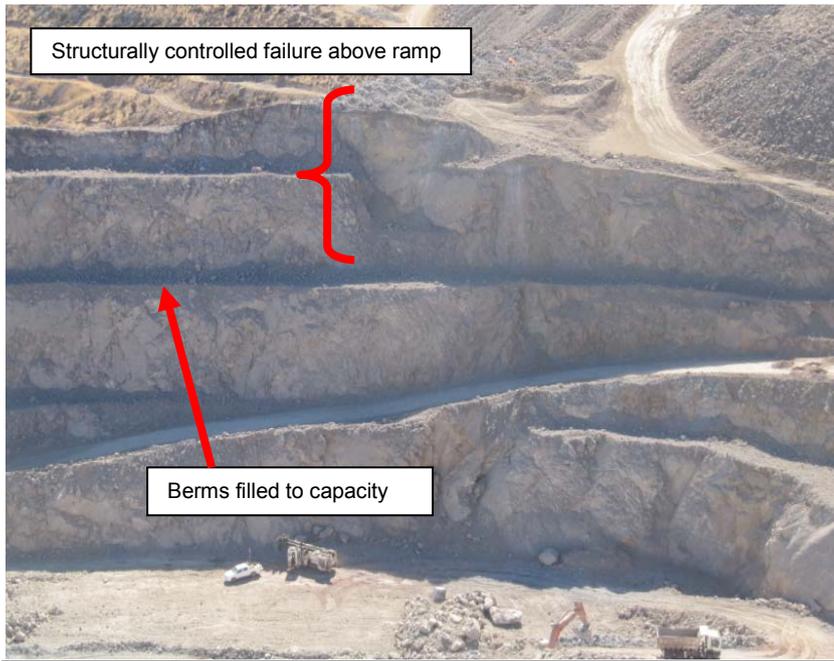
The figure below shows a multi-bench structurally controlled instability. It appears to be a planar sliding instability which has occurred just above an active access ramp. In some areas within the fresh zone, refer to second figure, due to the presence of intense but low persistence jointing, small blocks have been geometrically formed and have become unstable due to blasting; these blocks have however been contained by the berms. There is a possibility that during periods of intense rain, wind or seismicity, these blocks may become a rock fall hazard.

- Two pits (Las Loas and Tres Perlas) have demonstrated that structurally controlled instabilities have the potential to affect the up to multiple benches (up to two). In general terms this can be managed via close monitoring to determine signs of impending failure, however if these failures develop over or under an active access ramp, there is a possibility that access and personnel safety could be compromised. This phenomenon is exacerbated where pit walls have a convex profile i.e. bull noses.

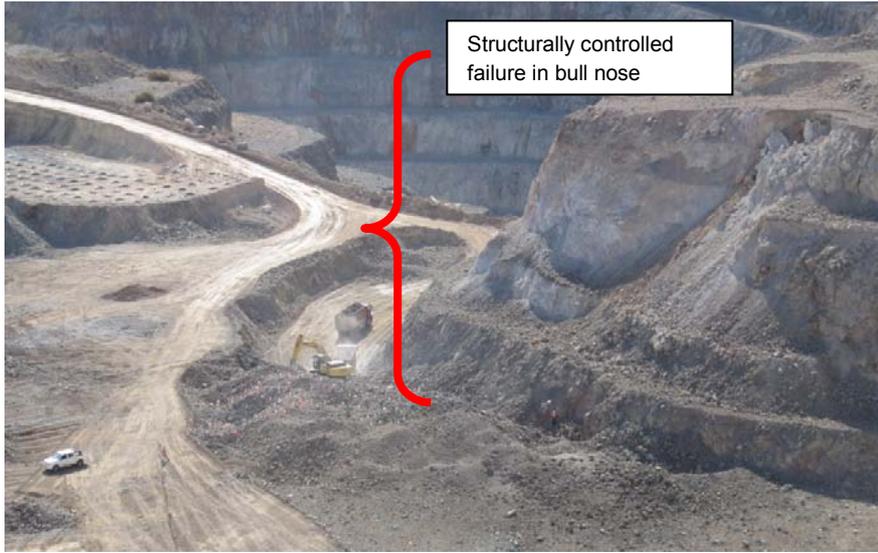
There are a number of batter scale instabilities noted in this pit. The figure below shows a multi-bench structurally controlled instability. It appears to be a planar sliding instability exacerbated by the lack on lateral confinement in the pit wall due to a convex profile i.e. a 'bull nose'.

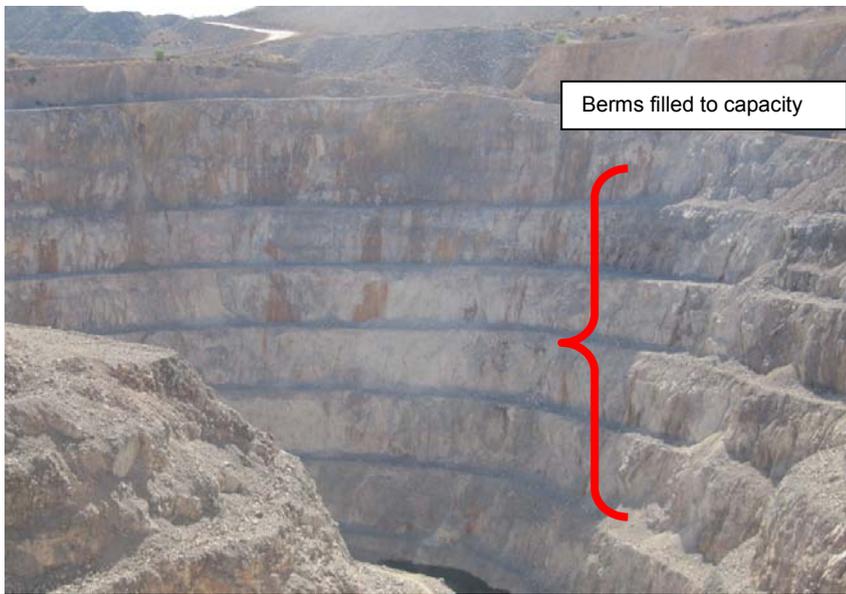
In some areas within the fresh zone, as shown in the next figure, due to the presence of intense but low persistence jointing, small blocks have been geometrically formed and have become unstable due to blasting; these blocks have however been contained by the berms. There is a possibility that during periods of intense rain or wind, these blocks may become a rock fall hazard.

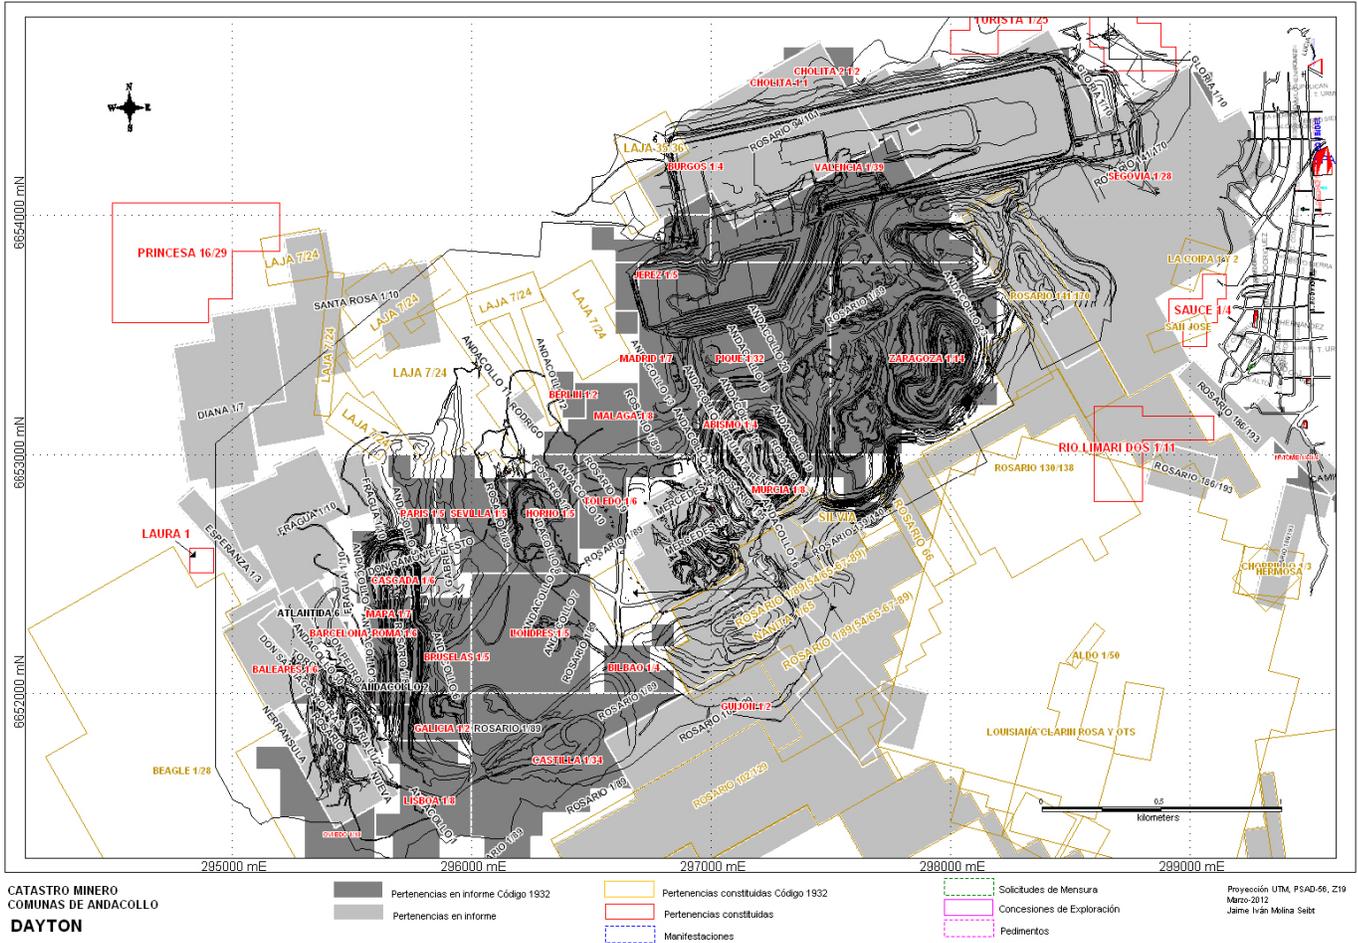
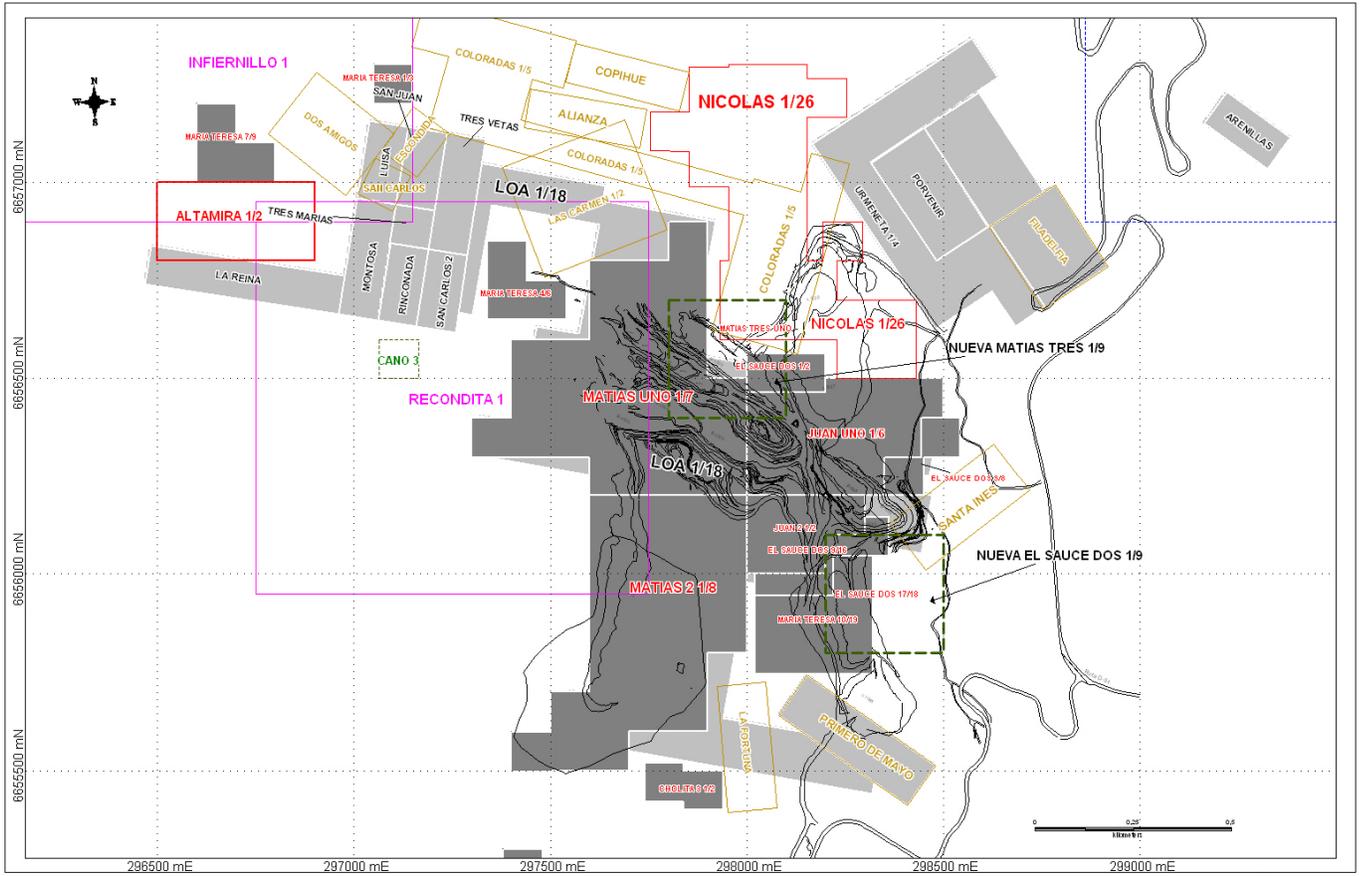
### ANNEX 1.4.3. MINING CONCESSIONS MAPS

**CATASTRO MINERO  
COMUNAS DE ANDACOLLO  
LAS LOAS**

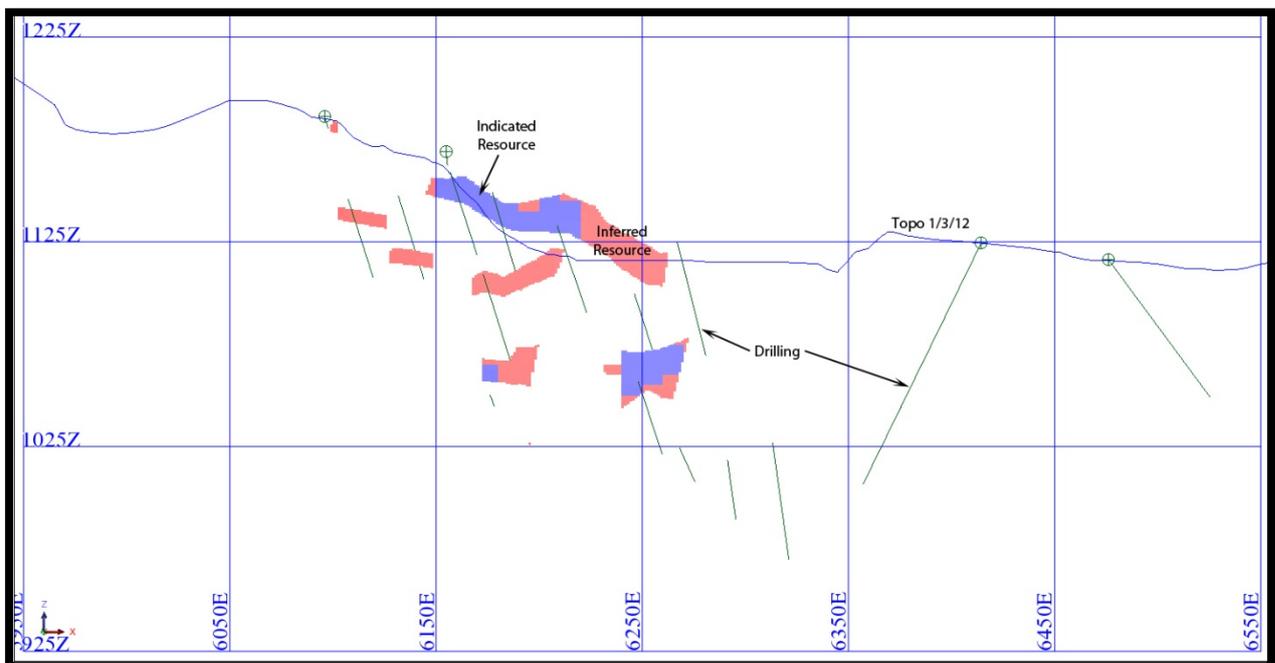
Figure 3.1 – Chisperos Section through 2825mN, looking north

72% of the mine ore tonnage of 141kt was sourced from outside the mine inventory, which in part is due to the proportion of Inferred Mineral Resource mined. The spatial relationship of the mineralisation and drilling that had been completed prior to the estimation resulted in a significant proportion of the resource close to surface being included in the inferred category. This is reflected in the low conversion to Probable Reserve in Table 3.4, and is significant in the relatively poor reconciliation between ore production and the estimate. This is illustrated in Figure 3.1.
