POSITIVE RESULTS FROM INITIAL MULGA BILL METALLURGICAL TESTWORK

Great Boulder Resources (“**Great Boulder**” or the “**Company**”) (ASX: **GBR**) is pleased to announce results from initial metallurgical tests conducted on a sample of high-grade drill chips from the Mulga Bill prospect at the Side Well Gold Project (“**Side Well**”) in Western Australia.

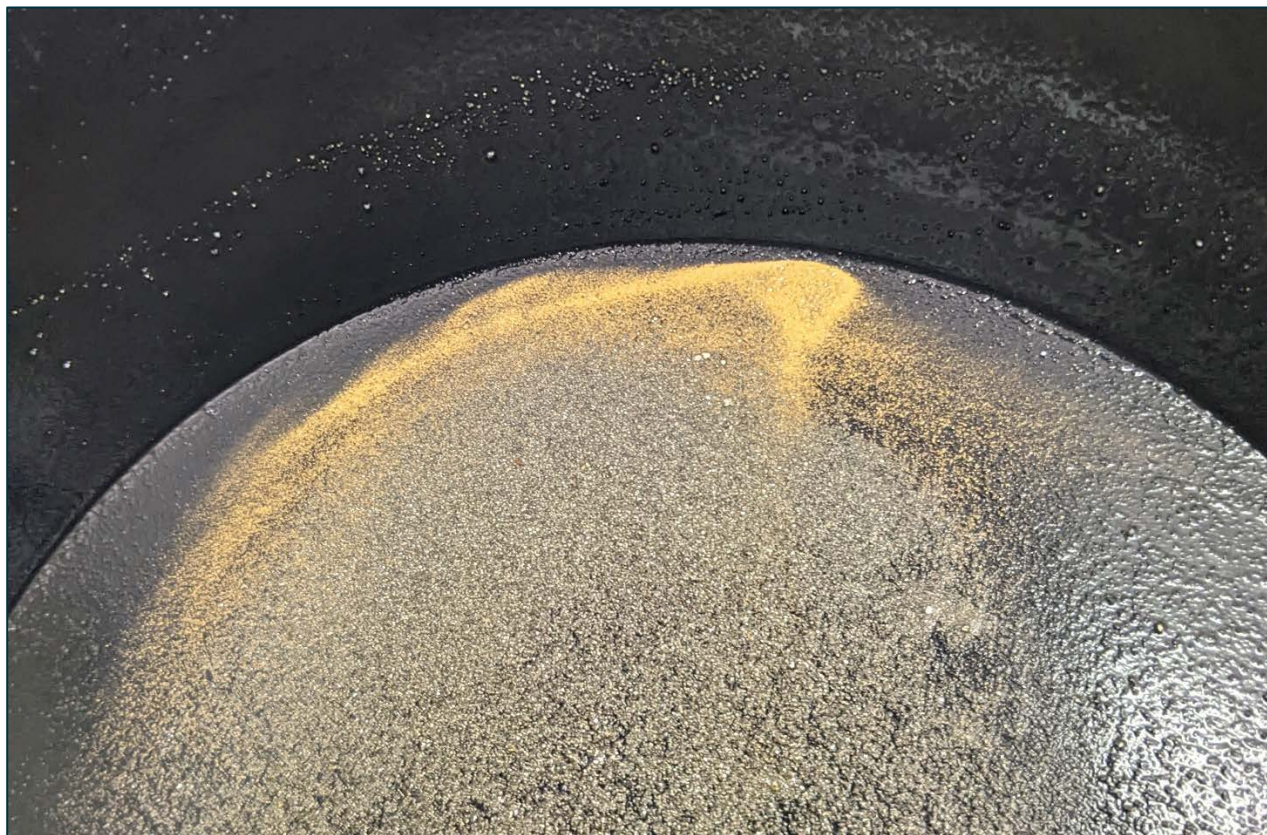
FIGURE 1: GOLD RECOVERED FROM A KNELSON CONCENTRATOR AT 300UM GRIND SIZE (PHOTO CREDIT: IMO).

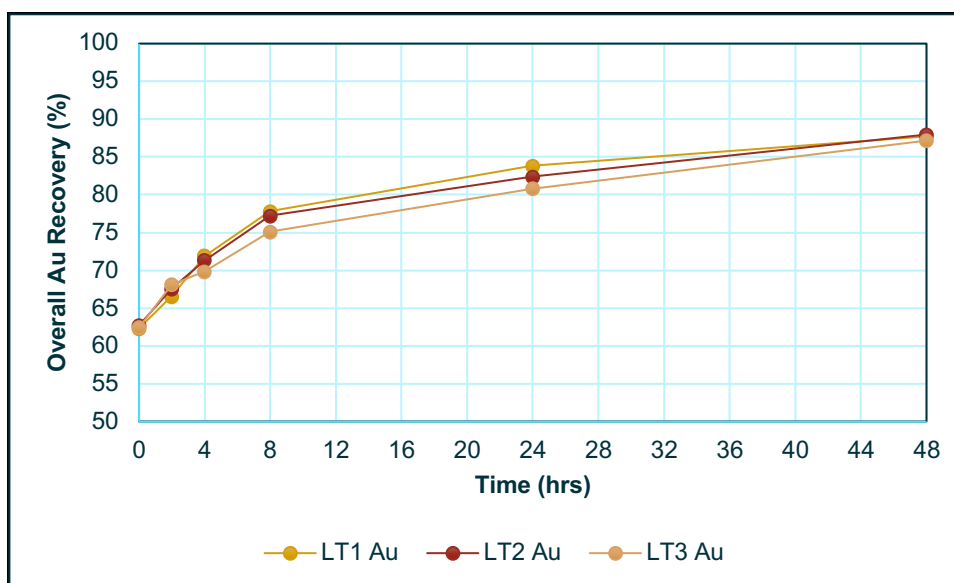
FIGURE 2: GOLD RECOVERIES WERE RELATIVELY CONSISTENT INDEPENDENT OF GRIND SIZE

TABLE 1: SUMMARY STATISTICS FROM 3 LEACH TESTS (AU ONLY)

Gold Summary		
		LT1	LT2	LT3
Grind Size	µm	150	106	75
CN Conc	ppm	500/300	500/300	500/300
Gravity Recovery	%	62.3	62.7	62.4
2 Hour Recovery	%	66.6	67.6	68.1
4 Hour Recovery	%	71.9	71.3	69.8
8 Hour Recovery	%	77.8	77.2	75.1
24 Hour Recovery	%	83.8	82.4	80.8
48 Hour Recovery	%	87.7	88.0	87.2
Calculated Head Grade	g/t	35.95	35.84	36.17
Assayed Head Grade	g/t	39.47	39.47	39.47
Residue Grade	g/t	4.41	4.31	4.64
Gravity Recovery	%	62.3	62.7	62.4
Gravity Recovery	g/t	22.40	22.48	22.58
Leach Recovery	g/t	9.13	9.05	8.95
Total Recovery	g/t	31.54	31.53	31.53
24 Hour Cyanide Cons	kg/t	0.82	0.79	1.05
48 Hour Cyanide Cons	kg/t	0.94	0.94	1.05
24 Hour Lime Cons	kg/t	0.24	0.15	0.20
48 Hour Lime Cons	kg/t	0.24	0.15	0.20
