PIKE RIVER COAL

PIKE RIVER COAL VENTILATION SHAFT ROCK FALL BEING REMEDIED

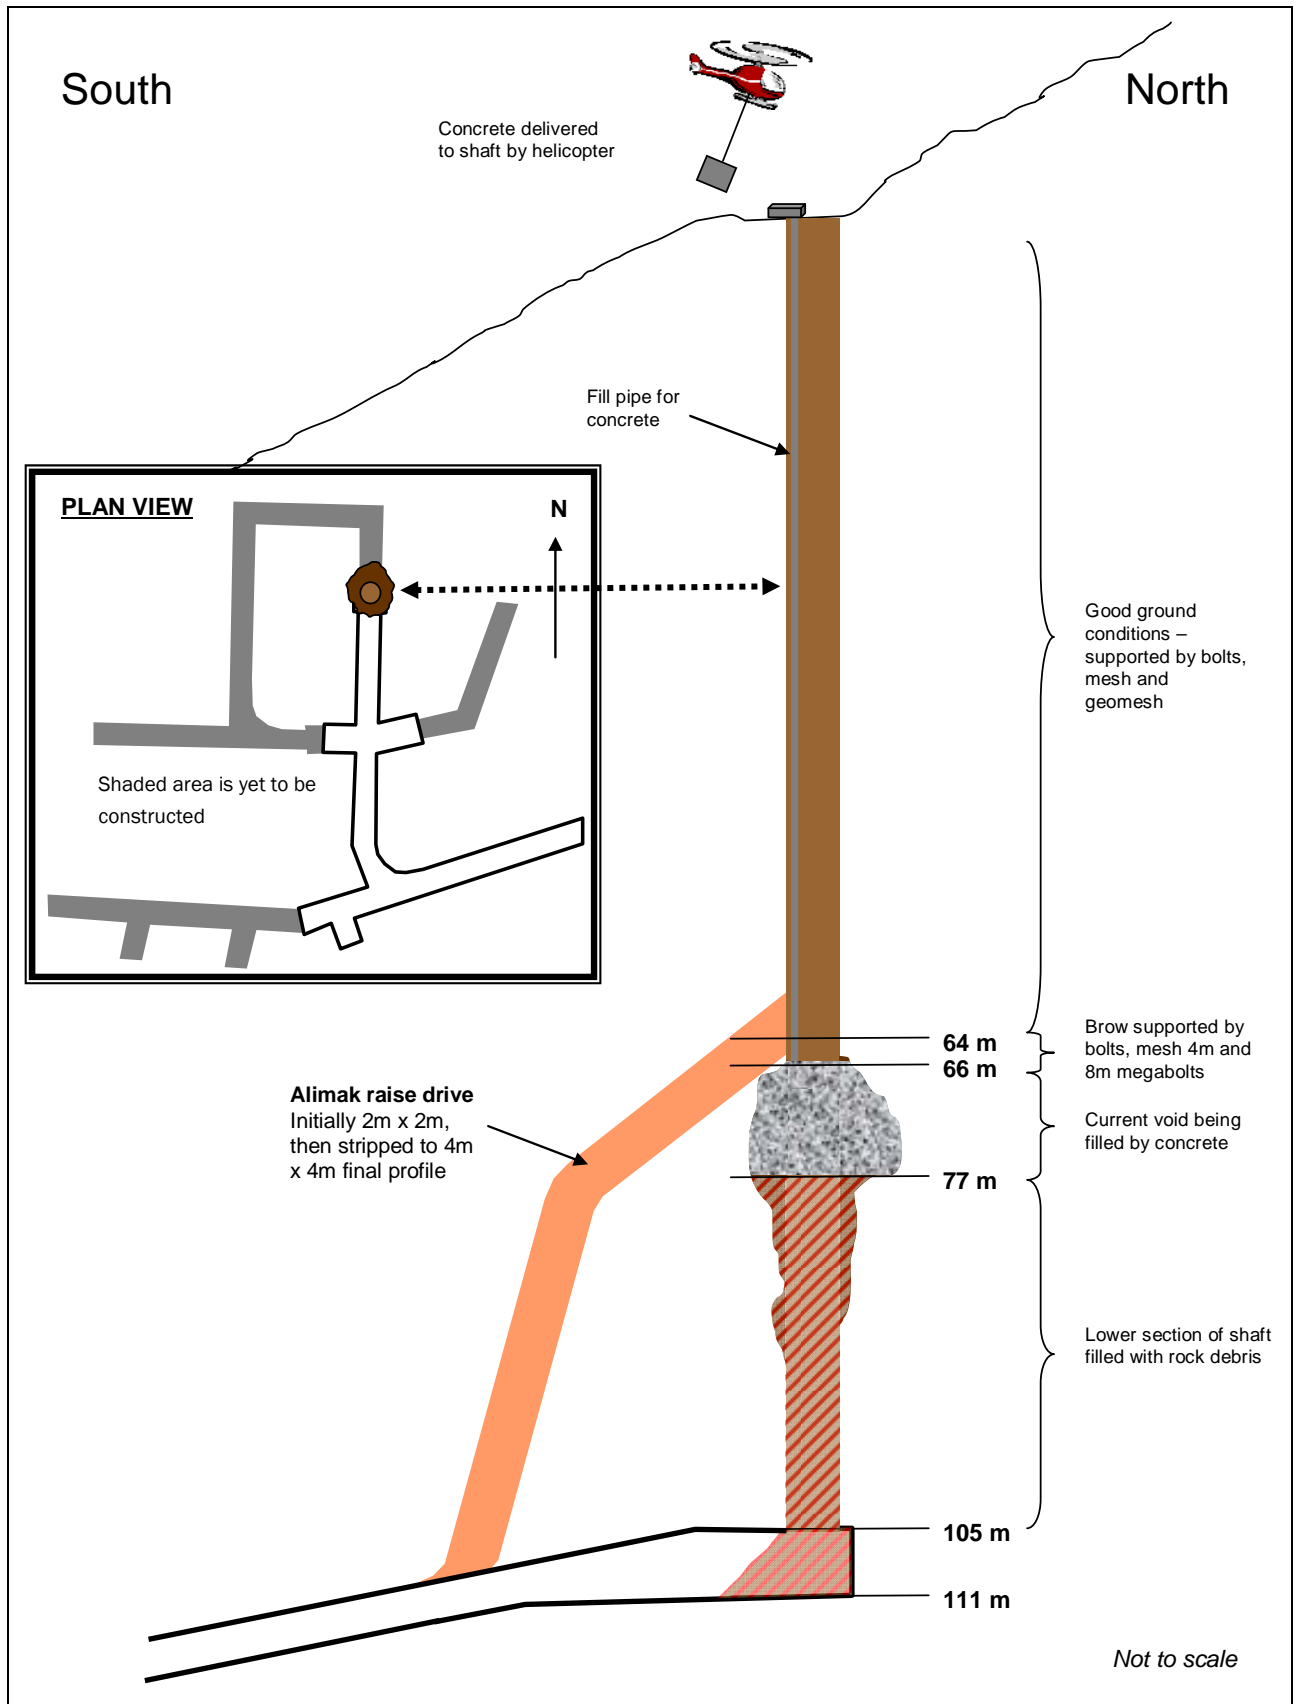
Cross-section and Plan View of Ventilation Shaft

The top 66 metres of the shaft was successfully supported and stabilised, prior to a rock fall affecting a zone of nearly 30 metres near the bottom of the ventilation shaft. This rock fall has blocked ventilation to the mine from the shaft, delaying mining operations underground until ventilation is re-established. The shaft is critical to venting mine air and gases to the surface and providing fresh air to the mine face for mining to operate safely.

It is expected that the bottom part of the shaft will be remedied by raising an angled drive from the tunnel using the "Alimak" method to intersect the main shaft at about 40 metres above its base. A contractor will be promptly mobilised from Australia to undertake this driveage. In the meantime, there is only enough ventilation for limited pit bottom development operations, although alternatives for getting more air into the mine are being investigated.

Pike River Coal is investigating alternative methods of remedying the problem to reinstate ventilation from the shaft. One step already underway to ensure the top 66 metres of the shaft is protected, is to fly concrete in by helicopter and pipe it down the shaft to fill a cavity at the top of the rock fall.
