12 March 2010

## **TAMBO PROJECT MARKET UPDATE**

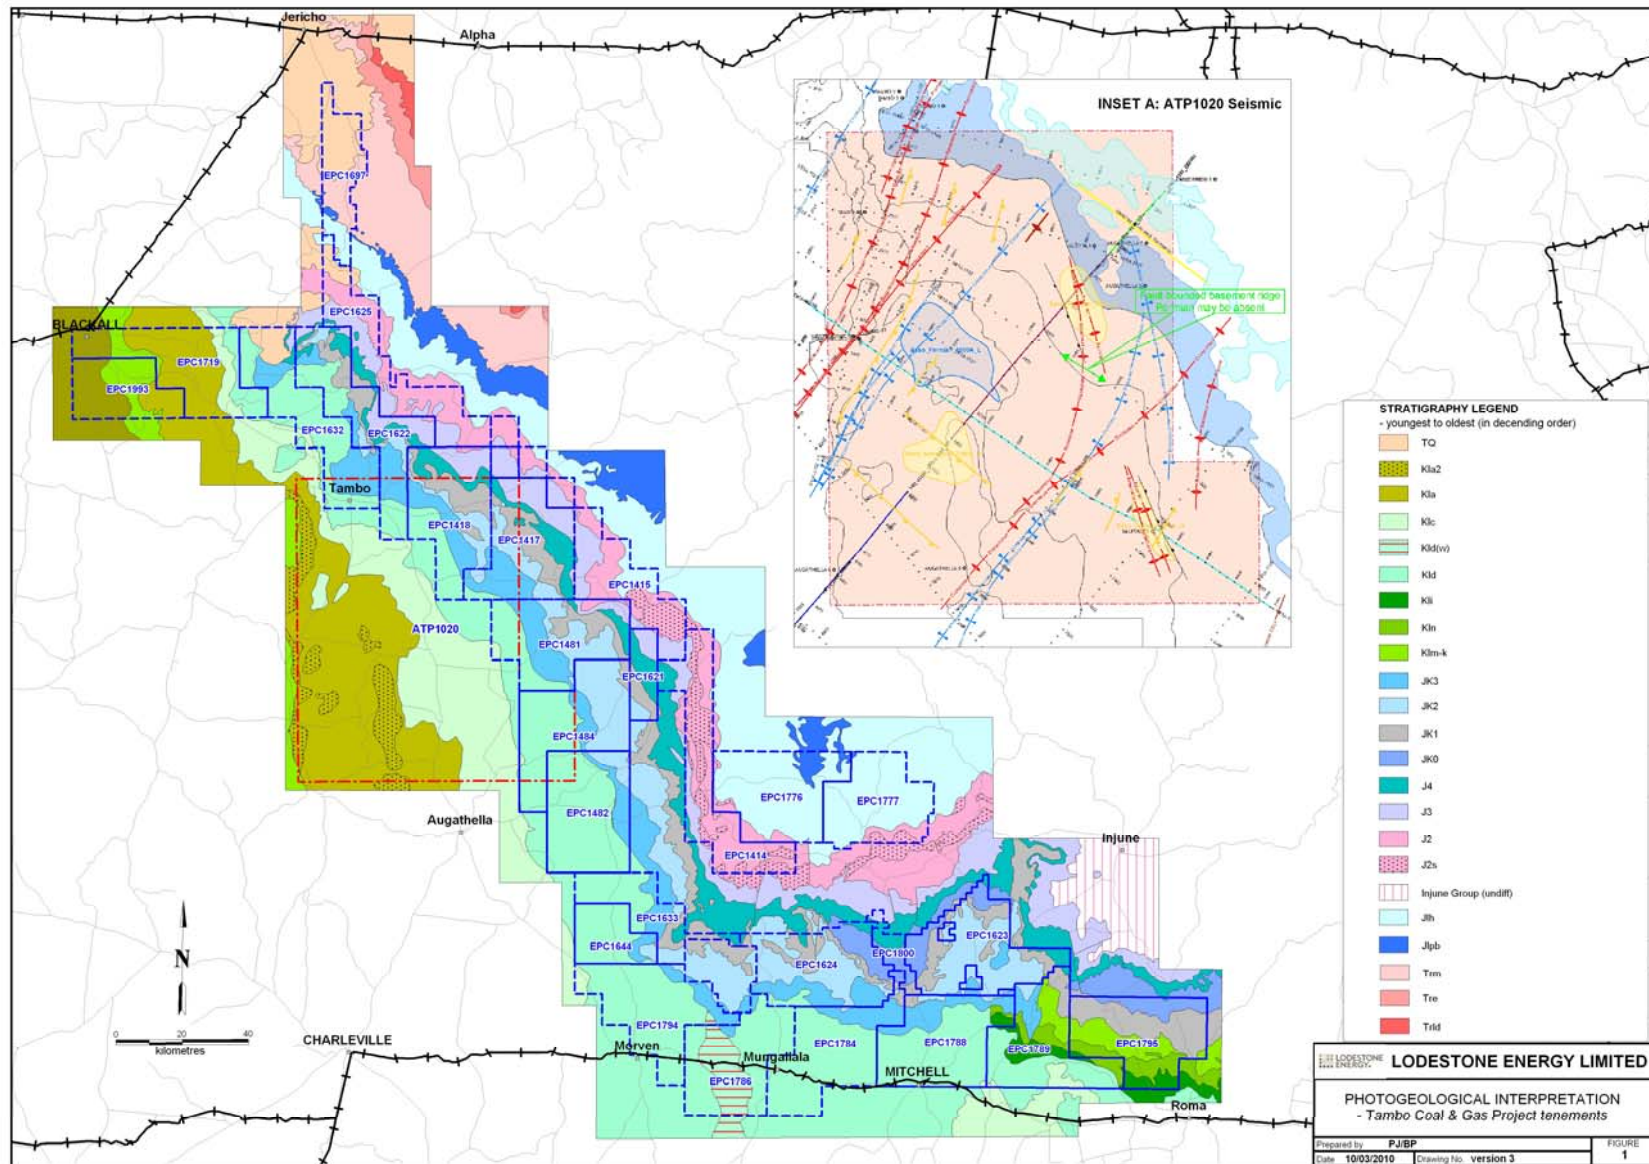
Figure 1 outlines these areas of heightened interest, the photogeology and seismic work (as an inset).

Figure 1: Photogeological Interpretation

The photo-geological work, which extended from Roma to Blackall, corrected numerous errors in the published maps compiled in the late 1960's and provided insight into the structural controls active during deposition of the important coal sequences.

Reprocessing of old data tapes from pre-existing seismic data in and near ATP 1020, enabled recovery of the higher level records traditionally deleted in old report presentations. This work revealed the shallower sequences for the first time, improving the company's understanding of the structural controls, and providing sound evidence for further drill targets within the ATP.

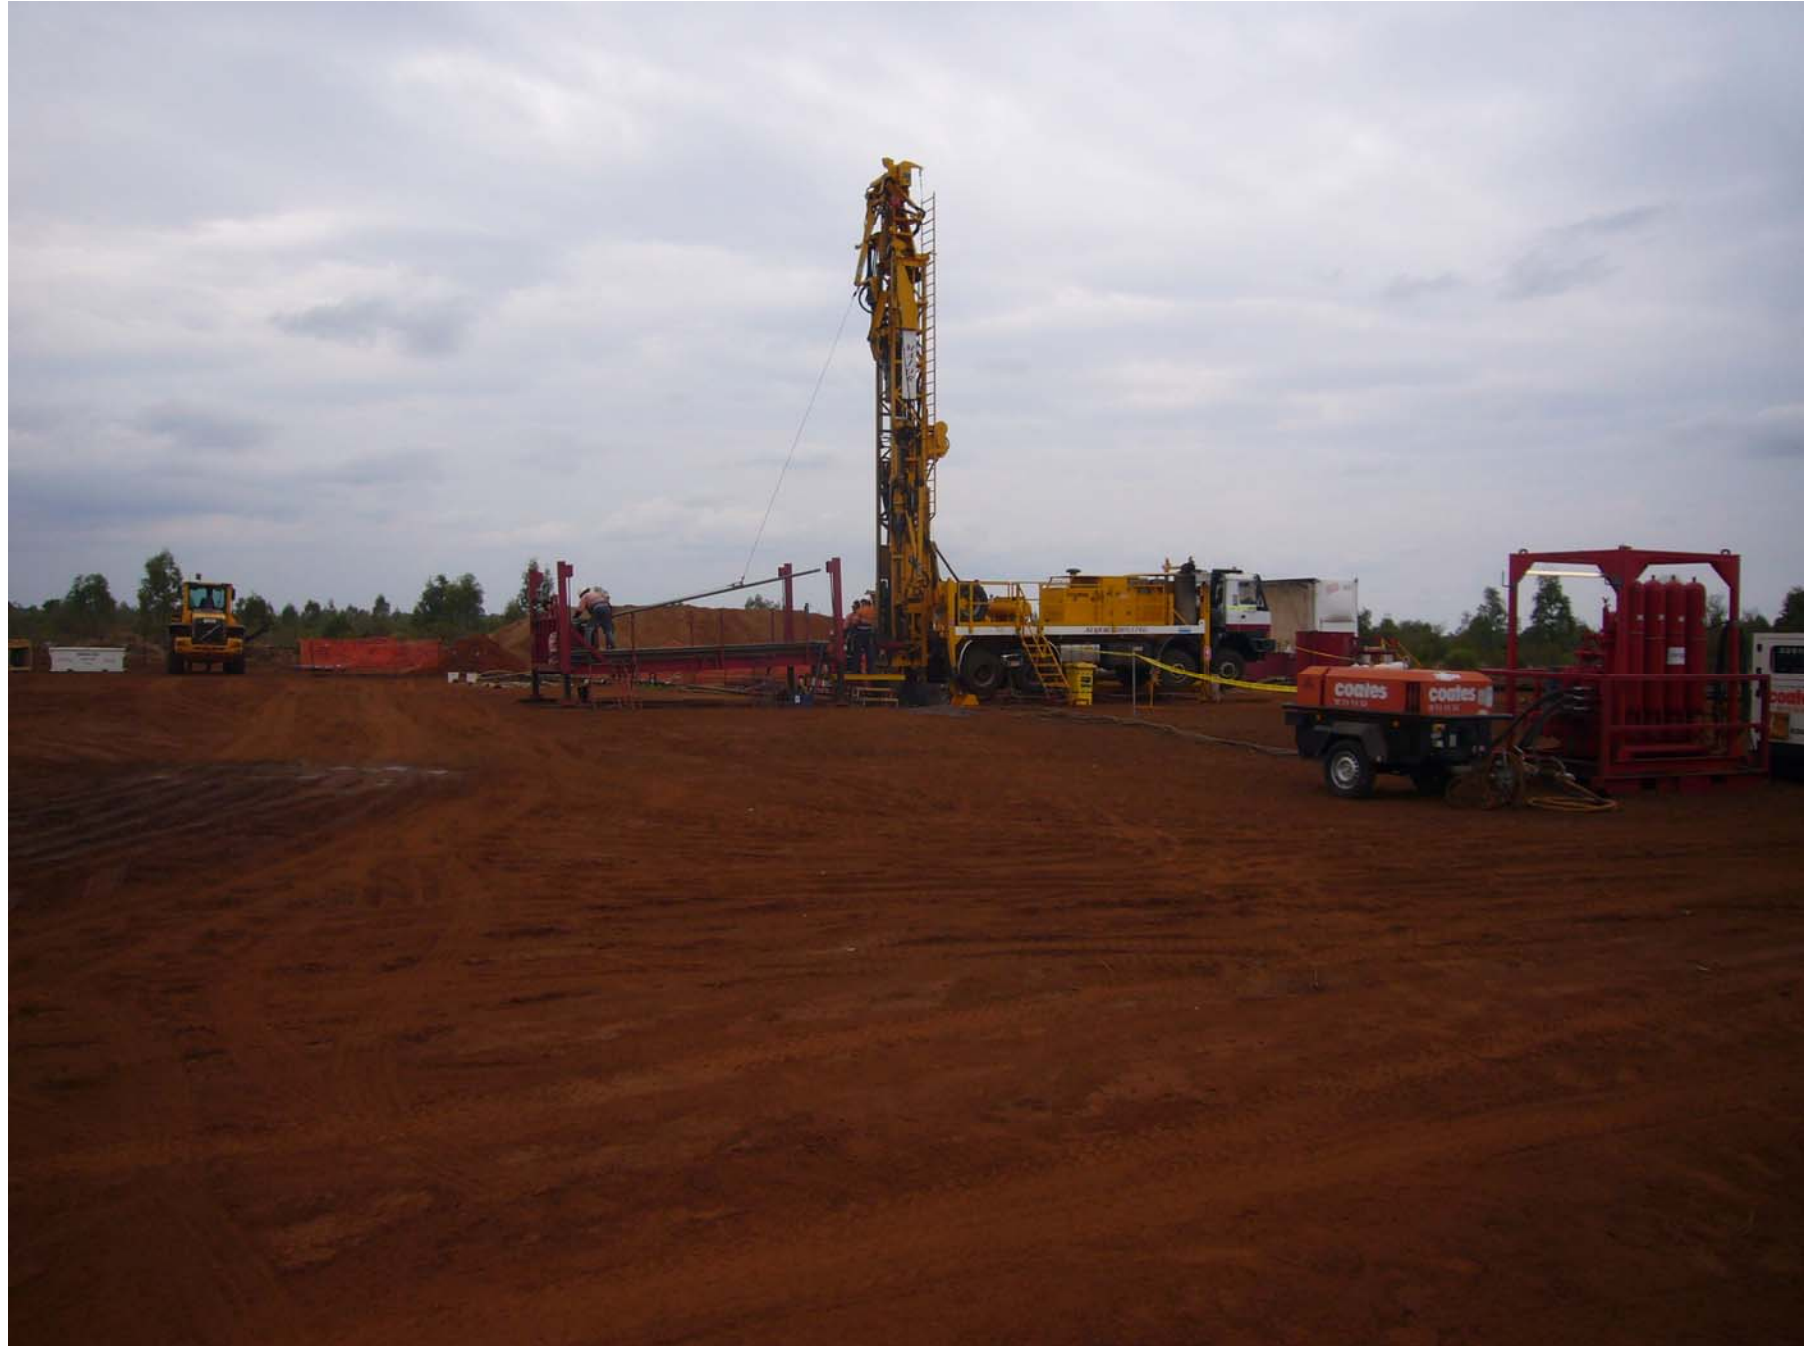
Figures 2 & 3 show drilling rigs at work in ATP 1020 and EPC 1623 during recent months.

Figure 2: Working Rig – ATP 1020

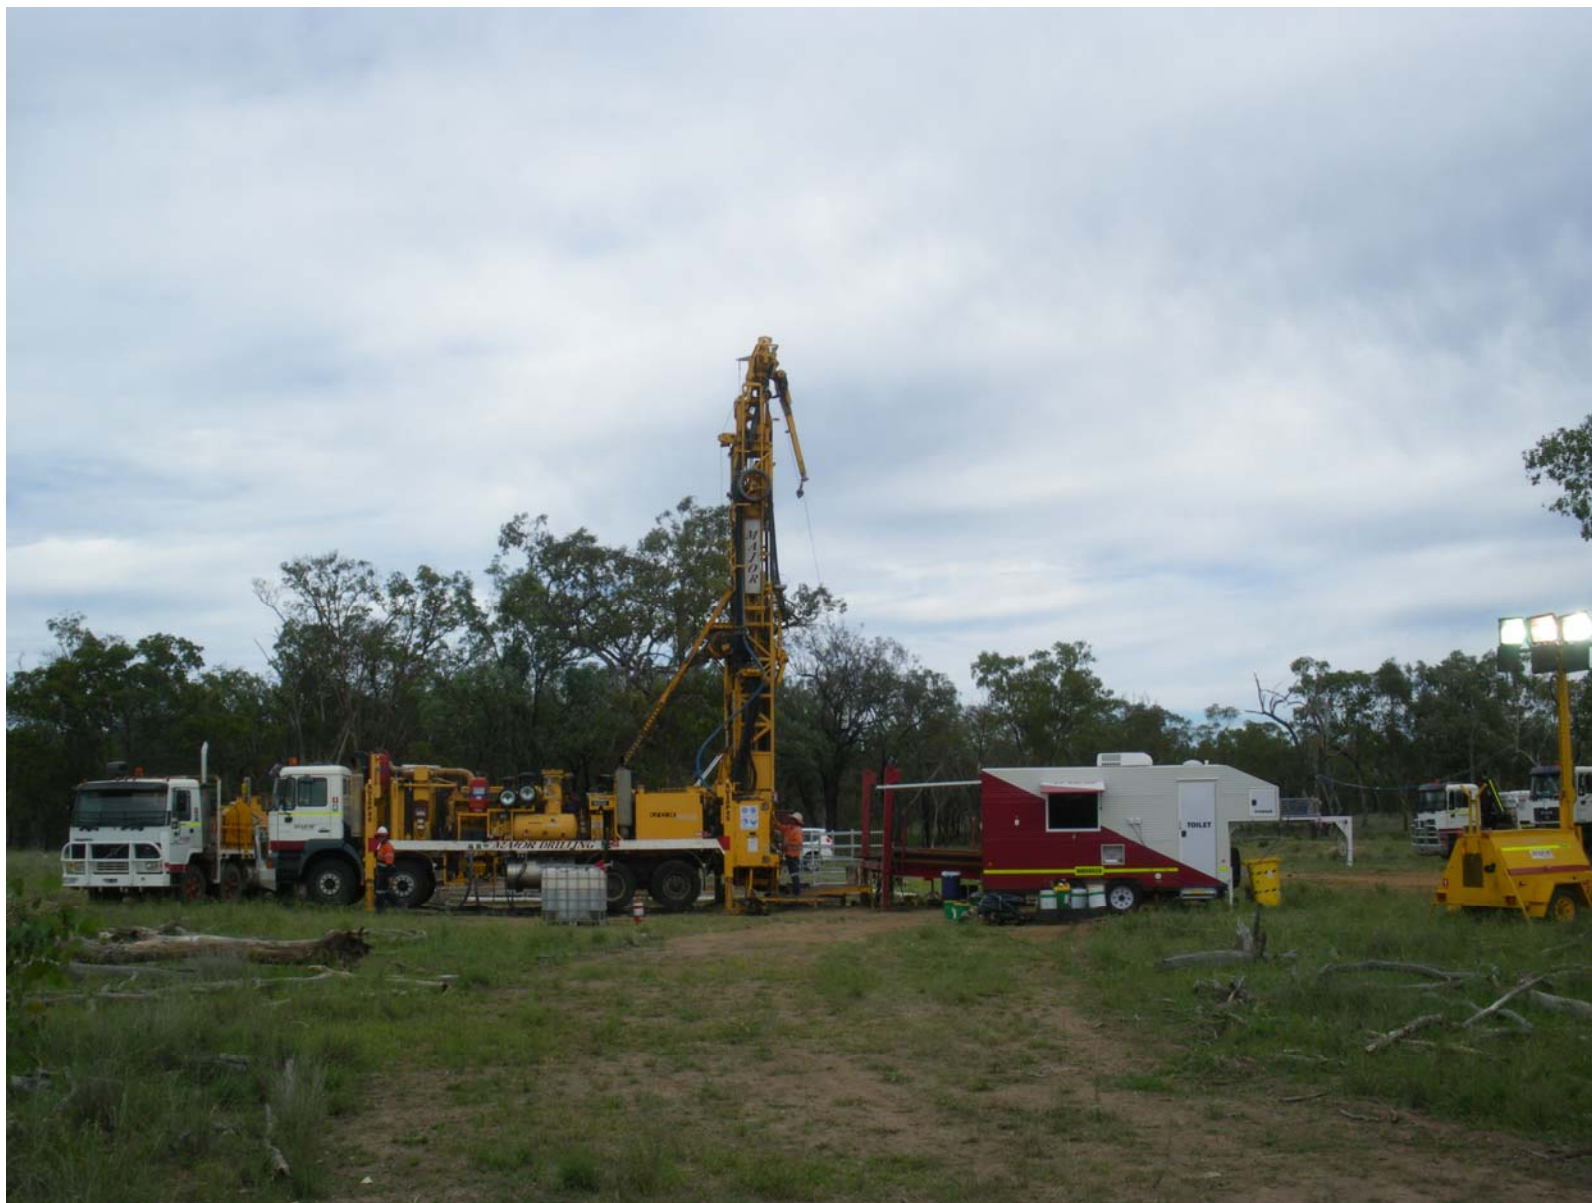
Figure 3: Working Rig – EPC 1623
