LION ONE: TUVATU GOLD MINE CONSTRUCTION IS 75% COMPLETE

North Vancouver, B.C., June 29, 2023 - Lion One Metals Limited (TSX-V: LIO) (OTCQX: LOMLF) (ASX: LLO) ("Lion One" or the "Company") is pleased to provide an update on construction progress at its 100% owned Tuvatu Alkaline Gold Project in Fiji.

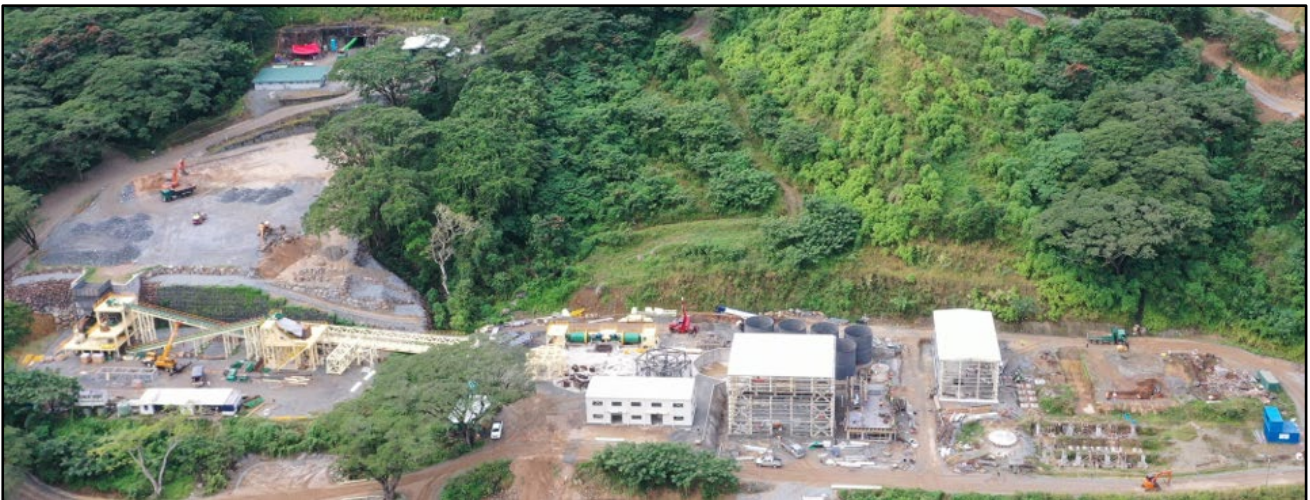
Figure 1. Tuvatu Gold Mine Under Construction. See below for additional images.

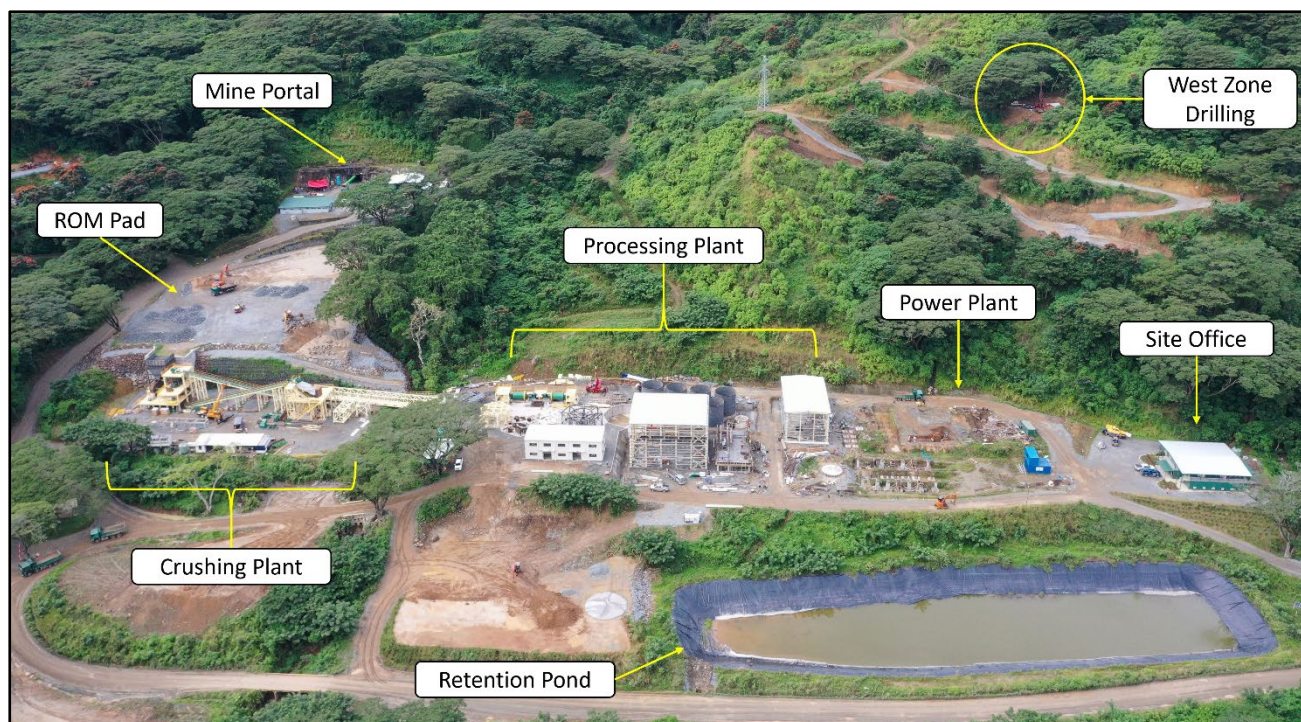
Figure 2. Oblique aerial view of mine site under construction, June 16, 2023.

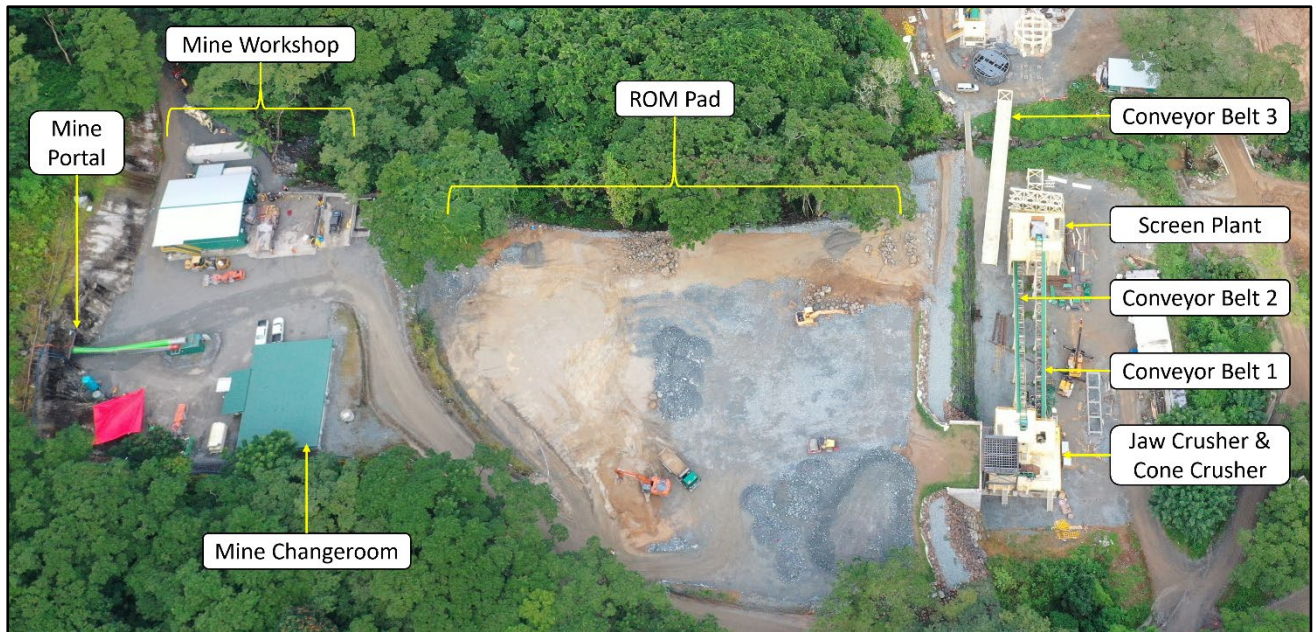
Figure 3. Aerial view of mine portal, ROM pad, and crushing plant, June 16, 2023.

The Lion One processing plant will treat material using a two-stage crushing process, with a primary jaw crusher and a secondary cone crusher. A system of three conveyor belts will transport material between the two crushers and on to the processing plant. The jaw crusher, cone crusher, conveyor belt 1 and conveyor belt

2 are all in place while conveyor belt 3 has been fabricated and needs to be lifted into place. Piping and electrical work remains to be completed. The ROM pad has also been constructed and is in use, with minor upgrades remaining to be completed.

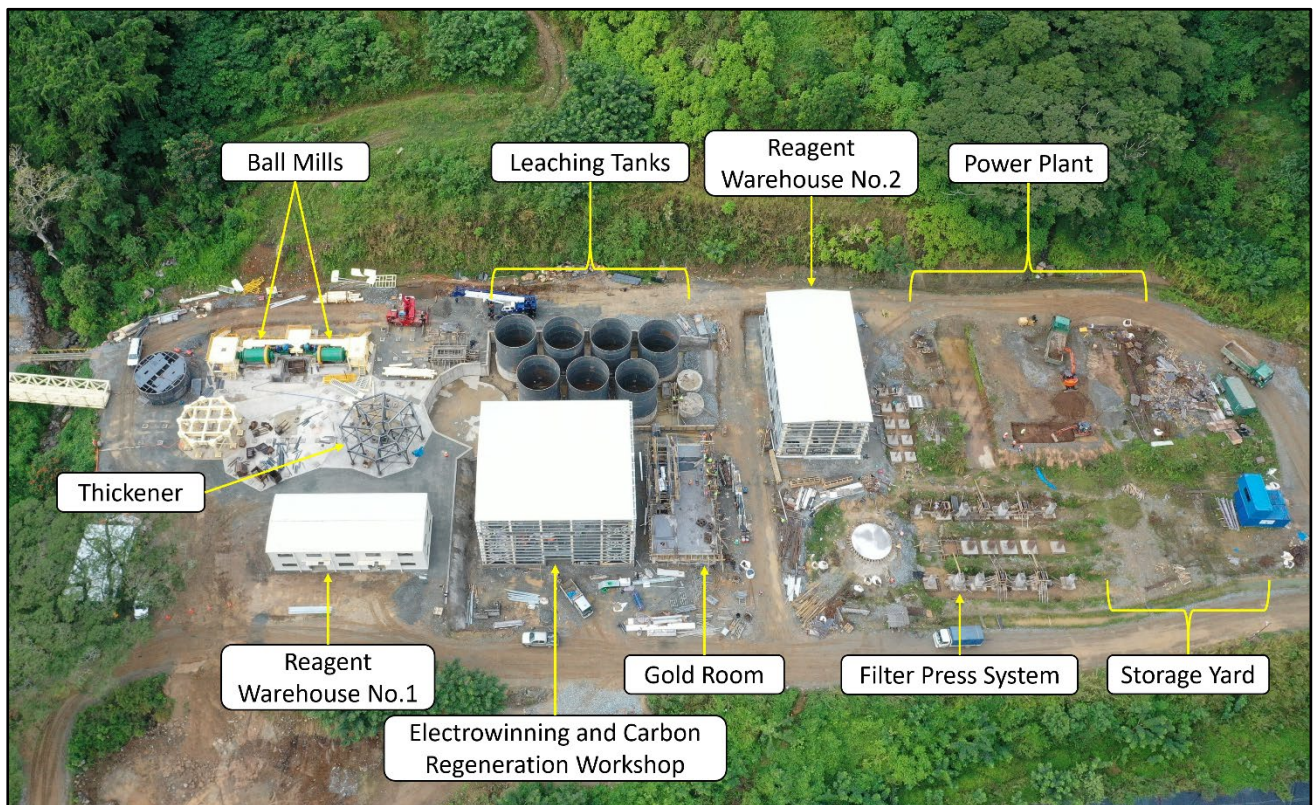
Figure 4. Aerial view of processing plant.

Material from the crushing process will be fed to a two-stage grinding circuit, followed by an integrated two-stage gravity concentration circuit. Some concentrates will then be treated by an intensive cyanide leaching reactor and the remainder of the concentrates will be leached using conventional cyanide Carbon in Leach (CIL) technology. Gold will be recovered from the gold laden carbon using conventional absorption desorption recovery (ADR) technology and smelted on site to produce gold doré bars. Construction is advancing rapidly on the grinding, concentrating, and leaching circuits, as well as on the necessary supporting infrastructure such as warehouses and workshops. Ball Mills 1 and 2 are in place, the leaching tanks are in place, and Reagent Warehouse 1 is nearing completion. All other components of the processing plant are in progress at varying levels of completion. Electrical and piping work remains to be completed.

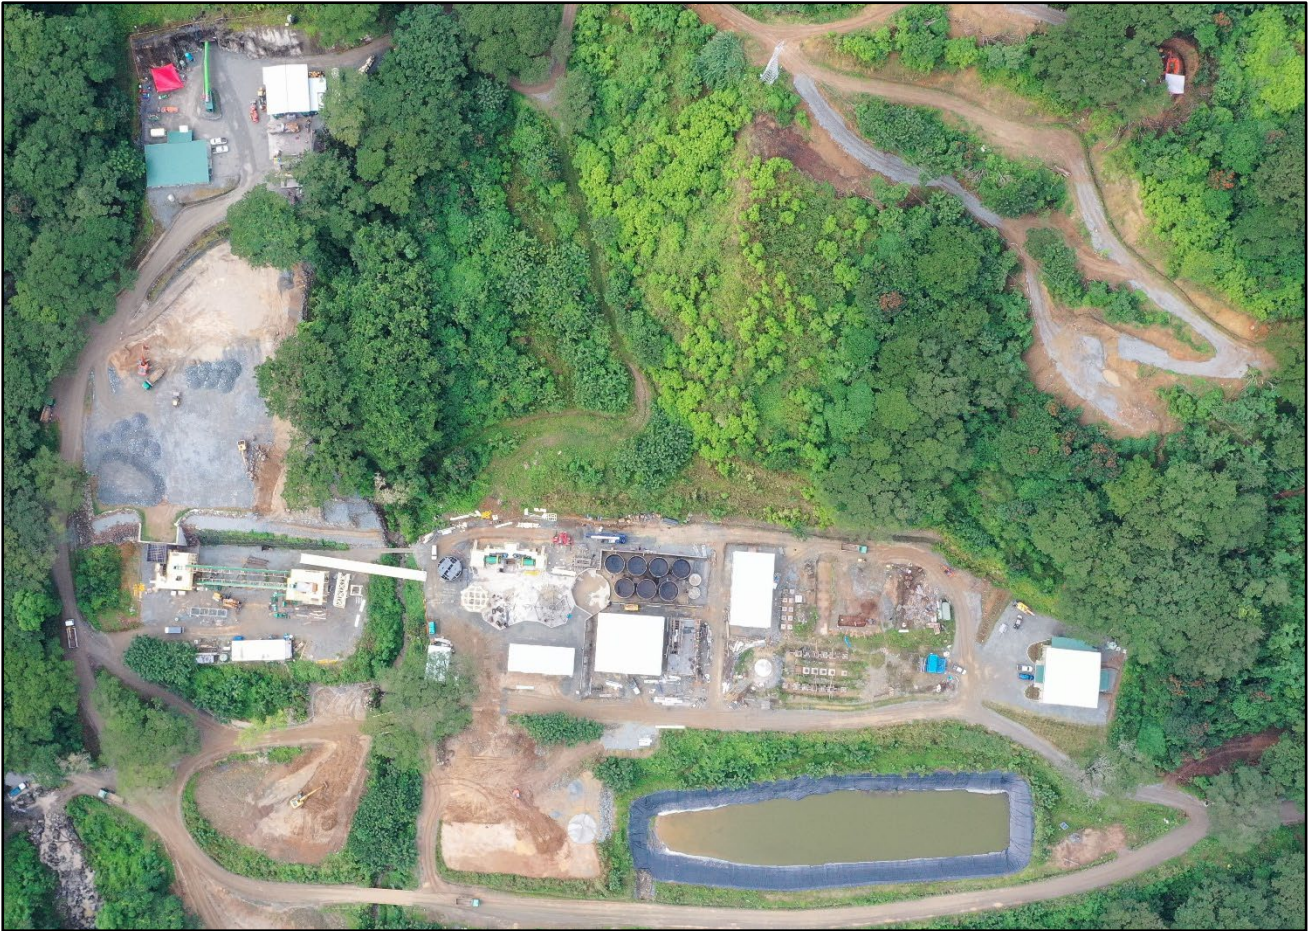
Figure 5. Vertical aerial view of mine site under construction, June 16, 2023.

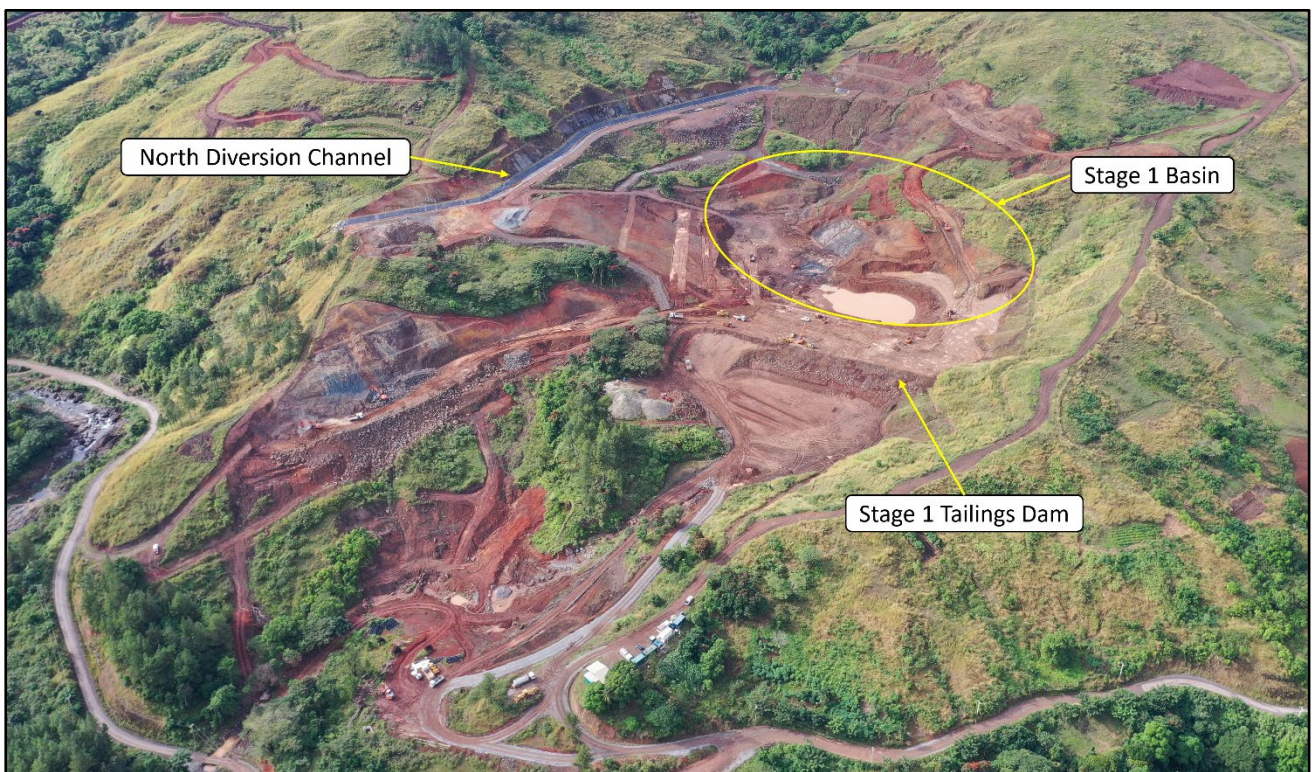
Figure 6. Aerial view of TSF under construction, June 16, 2023.

Tailings from the processing plant will be treated using the SO₂/air process to remove any residual cyanide and will be filtered to produce filtered tailings which will then be transported to the TSF for storage. Stage 1 of the TSF will consist of a dam with a finish level at 115 m elevation, and a pond with enough capacity for 18 months of operation. The tailings dam has currently been built to an elevation of 107 m. TSF construction has been ongoing since June 2022 and the TSF is anticipated to be in operation in Q4 of 2023. Other components of the TSF, such as diversion channels, dam spillway, and liner installation are advancing simultaneously.

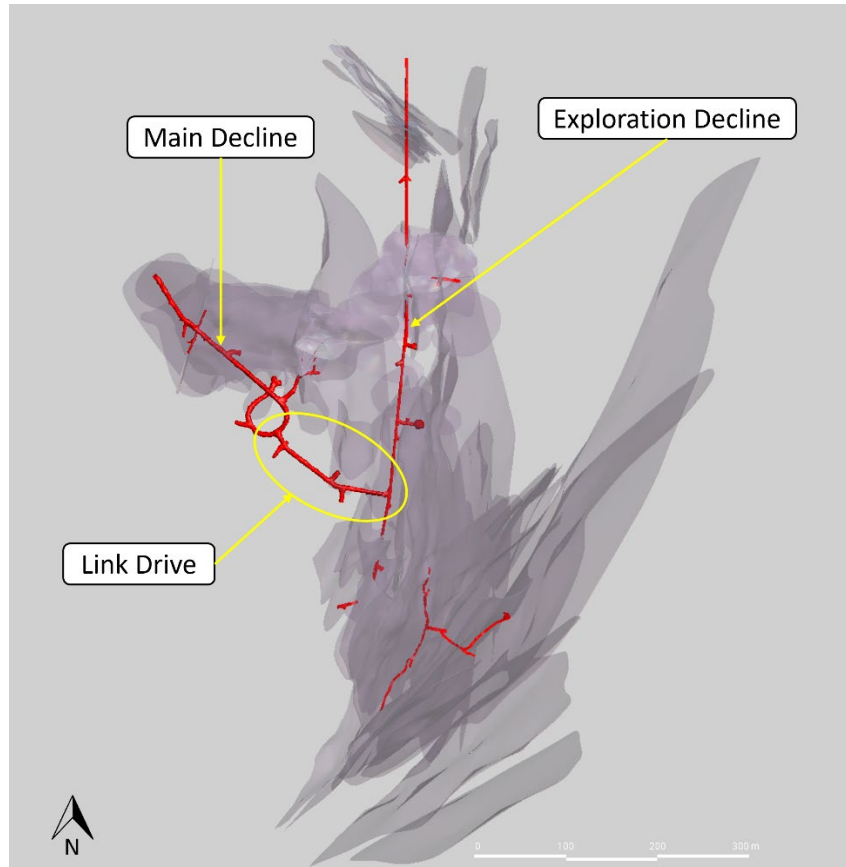
Figure 7. Location of link drive in relation to the main decline and the historical exploration decline. Mineralized lodes are shown in transparent grey. Connecting the main decline to the exploration decline enables the Stage 1 primary ventilation system to be installed and enables mining of the lodes accessed through the exploration decline.

Underground mining of the [URA1](#) , [URW1a](#) and [URW1b](#) lodes is ongoing. The main decline has reached a vertical depth of 99.4 m below surface and a total length of 344 m from the mine portal. The link drive connecting the main decline to the historical exploration decline has been completed and measures 140 m from the junction with the main decline to the junction with the historical exploration decline. The link decline was driven from the main decline to the exploration decline and broke through the exploration decline on June 21st, 2023.

The completion of the link drive is a major milestone in the development of the mine as it enables the Stage 1 primary ventilation system to be installed. The Stage 1 primary ventilation system consists of four 55KW exhaust fans that are being installed at the entrance to the historical exploration decline, and which will provide ventilation throughout the mine. The Stage 1 primary ventilation system will provide sufficient ventilation to mine all the way down to the 500 zone, which is part of the high-grade feeder zone underlying Tuvatu and which comprises a major component of the mine plan. The completion of the link drive also enables mineralized lodes to be mined both from the historical exploration decline as well as from the main decline, thereby increasing the number of faces available to mine and adding considerable flexibility to the mining operations.
